MILL CREEK GEOGRAPHIC INITIATIVE

**MILL CREEK WATERSHED
LOGAN, UNION, DELAWARE COUNTIES
and
MARYSVILLE, OHIO AREA**

SEPTEMBER 1998

Dan Tjoelker
Ohio Environmental Protection Agency
Division of Emergency & Remedial Response
Central District Office
Columbus, Ohio

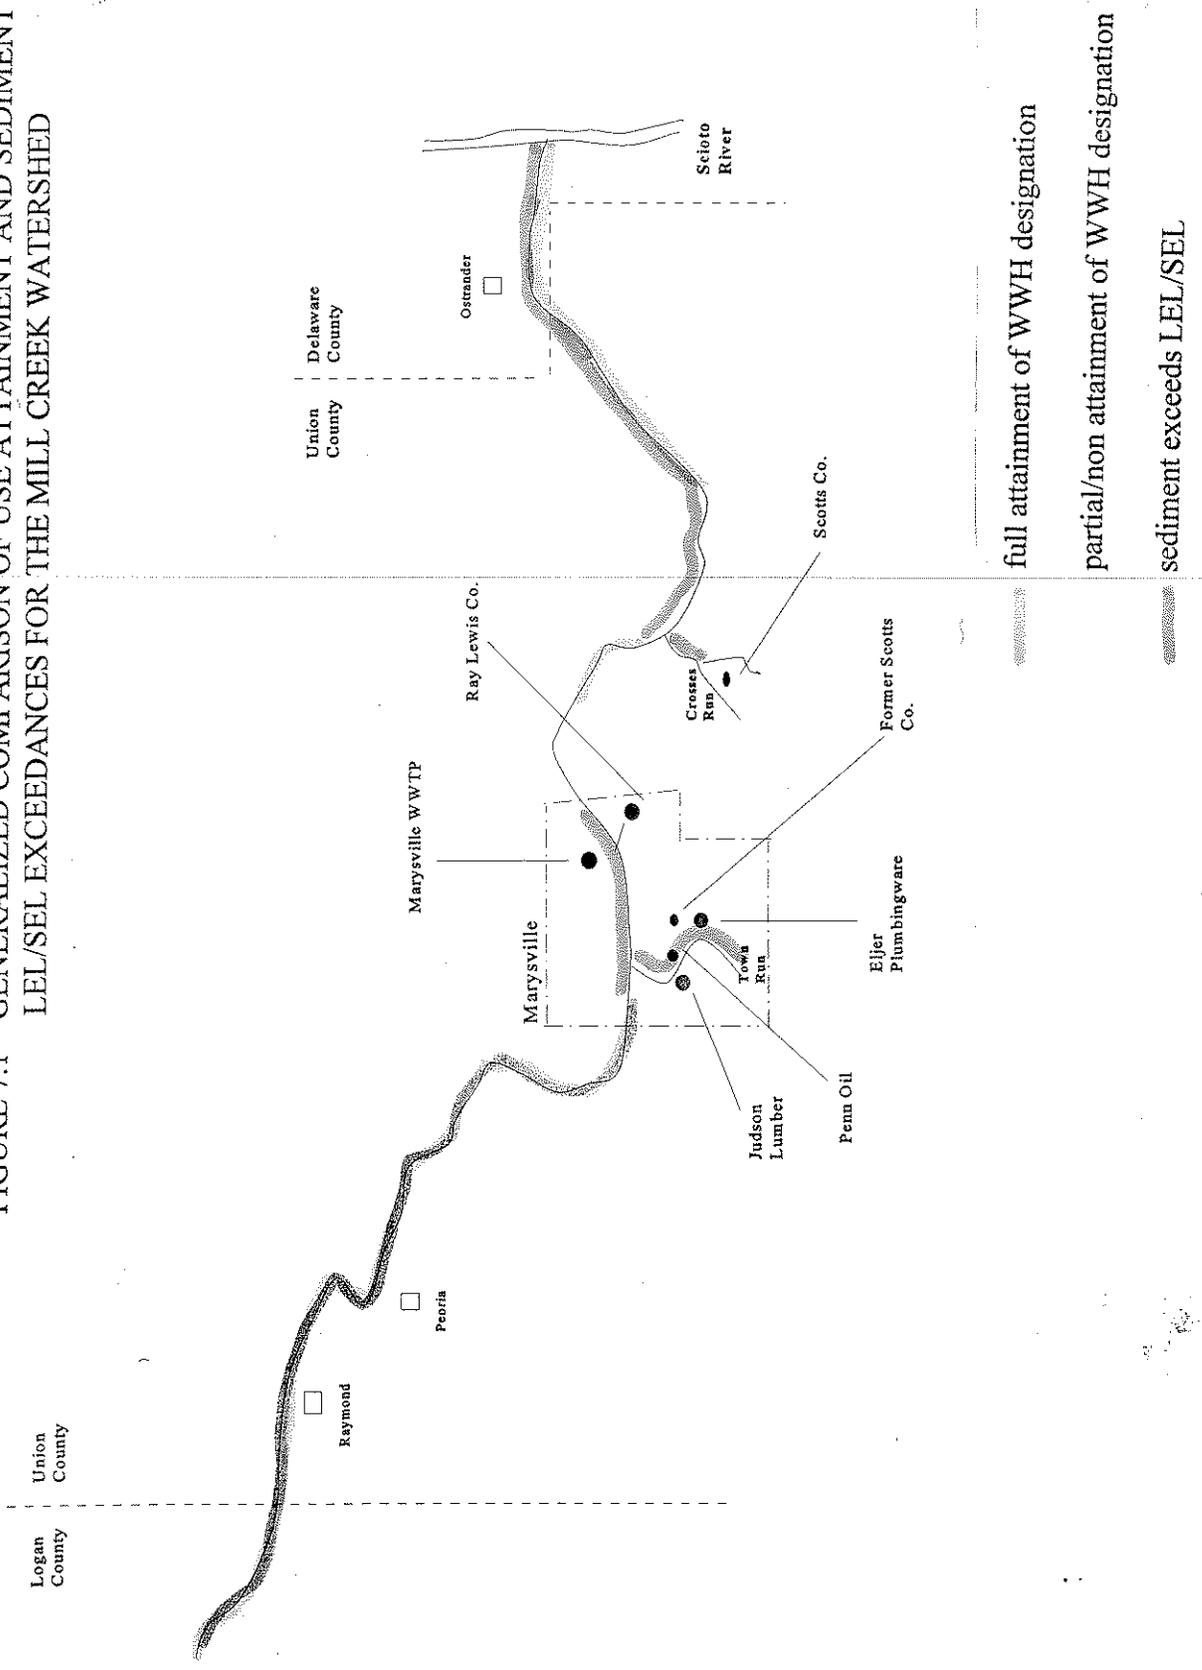
FIGURE 7.1 GENERALIZED COMPARISON OF USE ATTAINMENT AND SEDIMENT LEL/SEL EXCEEDANCES FOR THE MILL CREEK WATERSHED

Figure 7.1 provides a comparison of use attainment based on DSW ecological studies to the chemical sampling results and LEL/SEL exceedances. Where biological communities fail to support expected uses, the chemical data indicates elevated levels of contamination. The only instance where this correlation is not observed is well downstream of Crosses Run in the lower reaches of Mill Creek (RM 1.6). Biological communities reflected exceptional quality despite low level pesticide contamination that exceeded LEL screening values. Contamination persistence and further migration from upstream sources would be of greater concern in this portion of Mill Creek.
