Re: **Hazardous Waste Permit Modification**
Class 1 Acknowledgment – Envirosafe Services of Ohio, Inc.
U.S. EPA ID# OHD 045 243 706 / Ohio Permit #03-48-0092

CELL M TRANSDUCER CERTIFICATION REPORT

ENVIROSAFE SERVICES OF OHIO INC.
876 OTTER CREEK RD
OREGON, OH 43616

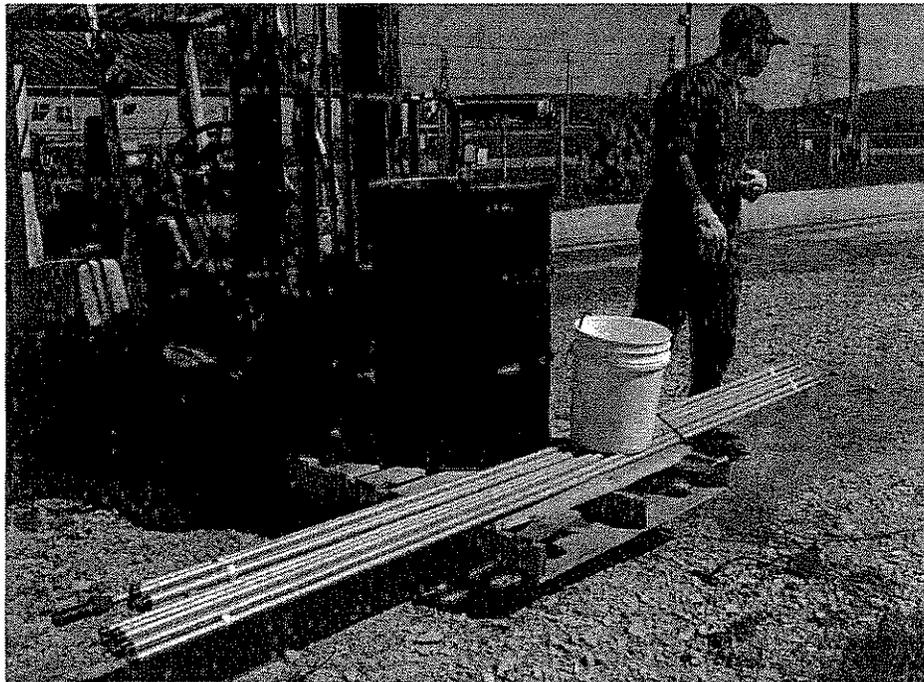
Threaded-galvanized steel rods (typical).

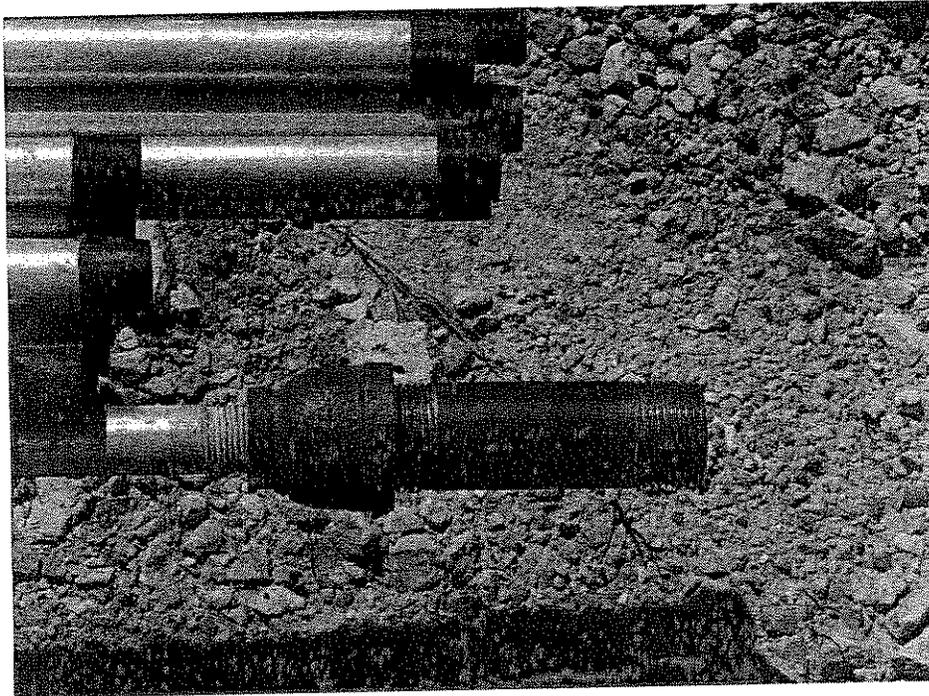
Typical protective steel pipe attached to reducer at end of galvanized steel rod.

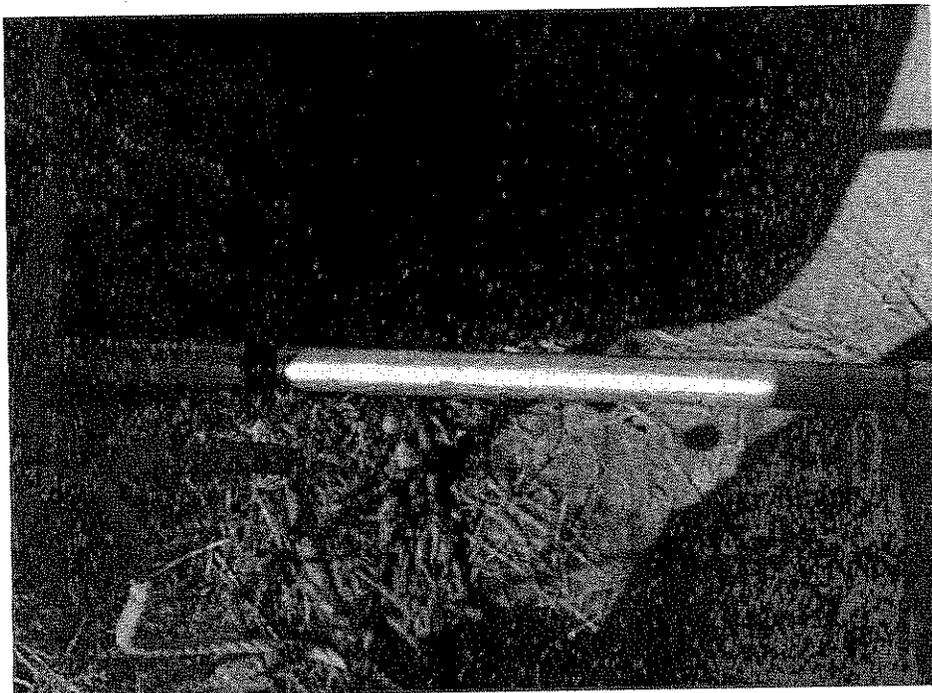
Galvanized steel rod (typical) during insertion.

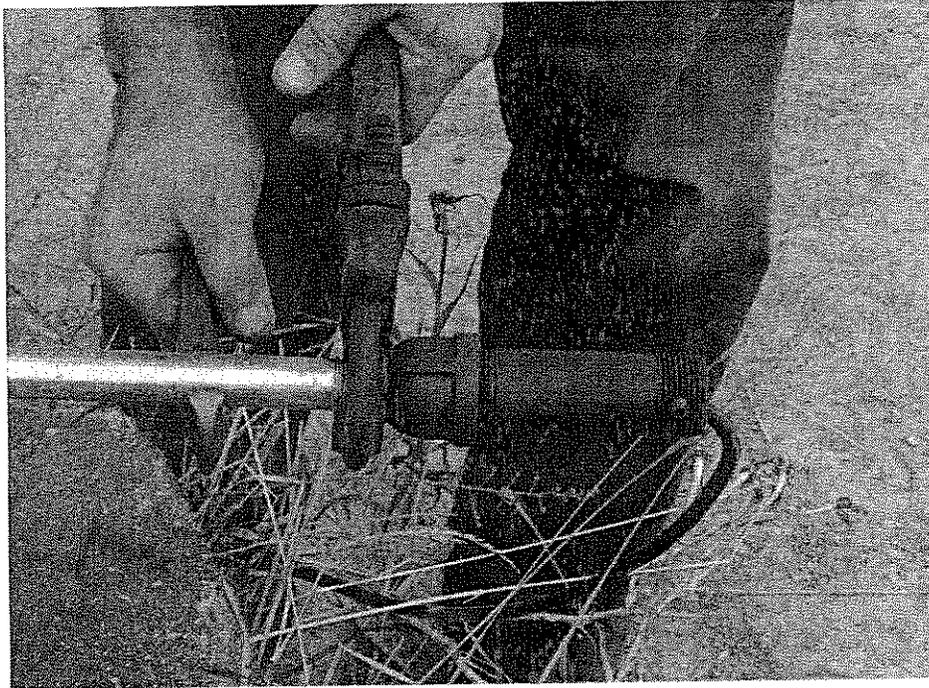
Galvanized steel rod with reducer. Attachment at end of steel rod protects transducer.

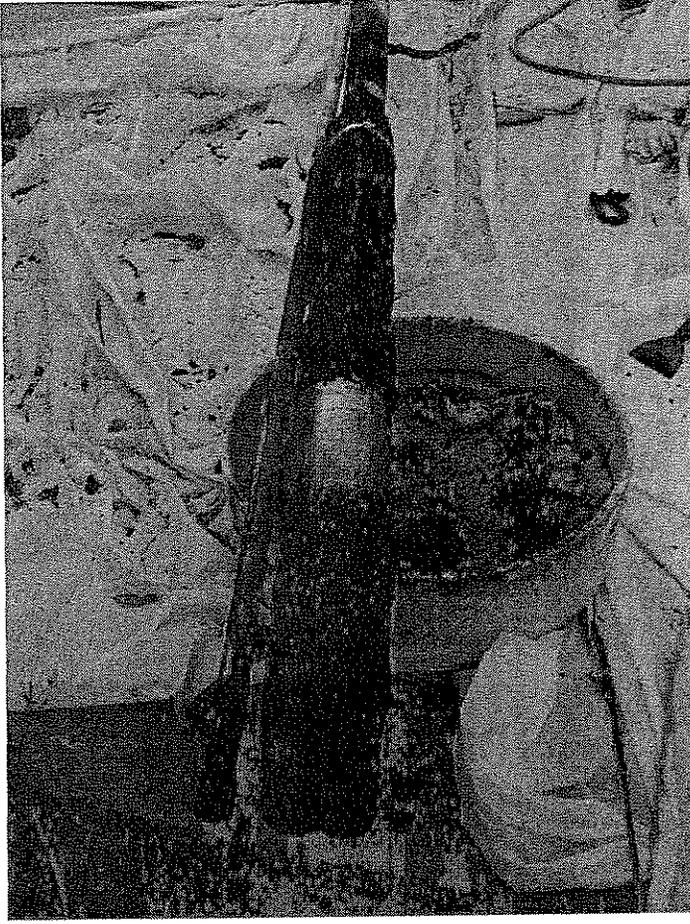
Pump with galvanized steel rod attached.

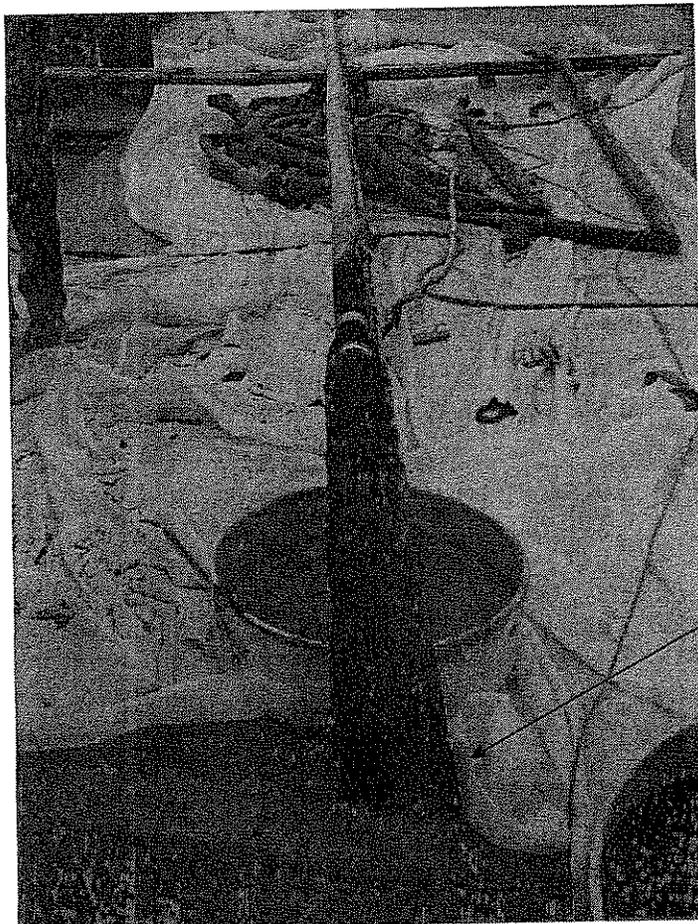
Pump to be replaced.

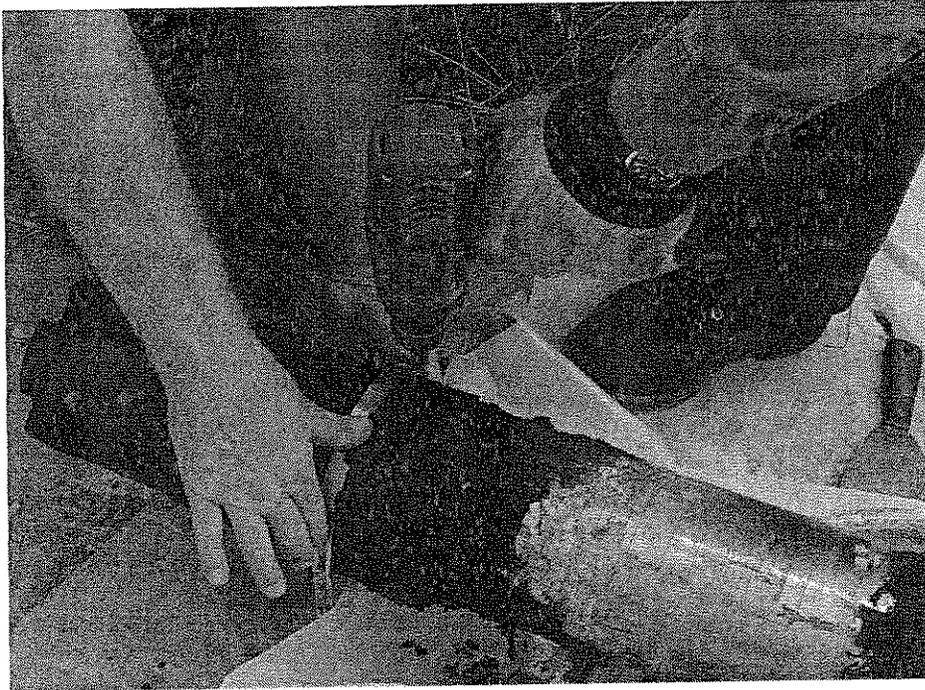
Attaching steel rod to motor housing with stainless steel clamp.

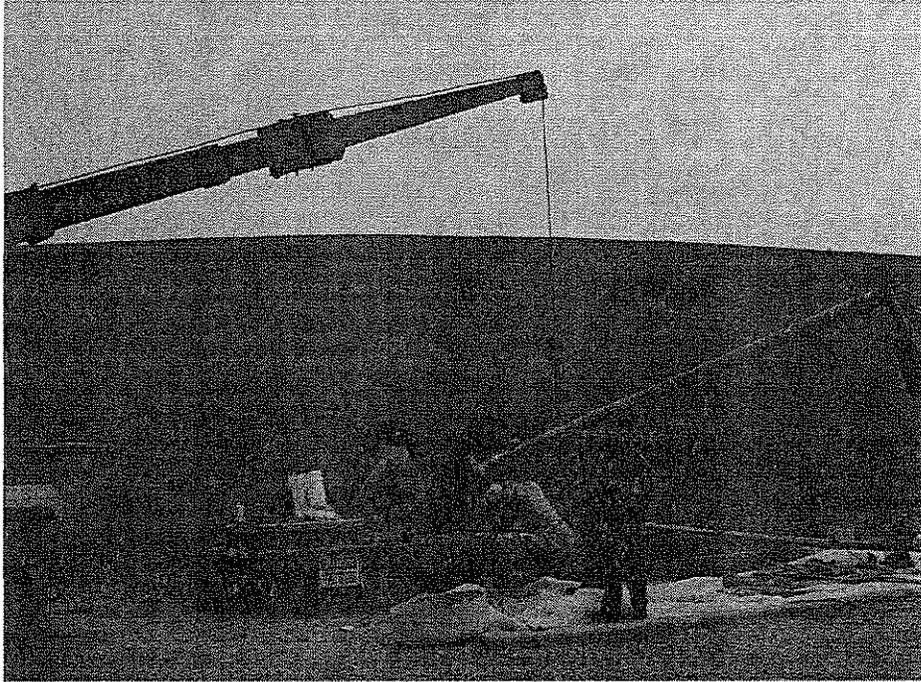
Installation of pump and transducer at M-5

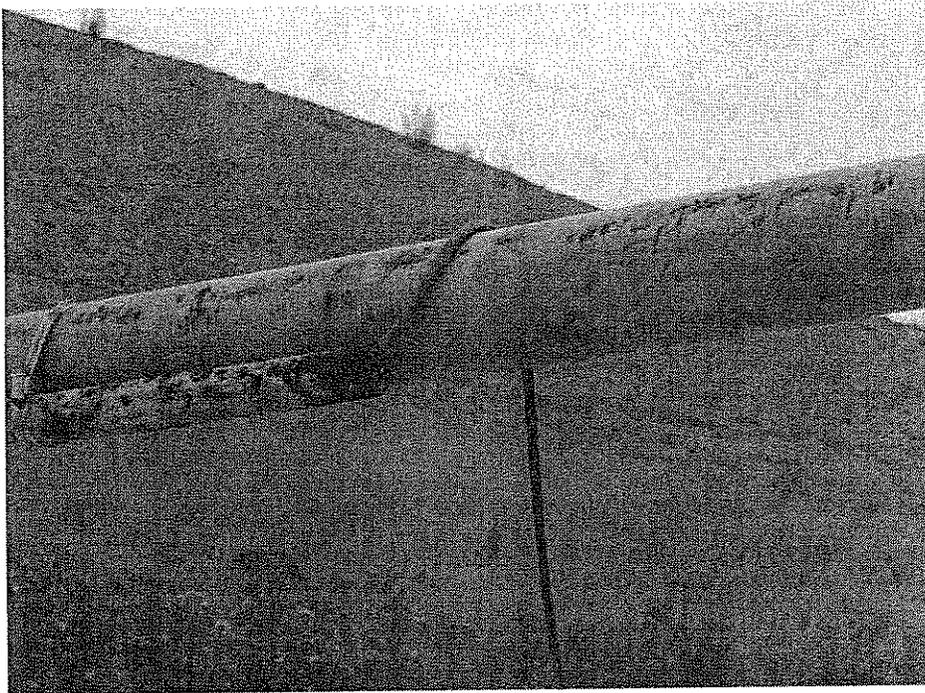
Upper end of steel rod attached to discharge pipe.

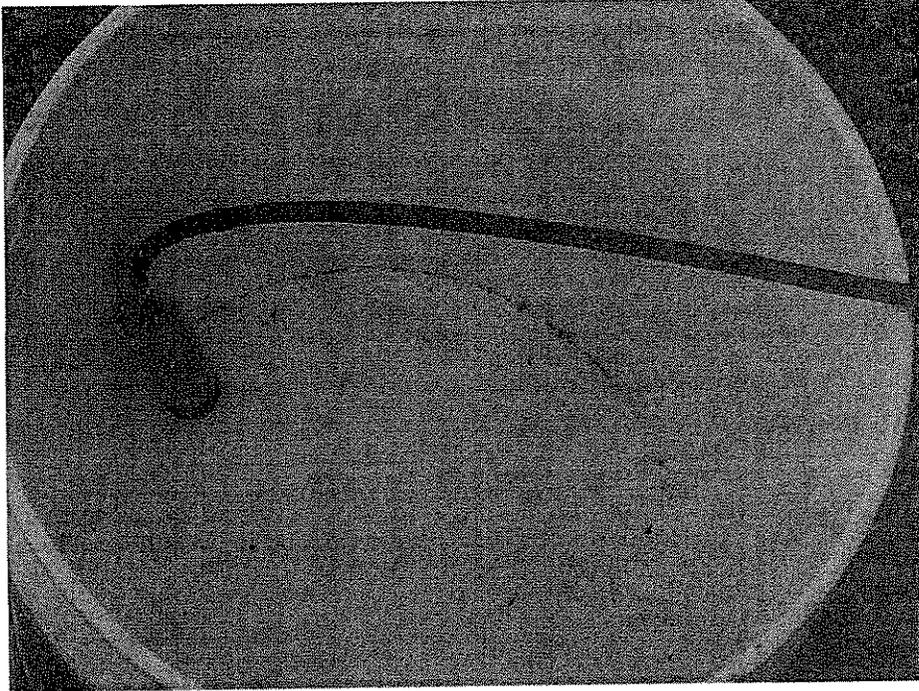
Confirming calibration of transducer prior to installation.

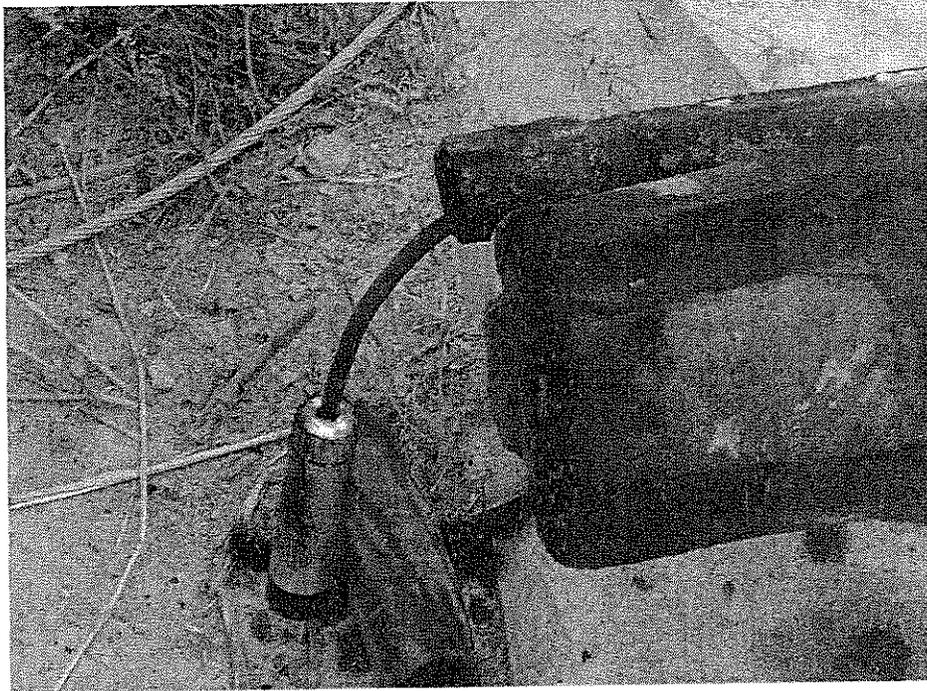
Transducer prior to insertion in steel rod.

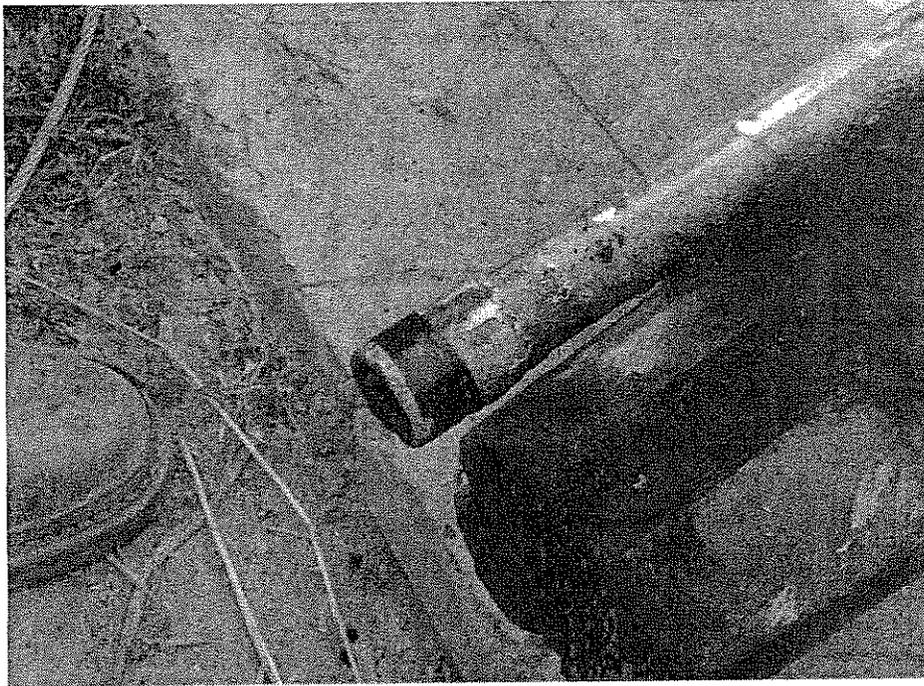
Galvanized steel rod attached to end of pump motor casing.
Transducer positioned inside rod end for protection.

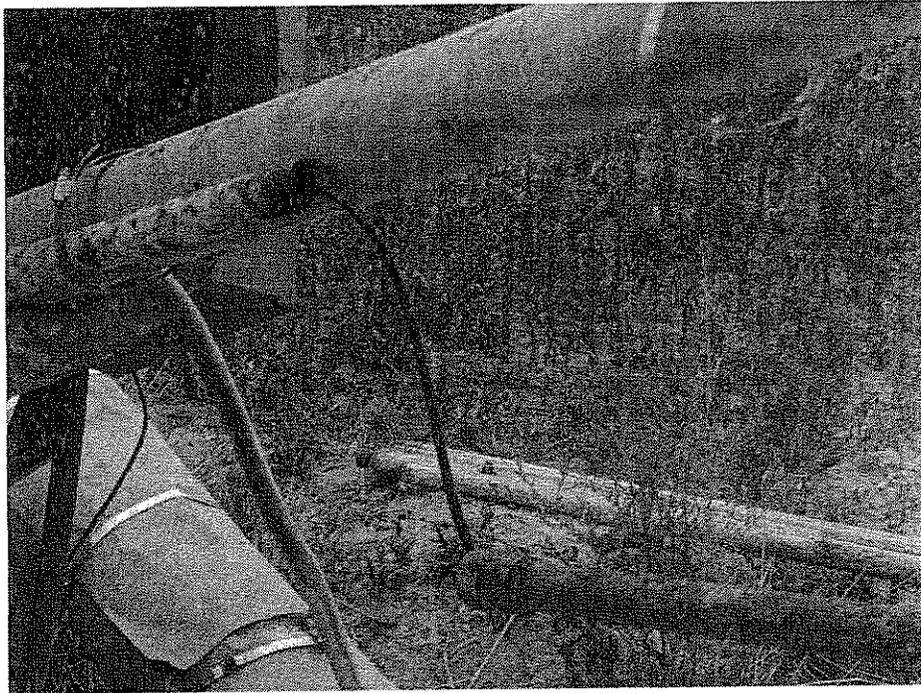
Steel rod with inserted transducer wire.

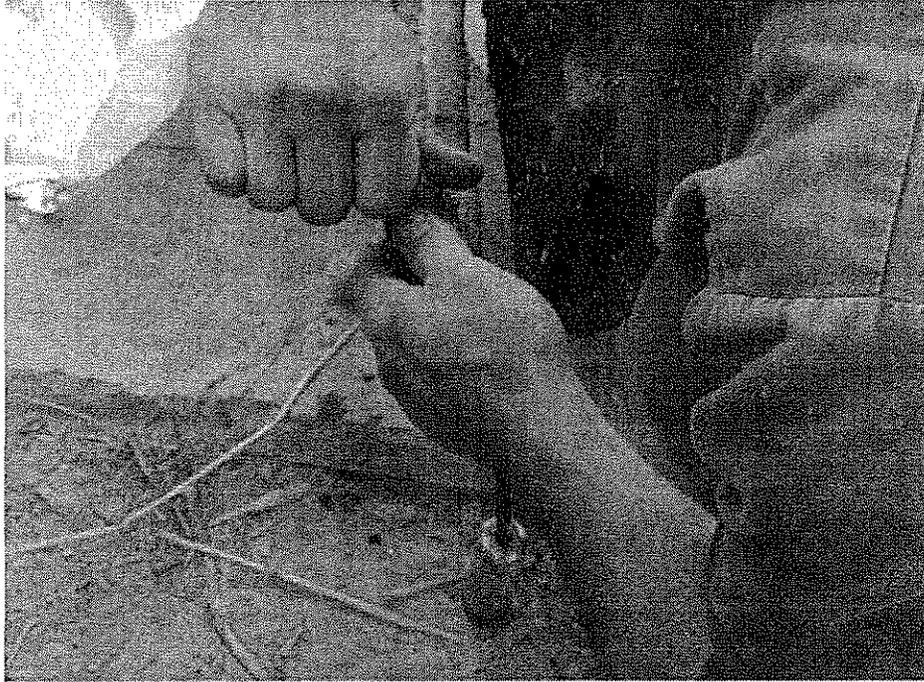
Installation of transducer in steel rod.

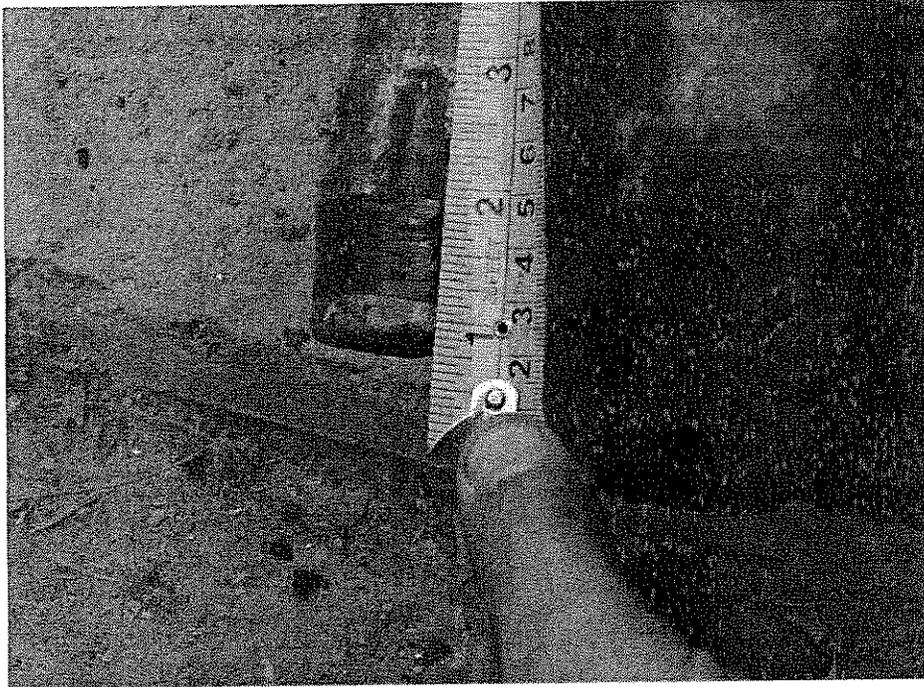
Measurement confirmation of position of end of rod (transducer) relative to end of pump motor housing where attached to pump (typical-M5 & M6).

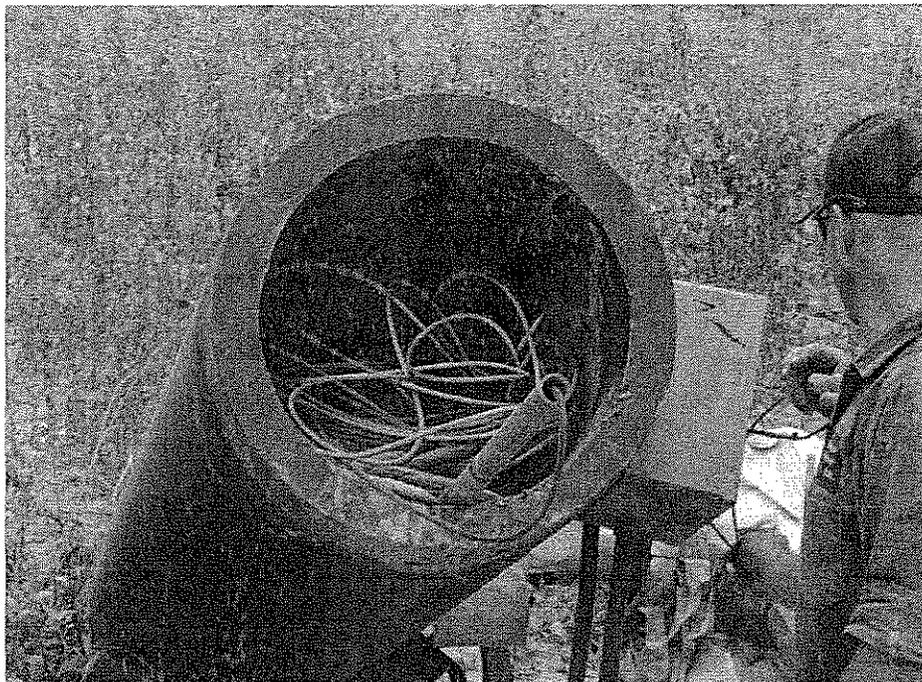
Galvanized steel rod in slope riser pipe following installation.

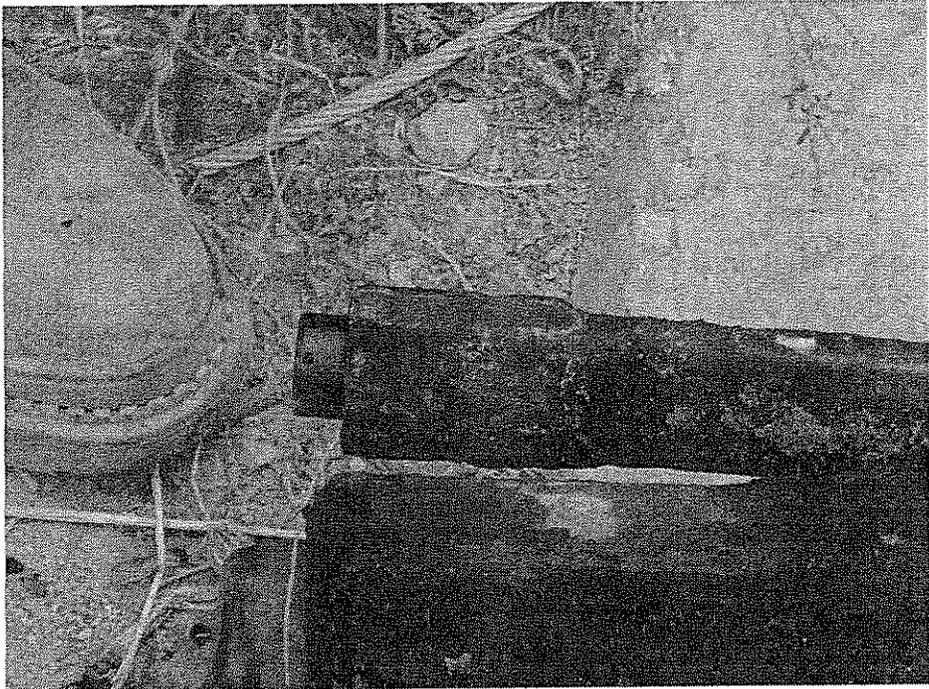
Transducer installed in protective pipe.
