Biological and Water Quality Study of the Ashtabula River and Select Tributaries, 2011

Ashtabula County

OHIO EPA Technical Report EAS/2014-01-01

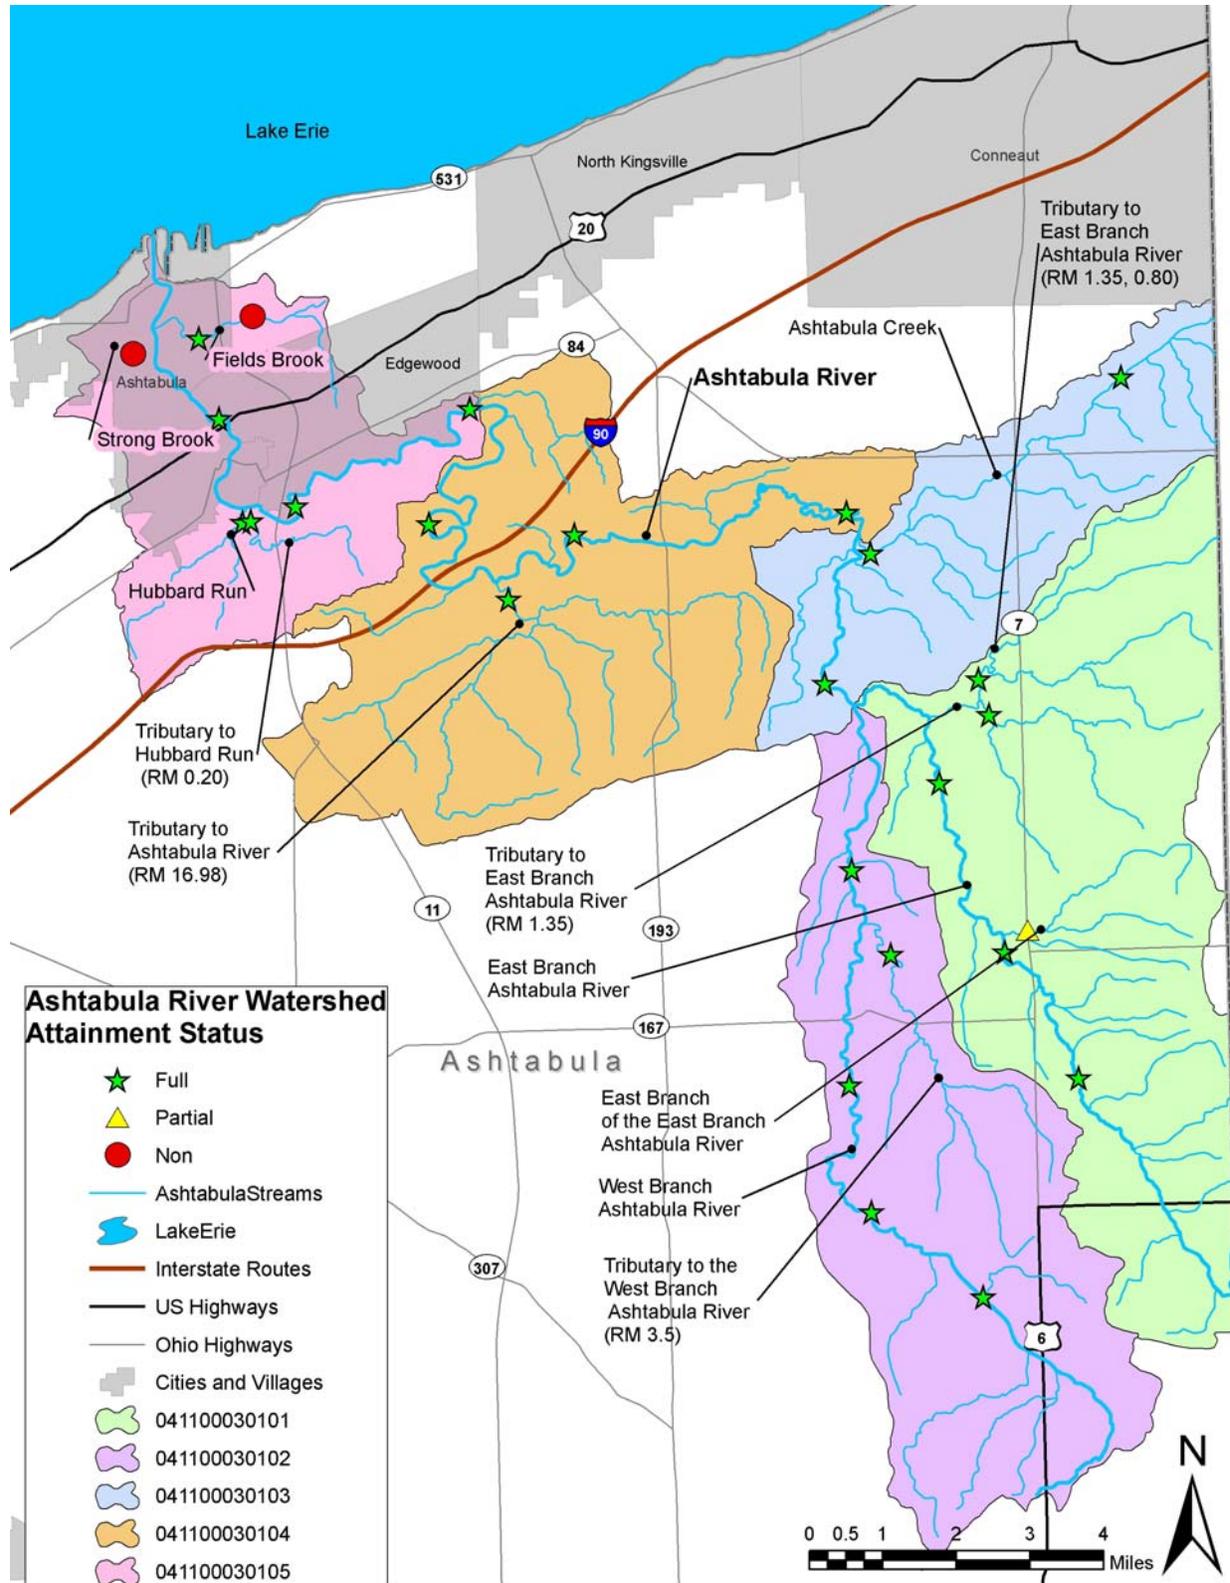
Figure 1. Map of the aquatic life use attainment status in the free-flowing reaches of the Ashtabula River basin, 2011.

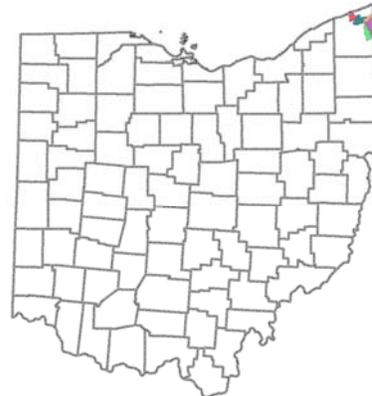
Figure 2. Location of the Ashtabula River watershed in Ohio.

The Ashtabula River watershed, delineated by United States Geological Survey as 8-digit hydrological unit code (HUC) 04110003, is located in the northeast corner of Ashtabula County in northeast Ohio (Figure 2). In 2011 the Ohio EPA conducted a water resource assessment of the Ashtabula River mainstem and tributaries using standard Ohio EPA protocols as described in Appendix A. Included in this study are assessments of the biological, habitat, surface water, sediment, and recreational (bacterial) condition. The Ashtabula River mainstem and twelve tributaries were evaluated with a total of 26 biological, 26 habitat, 27 water chemistry and 26 recreation stations sampled within the study area. Eight stations were sampled in 2012 from Strong Brook and its tributaries to evaluate sediment contamination (Table S1). Nine stations were also sampled in the lacustrine in 2011 as part of a Great Lakes Restoration Initiative (GLRI) grant (#GL00E00569) received by Ohio EPA and these will be further assessed and reported on in detail by that process.

Among Ohio's significant Lake Erie tributary rivers, the Ashtabula with a 137 mi² drainage area is the smallest. Located east of Cleveland, with 10 mi² of watershed across the Pennsylvania border, the Ashtabula River enters Lake Erie near the State's far northeastern corner (Figure 2). This location places the basin directly within the Lake's Snow Belt where 70 inches fall annually. Including snow, the area's annual 40 inches of precipitation ranks among the wetter places in the State. See the ODNR Division of Soil and Water Resources, Water Inventory web site for more information, <http://www.dnr.state.oh.us/tabid/4237/Default.aspx>.

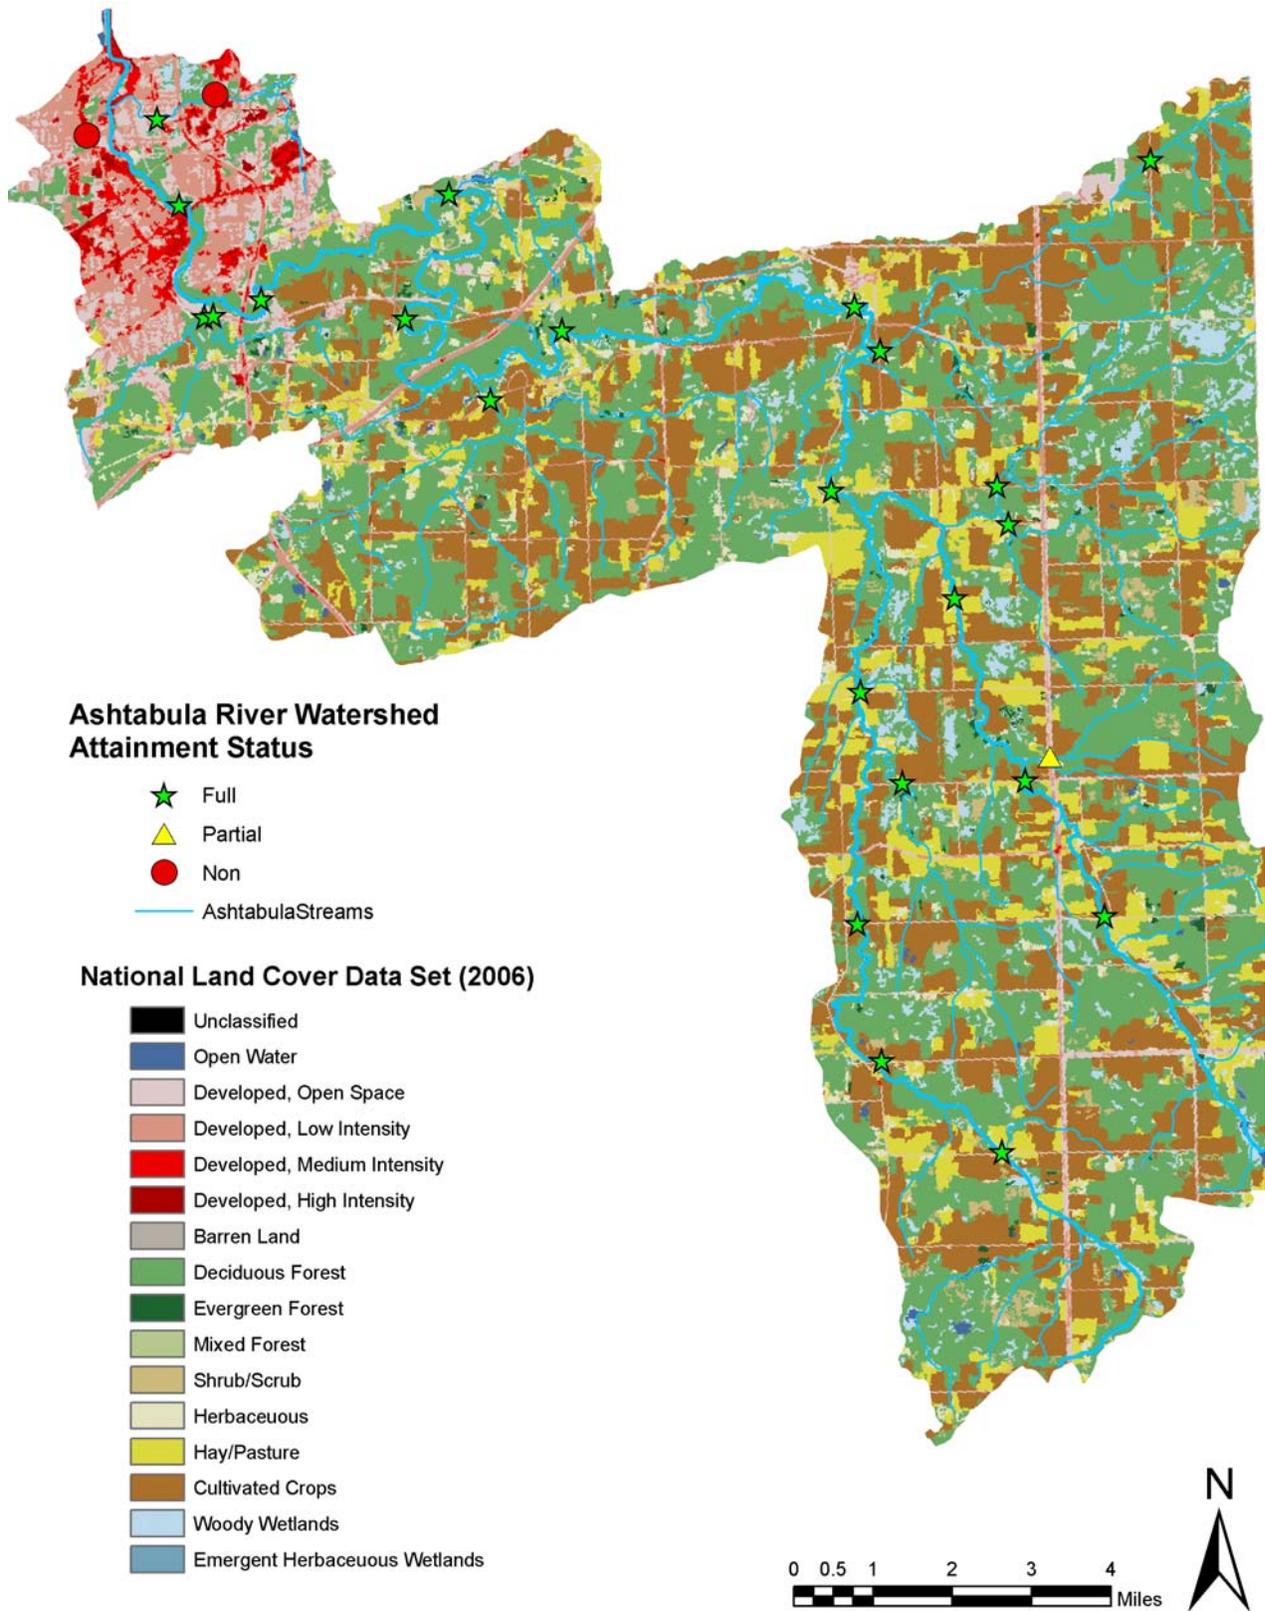
Figure 3. Map of land use in the Ashtabula River watershed (Fry et al. 2011) and the aquatic life use attainment status in the free-flowing reaches.

The area Mahoning soils common throughout the watershed have slow permeability and underlying shales return little ground water to surface flows (Schiefer 2002: 79). Agricultural and developed land uses further influence local hydrology (Figure 3, Table 3). Drainage improvements, encouraged since settlement (Williams 1878: 16) and continuing today, lower the local water table. Combined, these factors expedite surface runoff and impede infiltration. So, although the Ashtabula basin has a high mean annual runoff (17.3" compared to 10" to 21" statewide, Schiefer 2002: 81, 27), it routinely exhibits zero summer low flow conditions (Q7, 2=0 cfs).

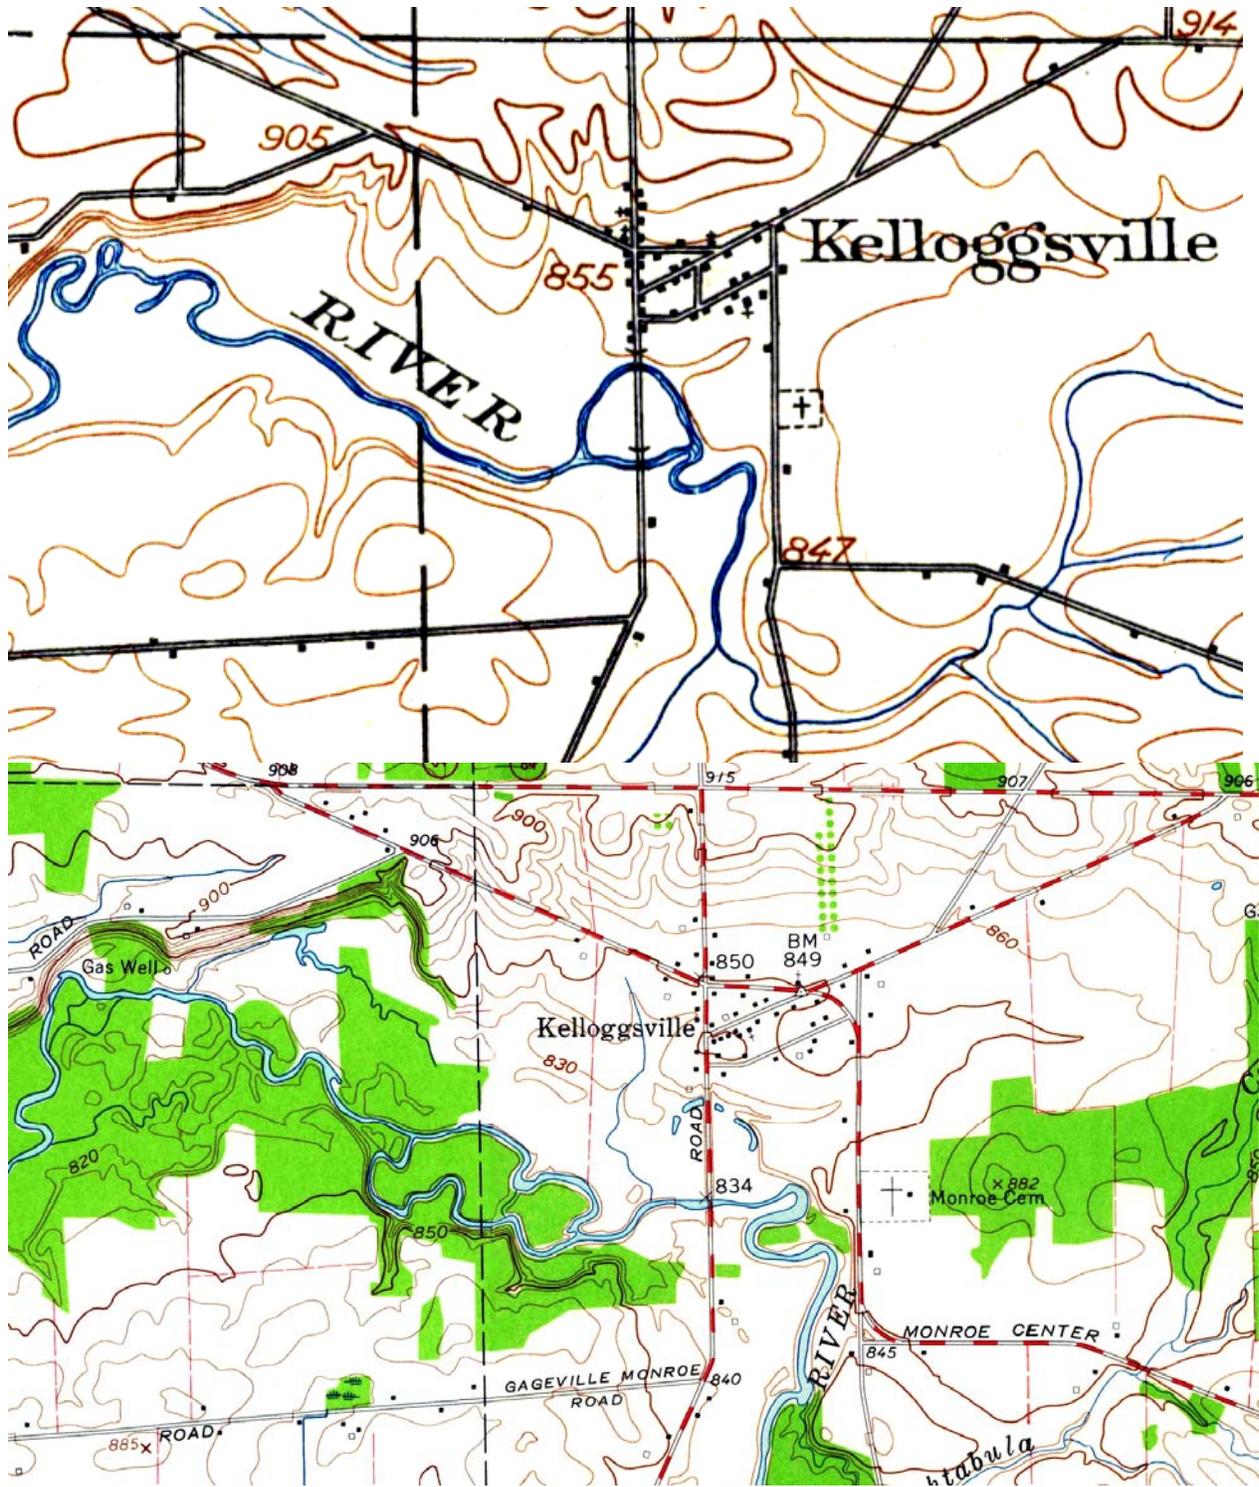
Figure 4. USGS topographic maps showing Ashtabula River changes in the Kelloggsville vicinity. Top map cropped from 1906 Conneaut quadrangle. Bottom map cropped and joined from 1960 Gageville and Pierpont quadrangles.

Historically, the Ashtabula River once flowed a few blocks from the center of Kelloggsville (Lake 1874). A cut off channel formed and other modifications occurred apparently as a consequence of a severe flood in 1878. The 1906 Conneaut, O.-PA. United States Geological Survey (USGS) topographic map shows the Ashtabula River with a large island south from Kelloggsville (USGS 1906). By 1960, the northern loop had been abandoned, but another channel formed downstream, creating a new island area (Figure 4, USGS 1960a, USGS 1960b). Contemporary maps appear similar to the 1960 conditions. In 2011, the Ashtabula River upstream from Stanhope Kelloggsville Road (the north south bisecting route in Figure 4) was unstable. Outside bends of the two closest meanders were severely eroded. Overall, this reach appeared to be in disequilibrium with periodically elevated storm flows.

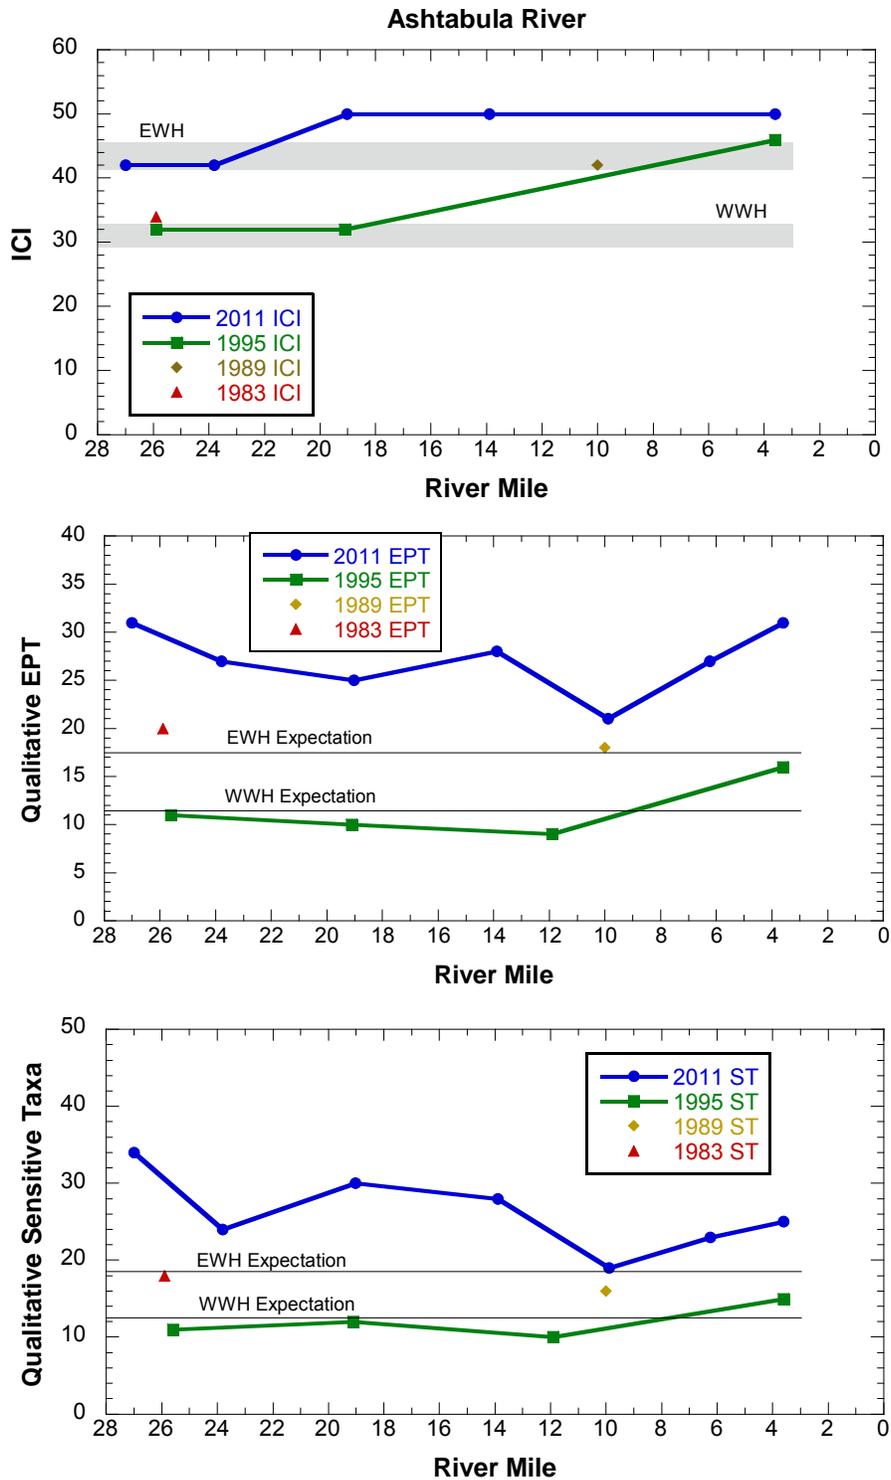
Figure 5. Longitudinal trend of the Invertebrate Community Index (ICI), number of mayfly, stonefly, and caddisfly taxa (EPT) in the qualitative samples, and number of sensitive taxa (ST) in the qualitative samples in the Ashtabula River, 1983-2011.

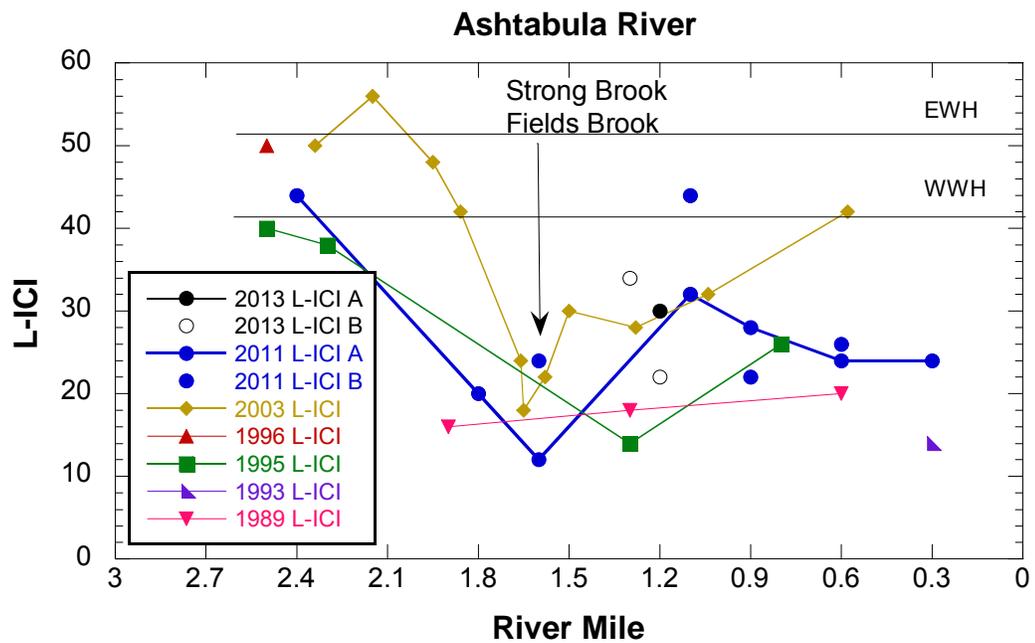
Figure 6. Longitudinal trend of the Lacustrine Invertebrate Community Index (L-ICI) in the Ashtabula River lacustrine, 1989-2013. The A samples were collected from mid-channel and the B samples were collected near the margin.

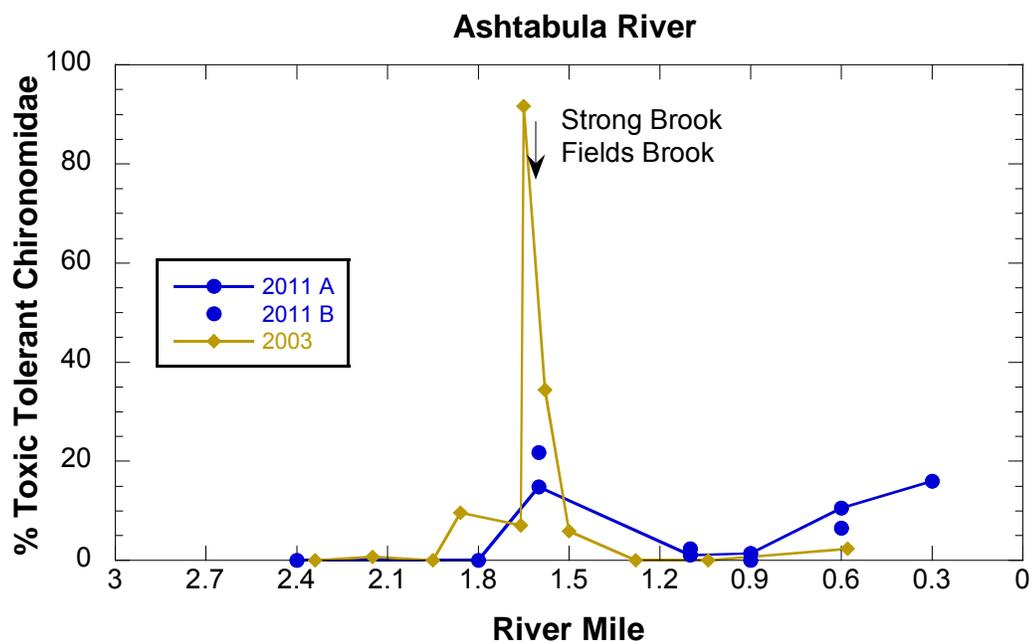
Figure 7. Longitudinal trend of the percent insect family Chironomidae (midges) that were toxic tolerant in the Ashtabula River lacustrine, 2003-2011. The A samples were collected from mid-channel and the B samples were collected near the margin.

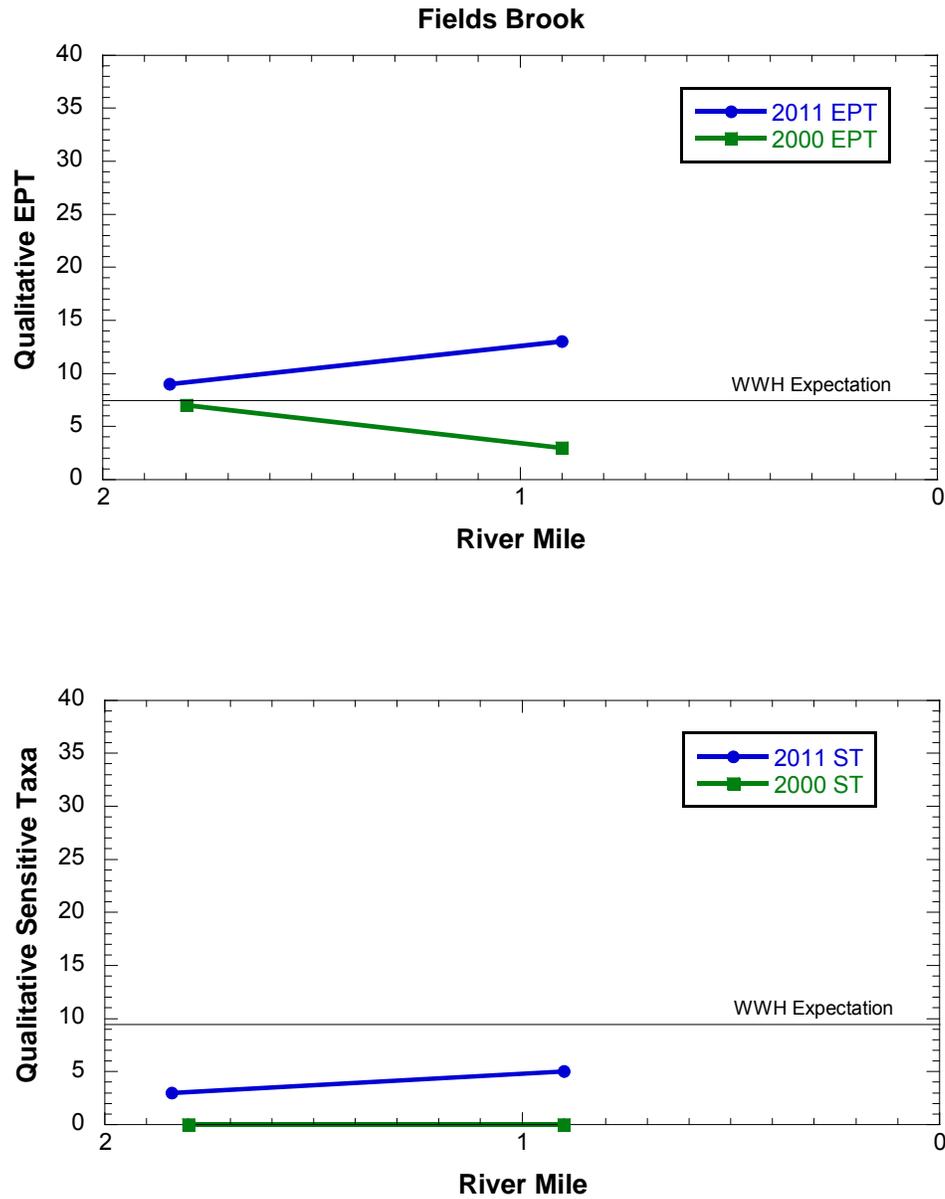
Figure 8. Longitudinal trend of the number of mayfly, stonefly, and caddisfly taxa (EPT) and number of sensitive taxa (ST) in the qualitative samples in Fields Brook, 2000-2011.

The 2011 survey was the first time that the majority of the Ashtabula River basin was systematically sampled. The Ashtabula River mainstem was sampled at four stations in 1995. The communities sampled during this study were performing substantially better than in 1995 with very good (2 sites) to exceptional (5 sites) evaluations compared to marginally good (3 sites) to exceptional (1 site) (Figure 5). A similar trend was observed at a station near the mouths of the West Branch Ashtabula River (very good in 2011 compared to marginally good in 1995 and good in 1984) and the East Branch Ashtabula River (exceptional in 2011 compared to marginally good in 1995). The macroinvertebrate communities sampled in Fields Brook during this study demonstrated moderate improvement compared to sampling in 2000 (Figure 8).

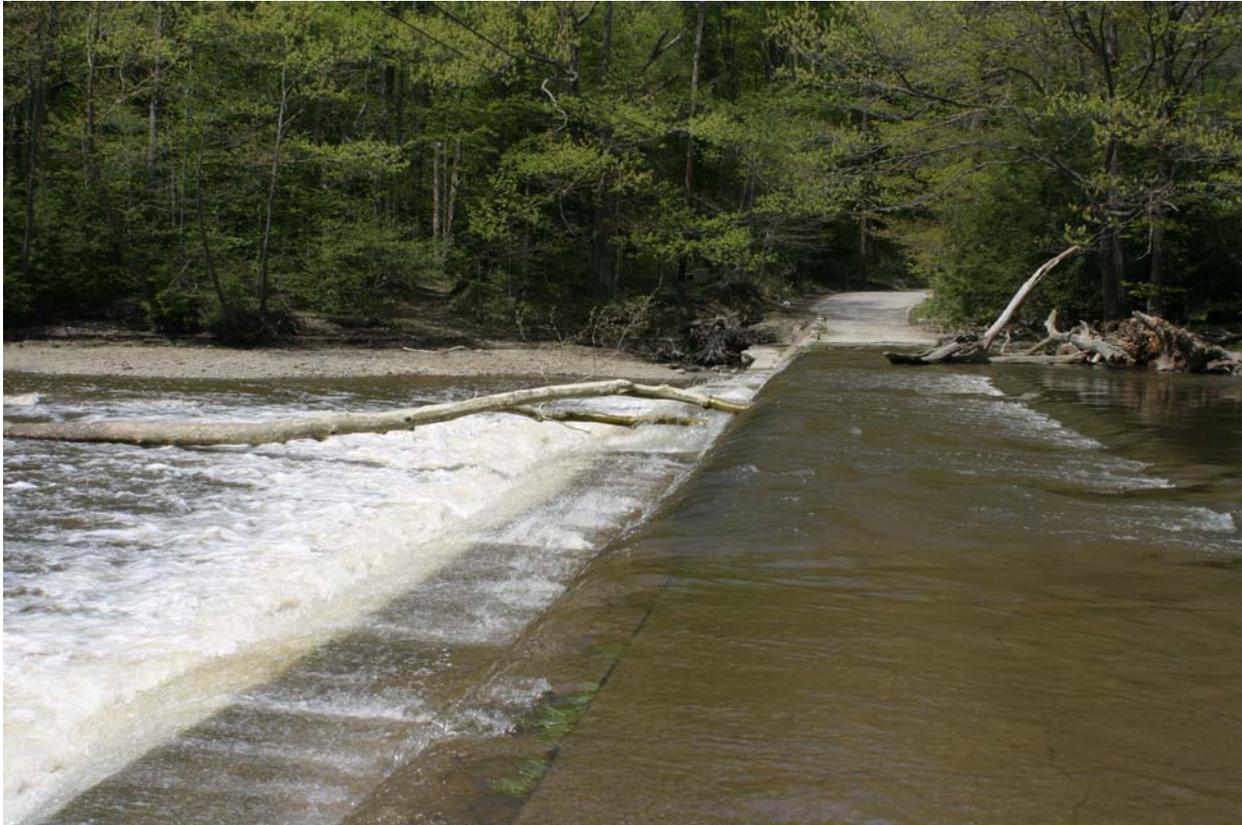
Built by the Works Progress Administration (1935-1943), the Hadlock Road ford shunts most normal summer water flow through two culverts so that little water actually passes over the single lane concrete road surface. From downstream, the face of the ford appears similar to a low head dam. Upstream, the lack of an appreciable pool makes the ford seem more like a ledge. Considering the disparity between fish species from either side of the ford, it's apparent that Hadlock Road is the upstream limit for many fish species.

Figure 9. Photo of the Hadlock Road ford on the Ashtabula River.

The Hadlock Road ford on the Ashtabula River (RM 10.04) appears to be a barrier to fish migration. Twice as many fish species were found downstream (67) from the ford compared to

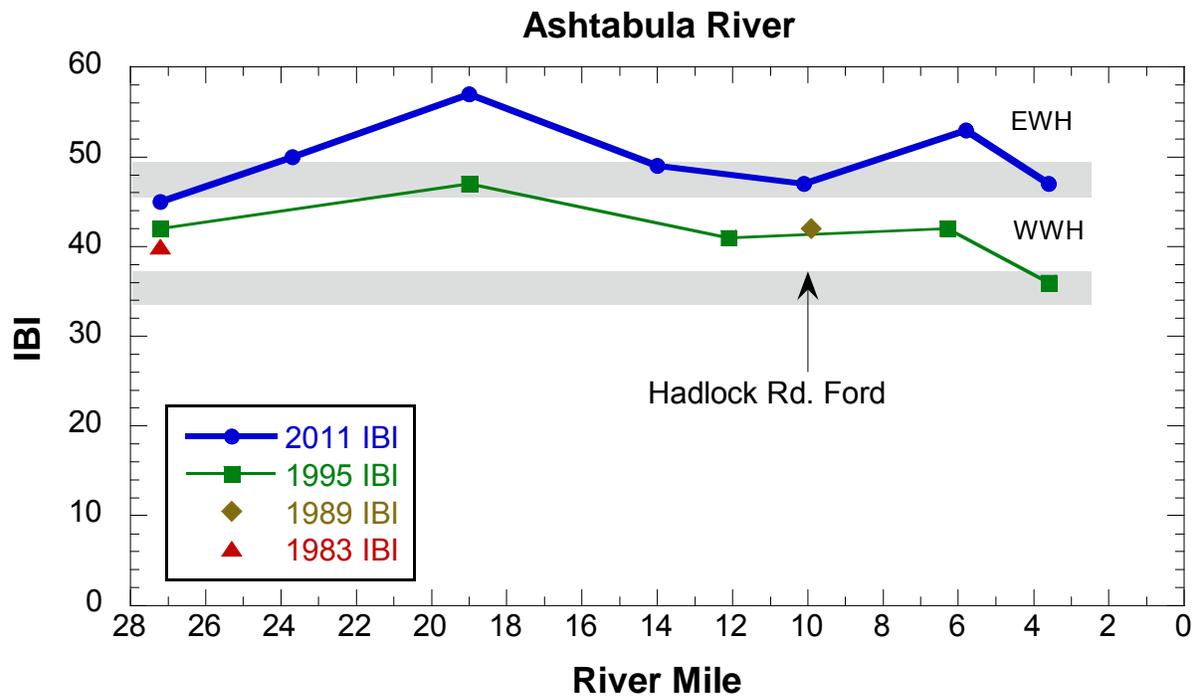
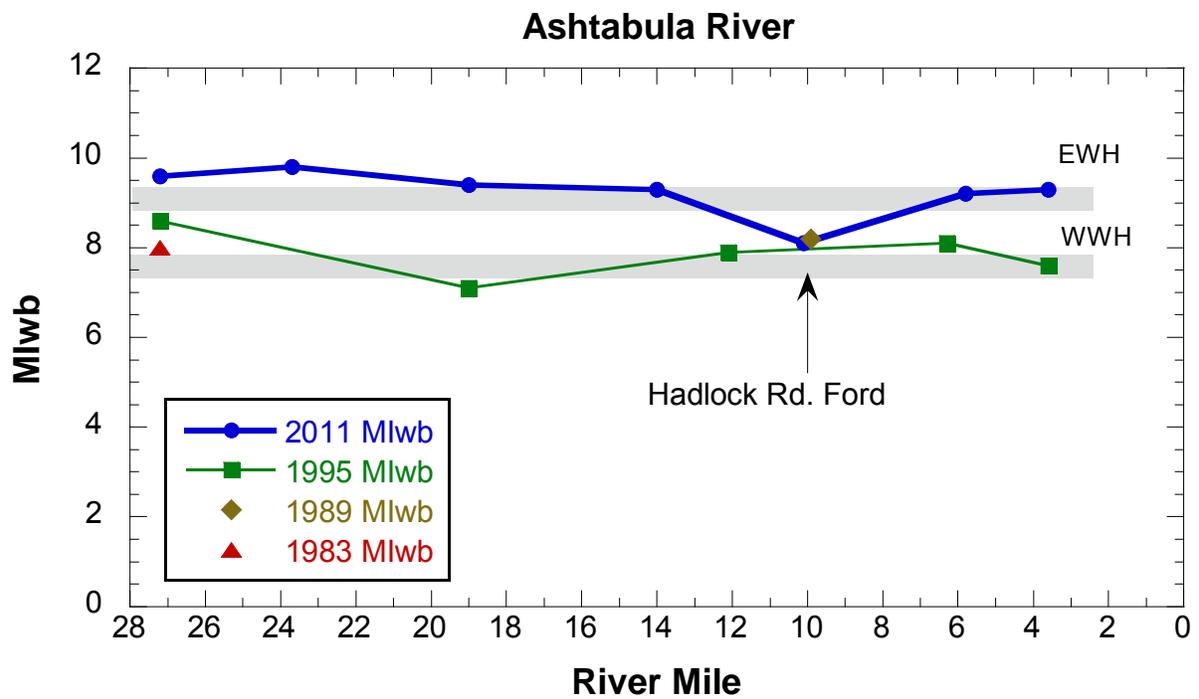
Figure 10. Longitudinal trend of the IBI and the MIwb in the Ashtabula River, 1983-2011.

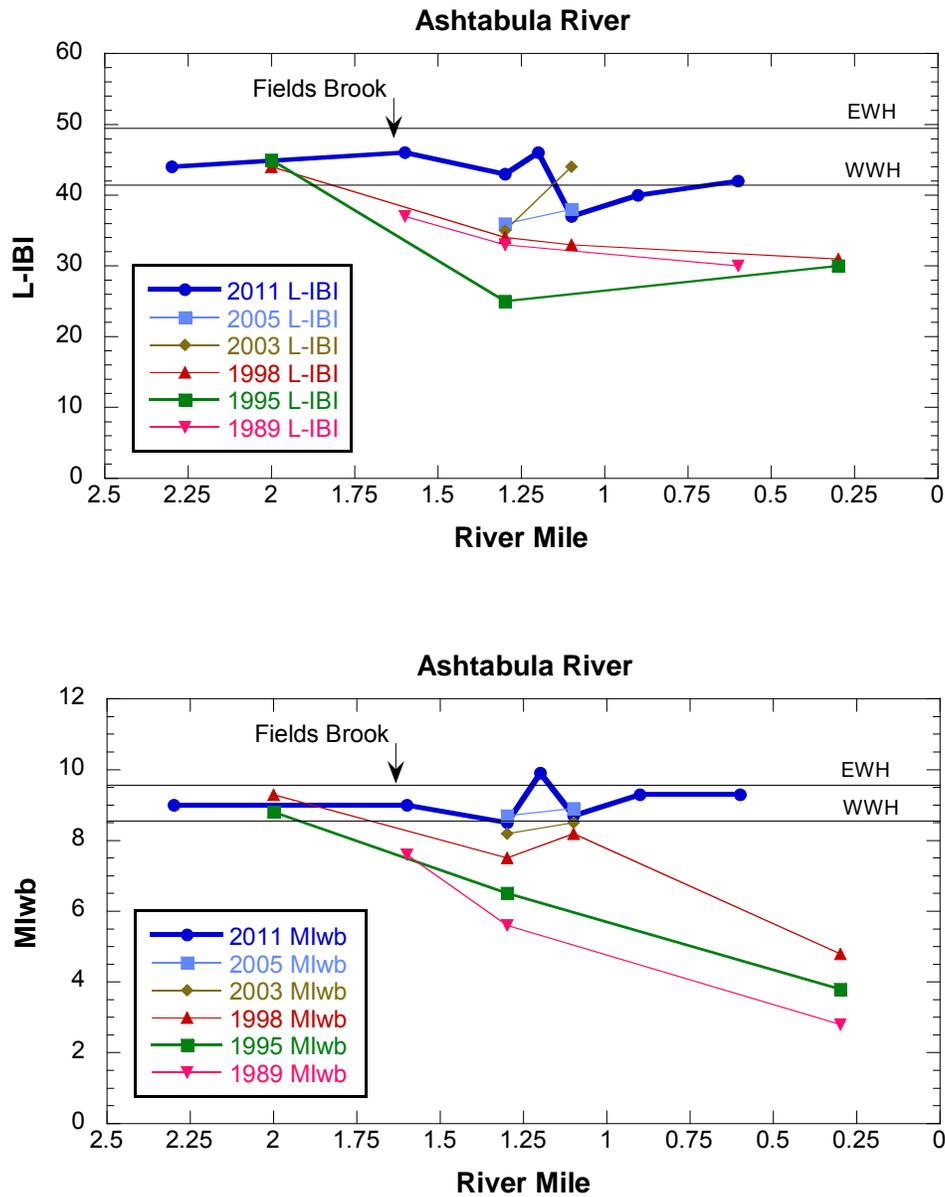
Figure 11. Longitudinal trend of the L-IBI and the MIwb in the Ashtabula River lacustry, 1989-2011.

Ashtabula lacustrary fish communities were assessed at seven sites in 2011 (Figure 11). Good community scores (L-IBI \bar{x} =43, MIWb \bar{x} =9.1) were typical, although variable results downstream from Fields Brook (RM 1.3) suggested it remains a source of perturbation. Fewer fish were present at RM 1.3 in June (192) compared to a September collection (254). The early sample included two brown bullheads with external lesions and no minnow species. No brown bullhead or external anomalies were present in the second pass when three types of minnows were collected. These factors, along with less piscivorous fish (17% vs. 31%, respectively) and slightly lower species richness (18 vs. 20 total species, respectively), resulted in a wide difference between L-IBI scores (37 vs. 48, respectively). Ironically, a better MIWb score (8.8) was registered by the first sample compared to the second sample (MIWb=8.3).

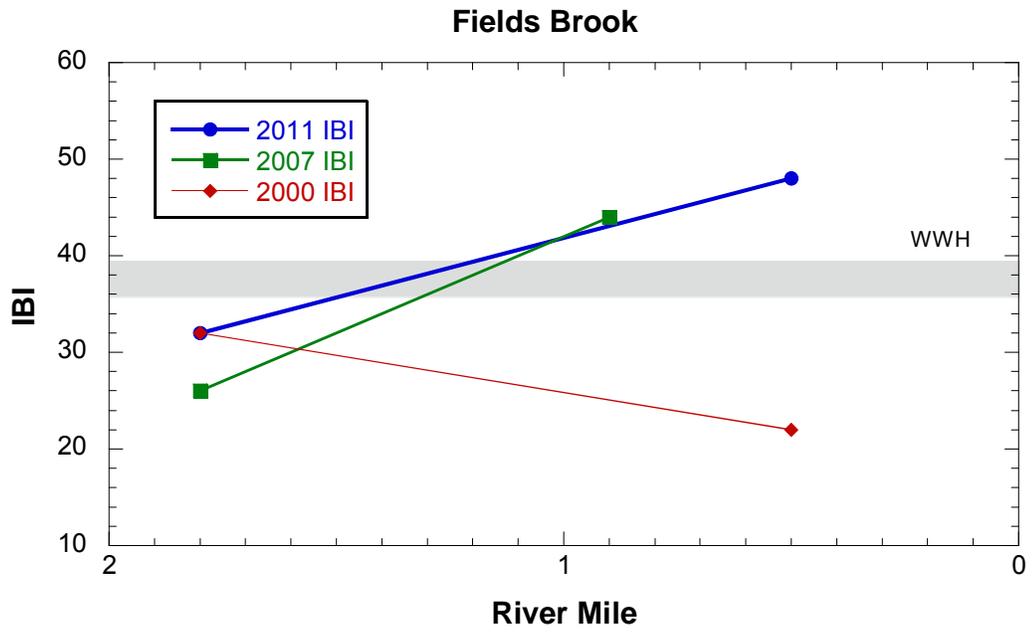
Figure 12. Longitudinal trend of the IBI in Fields Brook, 2000-2011.

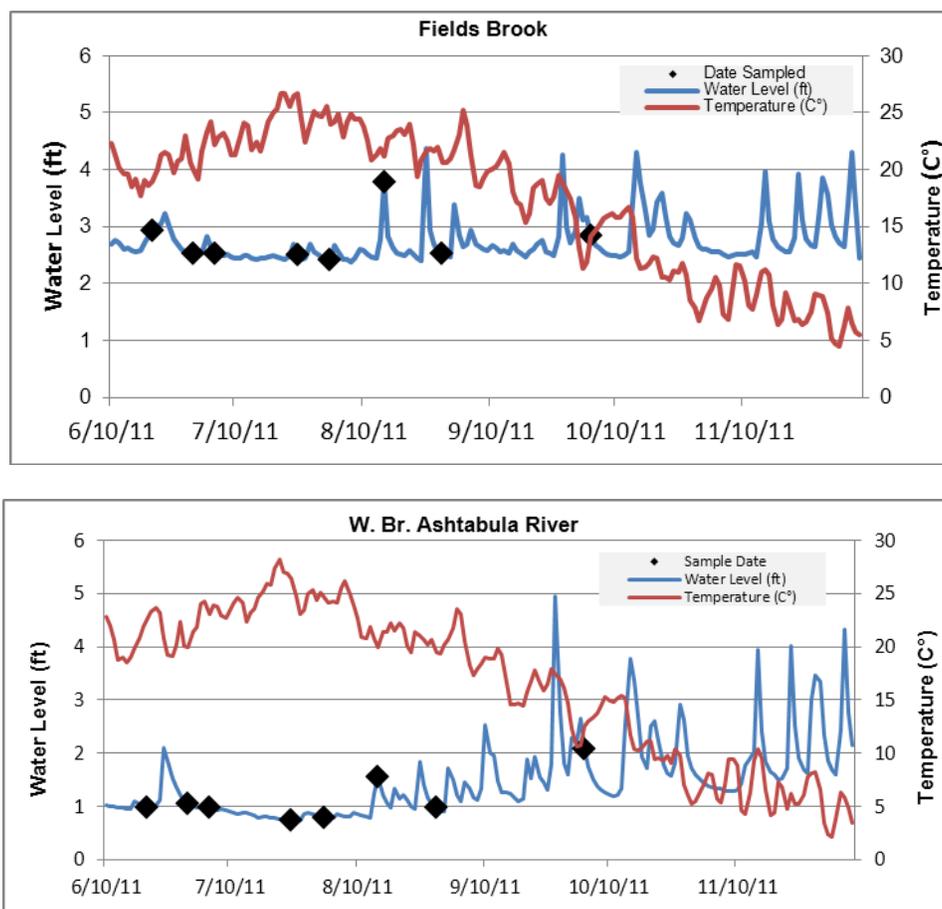
Figure 13. Flow conditions at Fields Brook and W. Br. Ashtabula River, 2011.

The Ashtabula River does not have a United States Geological Survey (USGS) gage station. Solinst Levelloggers® were deployed at three sampling locations within the study area [West

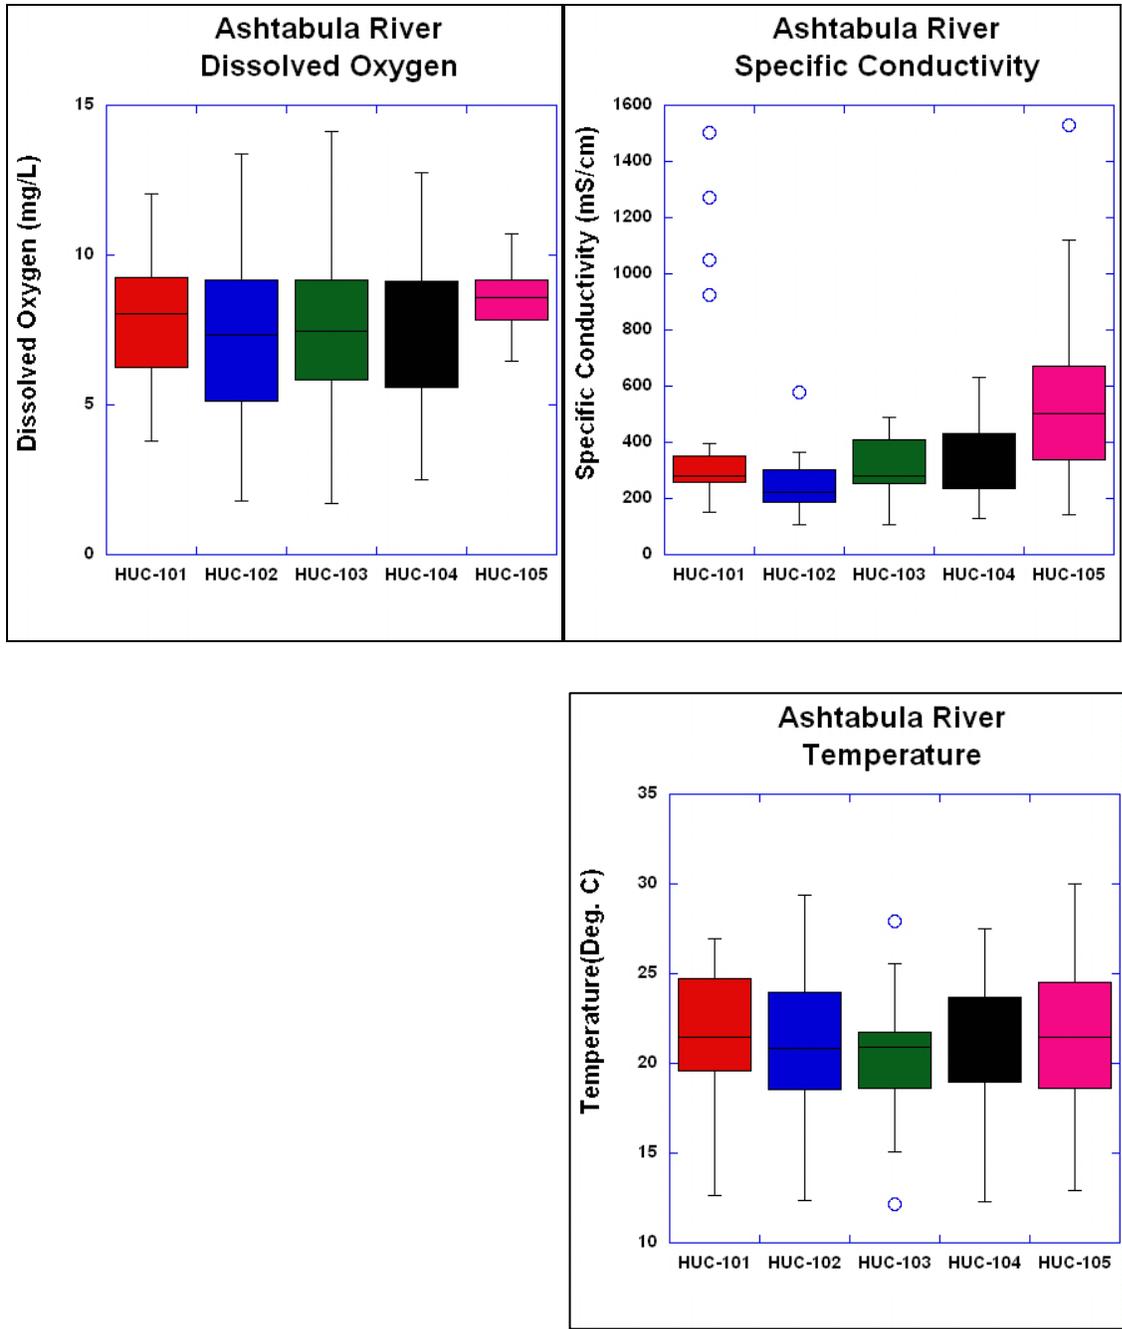
Figure 14. Box and whisker plots of dissolved oxygen, specific conductivity, and temperature from the Ashtabula River, 2011.

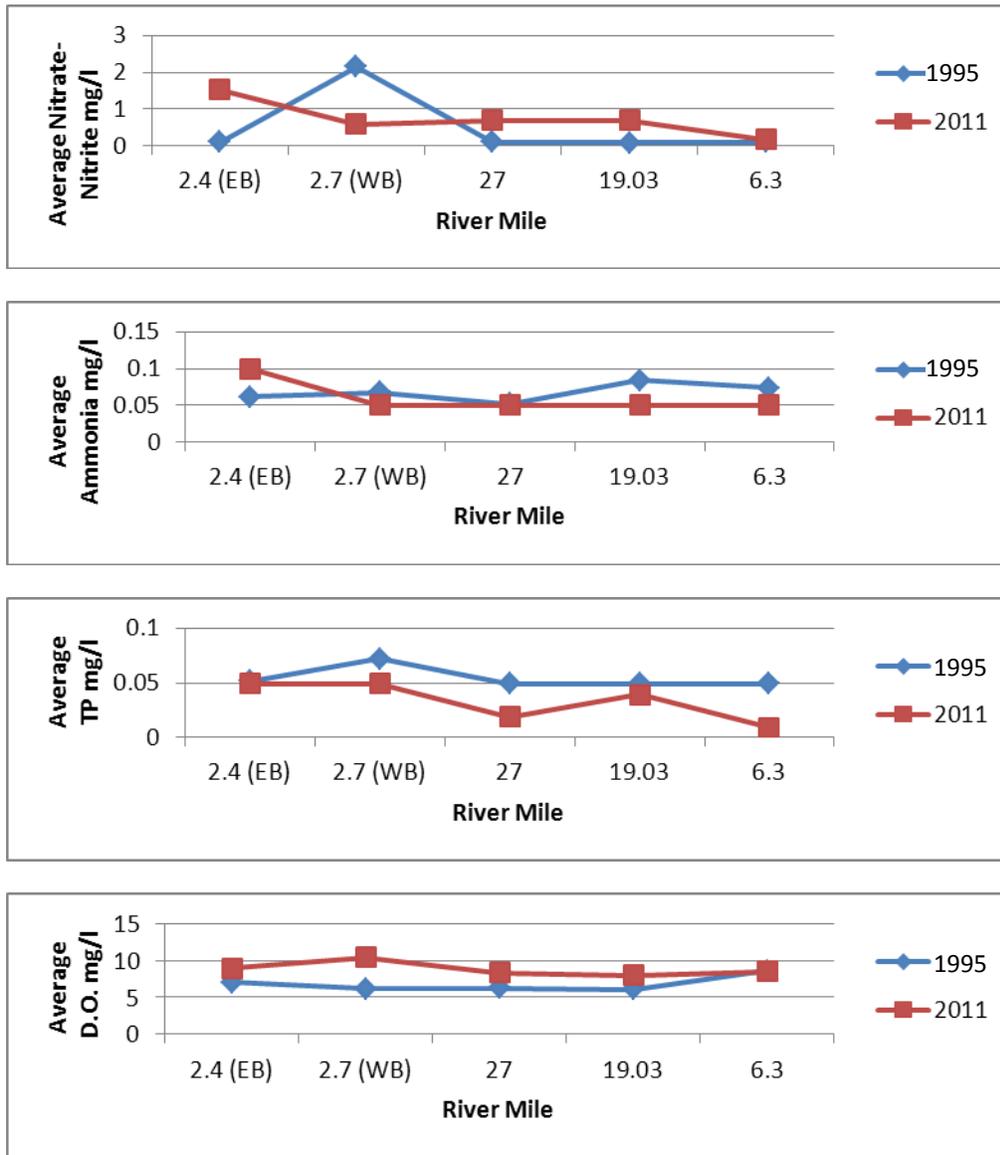
Figure 15. Longitudinal plots for averaged concentrations of nitrate-nitrite, ammonia, total phosphorus, and dissolved oxygen for the East Branch (EB), West Branch (WB), and the mainstem of the Ashtabula River, 1995 and 2011.

For water quality trends, nitrate-nitrite, ammonia, total phosphorus, and dissolved oxygen from the 2011 survey was compared to 1997 survey data. Figure 15 shows longitudinal trends comparing 1997 to 2011 sampling results from the East Branch Ashtabula River (RM 2.4) and West Branch Ashtabula River (RM 2.7), and starting in the mainstem from just below the confluence of the East and West branches at RM 27 continuing downstream to RM 6.3. Ammonia concentrations were down from the 1995 survey, except at the East Branch Ashtabula River location. This location also had an increase in nitrate-nitrite levels, which may suggest an increase in failing septic systems. Also, nitrate-nitrite values increased in the Ashtabula River mainstem from the 1997 survey levels. Longitudinal trends show a reduction in phosphorus concentrations for all survey locations in 2011. Dissolved oxygen levels have increased compared to 1997.

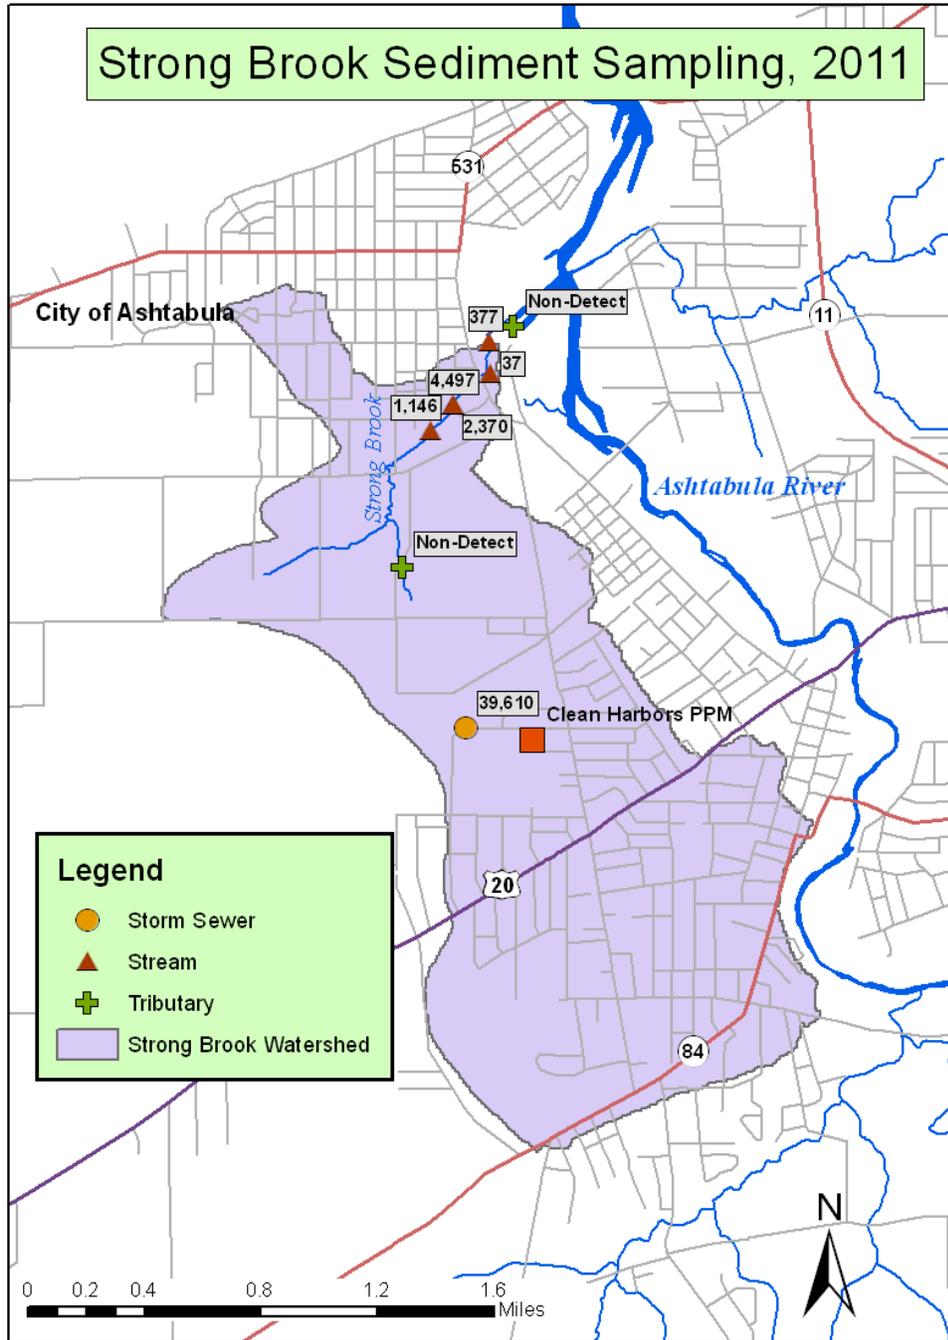
Figure 16. Sediment sampling locations in the Strong Brook watershed, 2012. Total PCB concentrations ($\mu\text{g}/\text{kg}$ dry weight) are indicated for each sampling location.
