Biological and Water Quality Study of the Aurora Branch Chagrin River, 2012

**Aurora Country Club WRRSP Project WR390126-0013
Baseline Report**

Portage County

Ohio EPA Technical Report EAS/2012-12-19

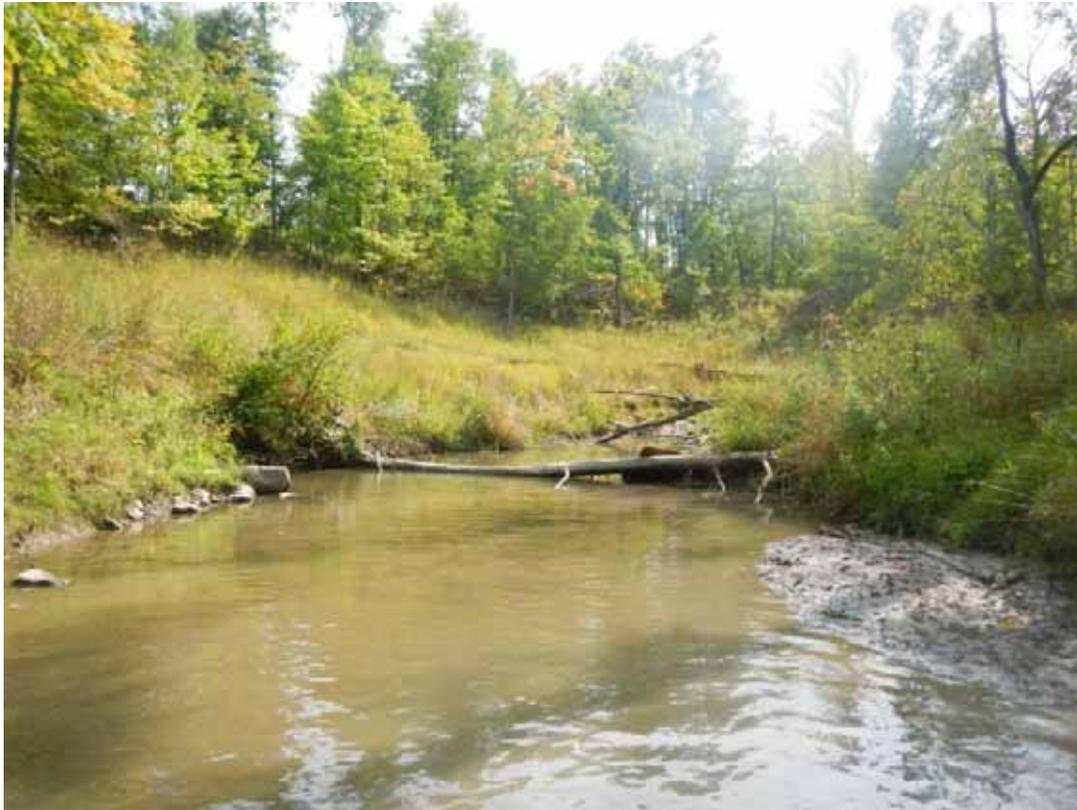
Aurora Branch Chagrin River within the Aurora Country Club property.

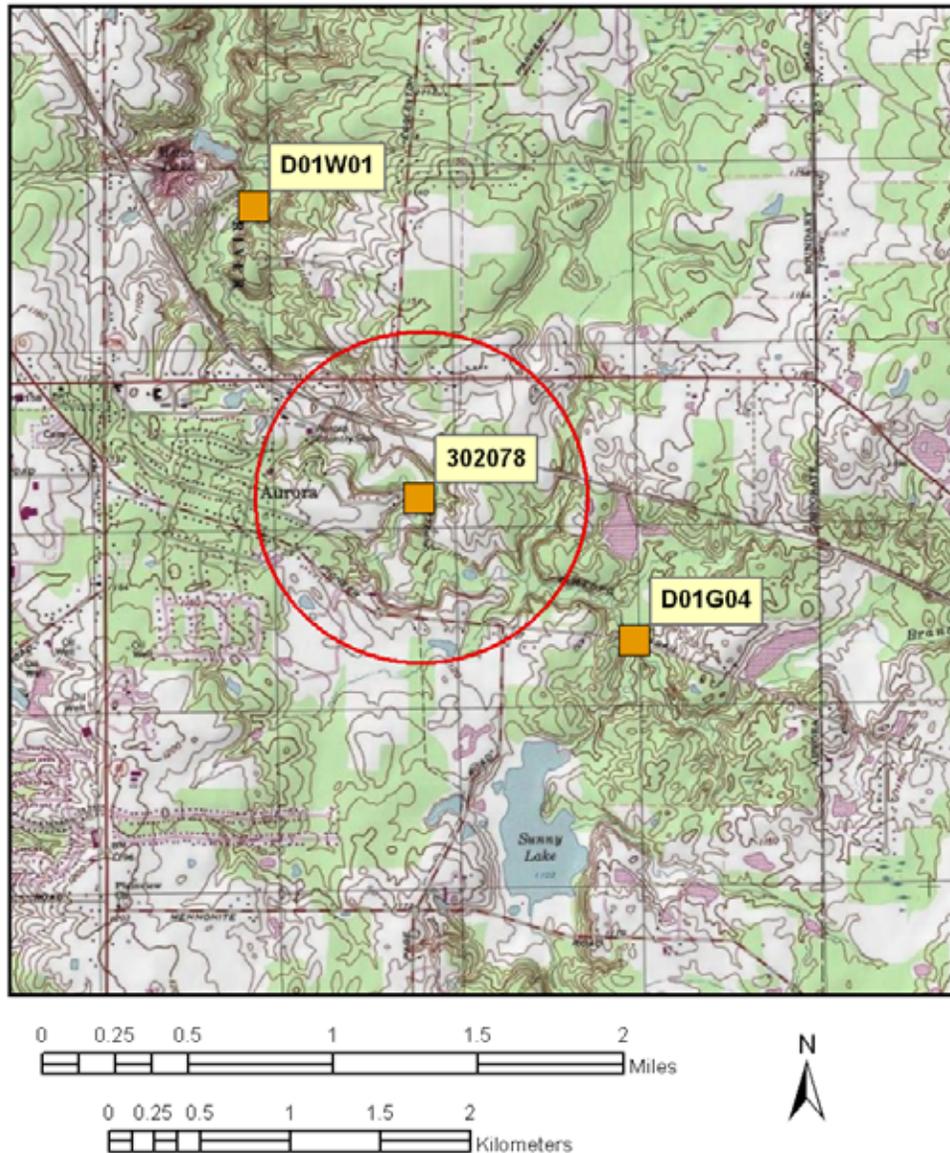
Figure 1. Stream sampling locations surveyed in the Aurora Branch Chagrin River in the vicinity of the Aurora Country Club, 2012. The general location of the Aurora Country Club is indicated by the red circle. Stream flow is generally northward in this watershed.

Aquatic life use attainment conditions are presented in Table 1, and sampling locations are detailed in Table 2 and graphically presented in Figure 1.

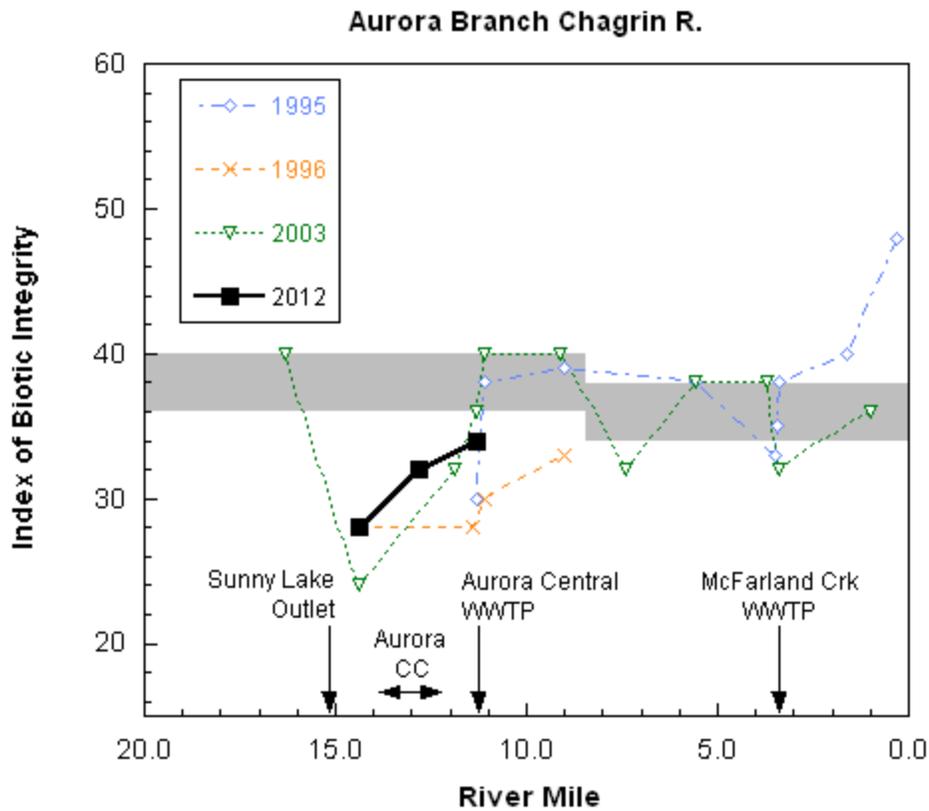
Figure 2. Fish community trends for the Index of Biotic Integrity in the Aurora Branch Chagrin River, 1995-2012.

Comparison of historical fish data from the Aurora Branch with the present data set (Figure 2) indicates that the pattern of non-attainment of the IBI biological criterion has not changed significantly over time in the section of the stream upstream of the Aurora Central WWTP. This is a strong indicator that pollution abatement and habitat protection and restoration activities are still needed in this watershed to achieve the water quality standards and the goals for reductions in nutrient and sediment loadings and habitat improvement as called for in the Chagrin River TMDL report (Ohio EPA, 2007).

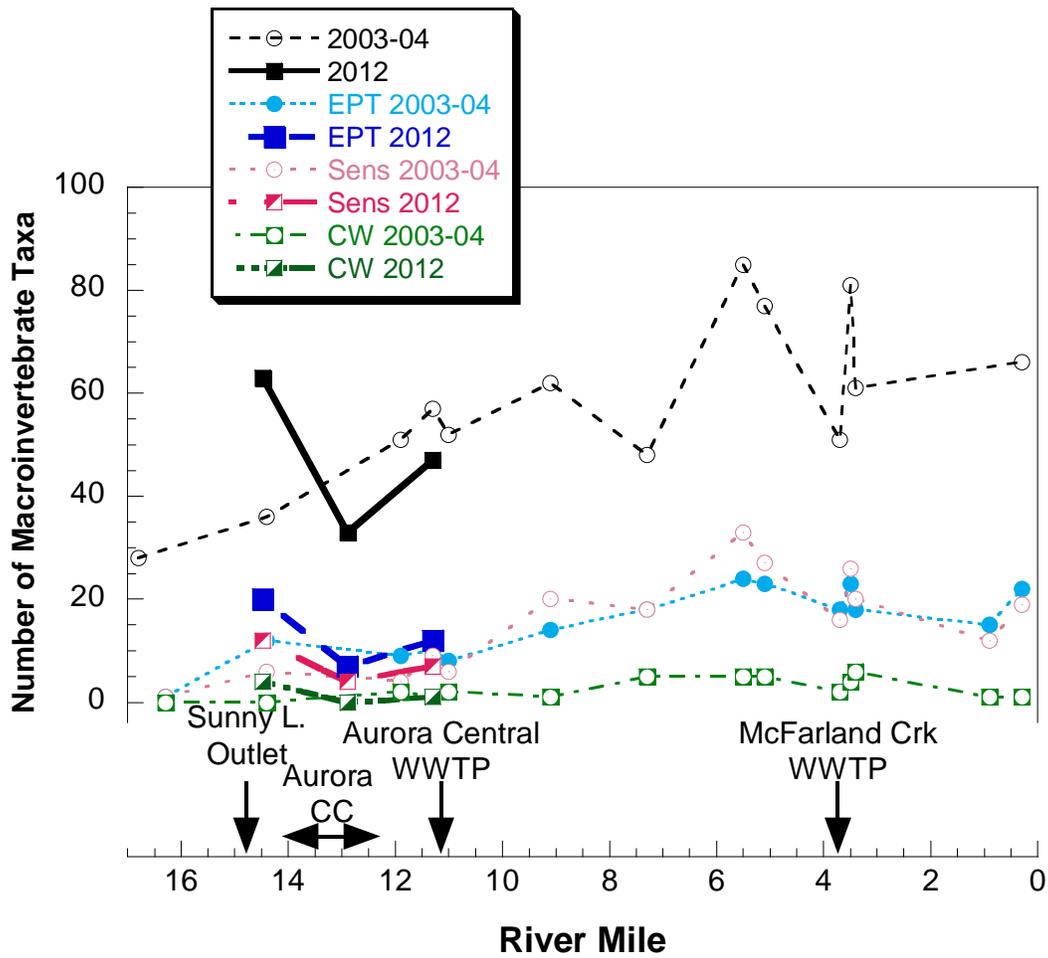
Figure 3. Historical comparison of selected macroinvertebrate community indicators in the Aurora Branch Chagrin River to data collected in 2012. Key: data indicated by year alone = total number of taxa collected; “EPT” = number of EPT taxa; “Sens” = number of sensitive taxa, “CW” = number of cold water taxa. Stream flow goes from higher river miles to the mouth at river mile 0 (left to right in figure).

The macroinvertebrate community from the upstream sampling location at Pioneer Trail (RM 14.48) was evaluated as “exceptional”, with a high number of EPT taxa, a high percentage of sensitive (pollution intolerant) taxa, and four cold water indicator taxa present. The macroinvertebrate community at this location has improved significantly since the last Ohio EPA survey in 2003-04 (Figure 3).

Comparison of historical Ohio EPA data for the Aurora Branch to the 2012 data set indicates that the macroinvertebrate community at the RM 14.48 location (Pioneer Trail) has improved dramatically since the last Ohio EPA survey in 2003-04 (Figure 3). Increases were observed for the number of macroinvertebrate taxa collected, as well as in the numbers of EPT taxa, sensitive taxa, and the number of cold water indicator taxa. This improvement can be attributed largely to the restoration efforts undertaken in Sunny Lake and its watershed and associated improvements in the water quality of drainage entering the Aurora Branch from this sub-watershed. In contrast, the macroinvertebrate community at the downstream site (RM 11.30) has shown no improvement since the 2003-04 Ohio EPA survey (Figure 3). As discussed above, the detrimental water quality impacts from the highly modified reach within the Aurora Country Club likely is contributing to water quality degradation in the Aurora Branch downstream, hindering full recovery of the biological community to the upstream condition.
