**MILL CREEK GEOGRAPHIC INITIATIVE
PHASE II**

MILL CREEK WATERSHED
LOGAN, UNION, DELAWARE COUNTIES
and
MARYSVILLE, OHIO AREA

JANUARY 1999

Dan Tjoelker
Ohio Environmental Protection Agency
Division of Emergency & Remedial Response
Central District Office
Columbus, Ohio

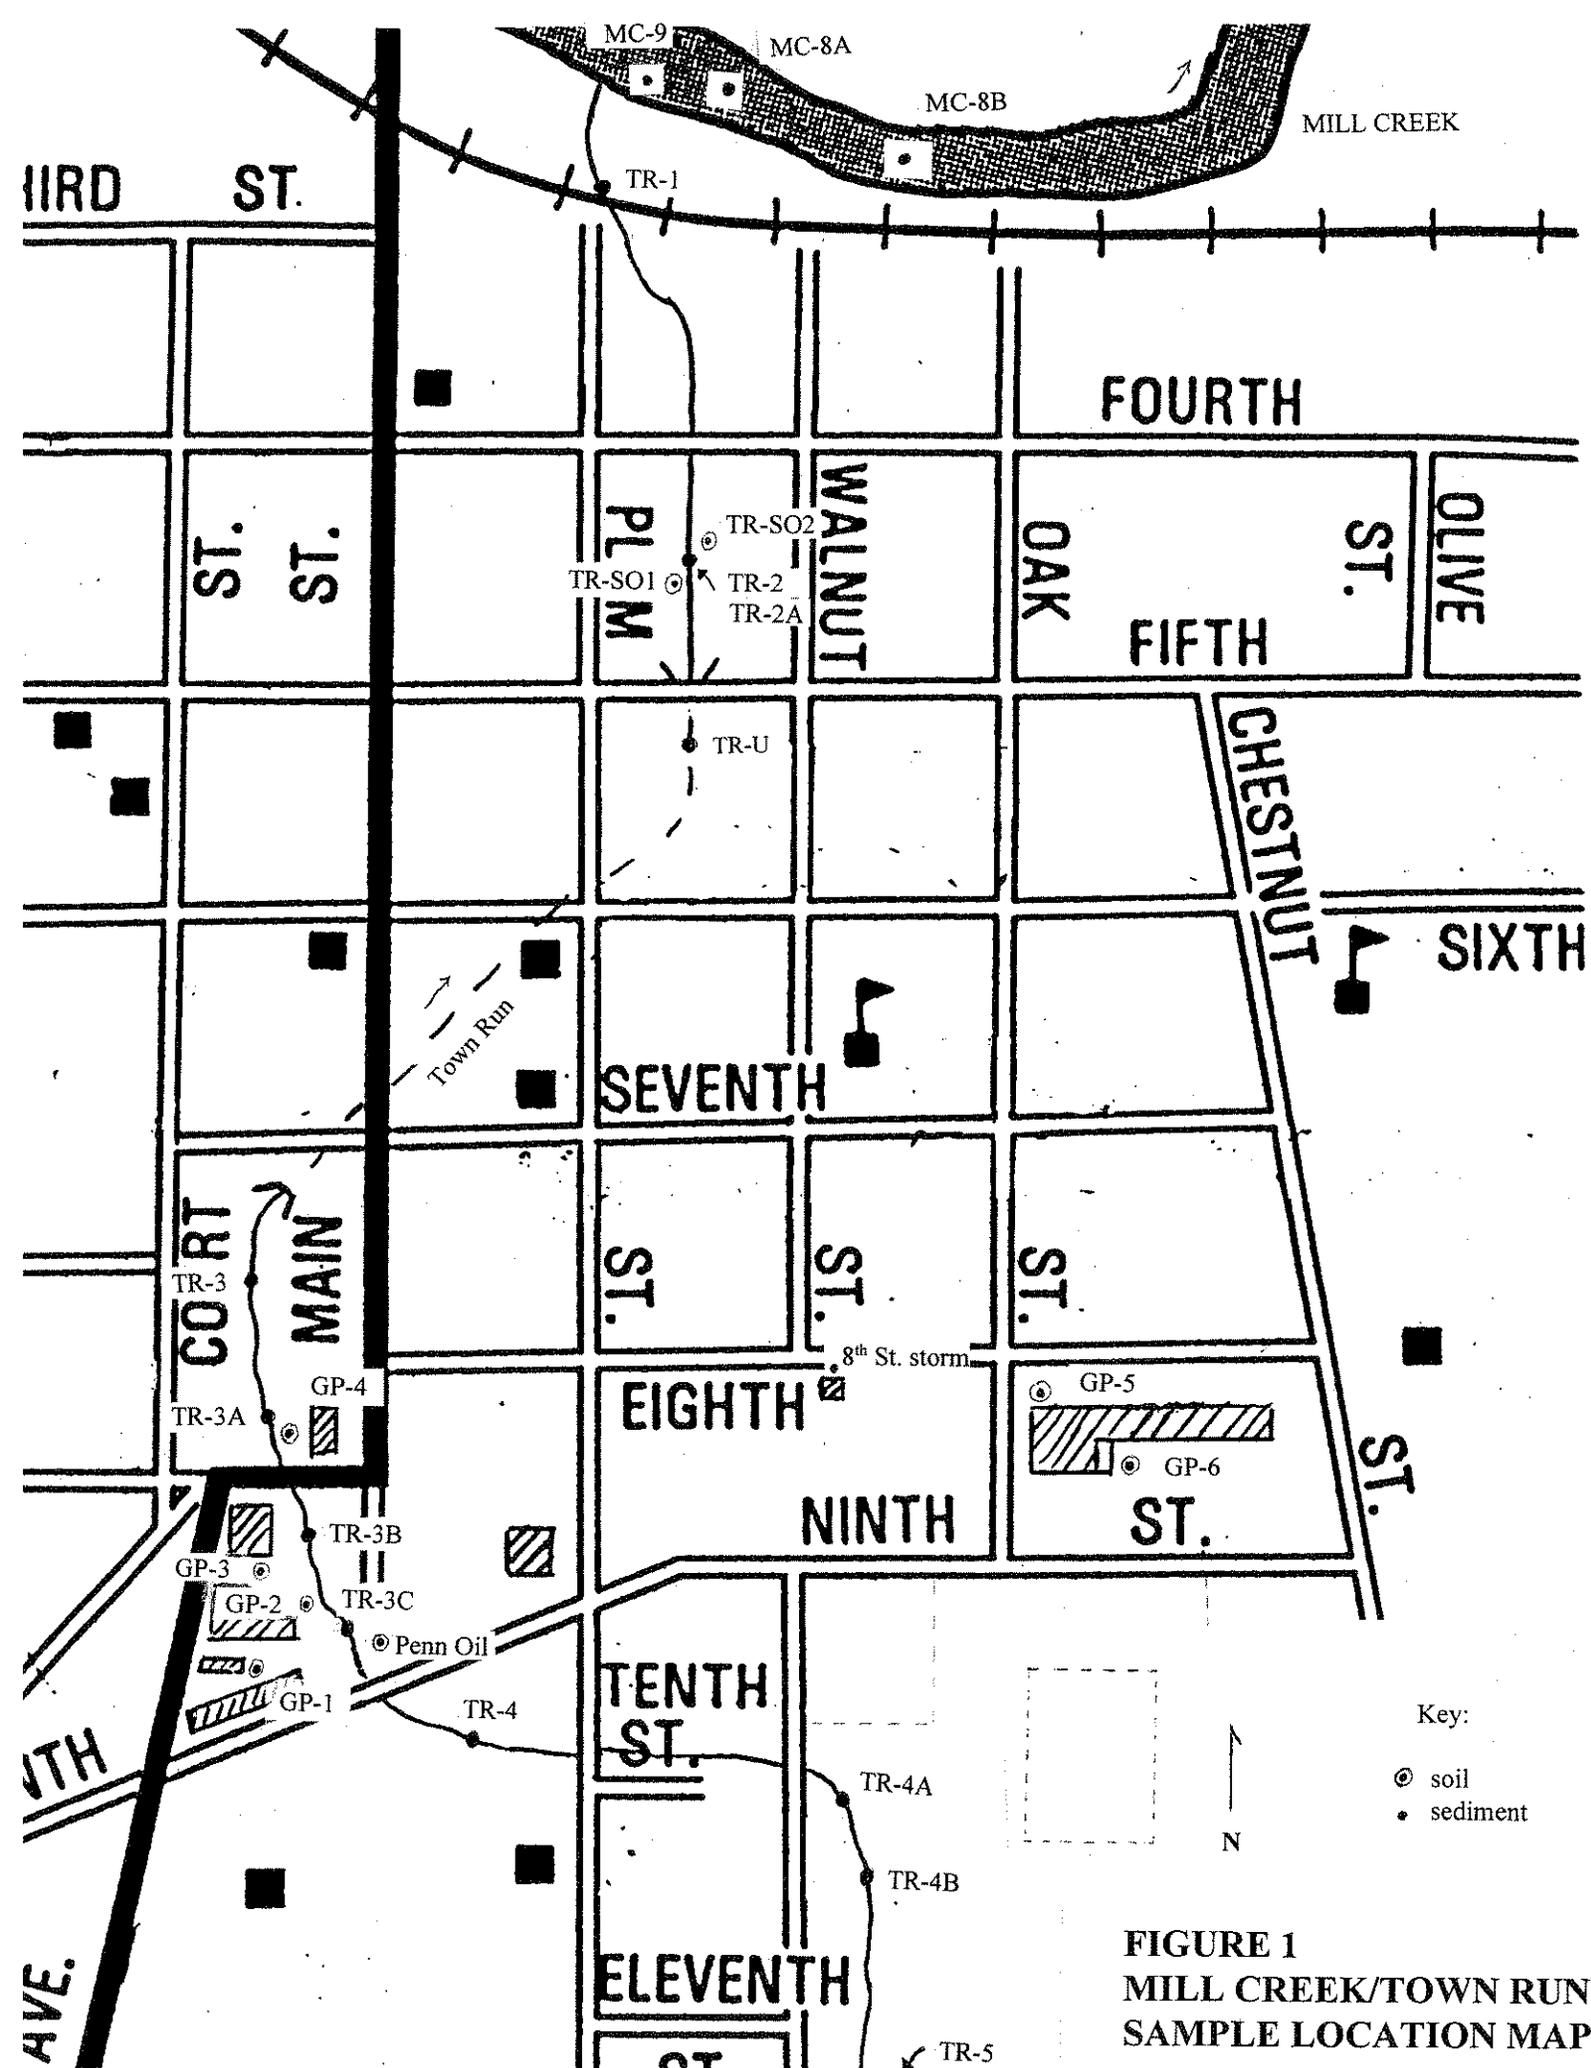
FIGURE 1
MILL CREEK/TOWN RUN
SAMPLE LOCATION MAP

Phase II sampling locations are presented in Figure 1. Elevated levels of polynuclear aromatic hydrocarbons (PAHs) and frequent detections of various pesticide compounds prompted additional investigation along Town Run. Samples were collected to reconfirm past samples, to fill in data gaps through additional coverage of Town Run, and to directly sample near potential

sources. Two sample locations were also selected in Mill Creek, down gradient of Town Run, to provide a more representative sediment sample than MC-9 of the September 1998 GI report and to further define possible down stream migration of contaminants from Town Run to Mill Creek. Table 1 and 2 provide a summary of the sample locations for the Phase II investigation.

Table 7 provides a summary of soil samples collected at the various sites along Town Run. Figures 1 and 2 show a map of all sampling locations and potential sources evaluated.

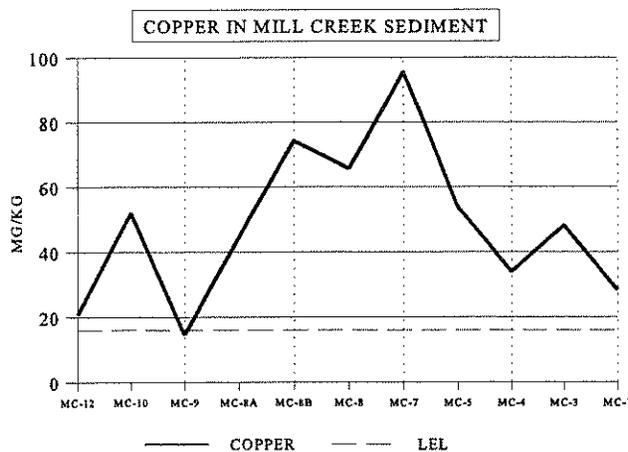
In Mill Creek sediment, copper ranged from 14.6 to 95.6 mg/kg. The LEL was exceeded in all but one sample. Due to its persistence, copper may be naturally elevated. Although concentrations of 2-3 times background (20.8 mg/kg) in the Marysville portion of Mill Creek (TR-10 to TR-7) are likely due to urban impacts. Town Run appears to contribute additional copper contamination as seen by the elevated levels at TR-8B, TR-8A, and TR-8.

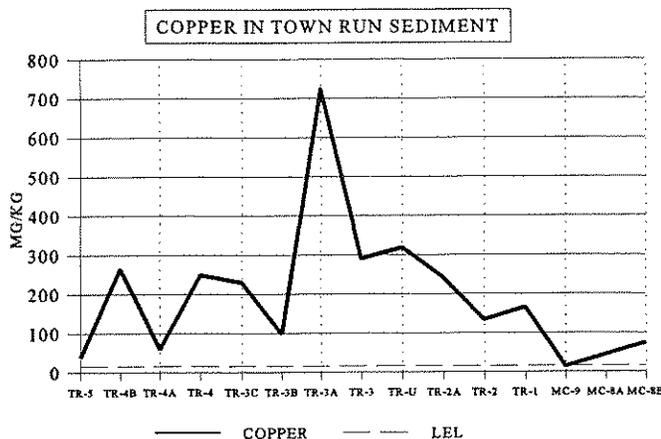
Town Run sediments showed significantly higher concentrations of copper than Mill Creek sediments. Copper concentrations in sediment ranged from 38.4 mg/kg to 720 mg/kg. Every sample location exceeded the LEL for copper. Concentrations were typically 4-6 times higher than in Mill Creek. Elevated copper levels are first observed between TR-4B to TR-4, which is adjacent and downstream from the former Eljer Plumbingware facility. The lower concentration at TR-4A is a result of sediment removal completed as part of remediation activities occurring at the former Eljer Plumbingware facility. The highest copper concentration at TR-3A is downstream from Eljer Plumbingware and a former lumber yard. A decreasing concentration trend is apparent in downstream locations to Mill Creek. The coarse nature of the sediment at MC-9 may not allow for an adequate concentration representation of the Town Run impacts to Mill Creek.

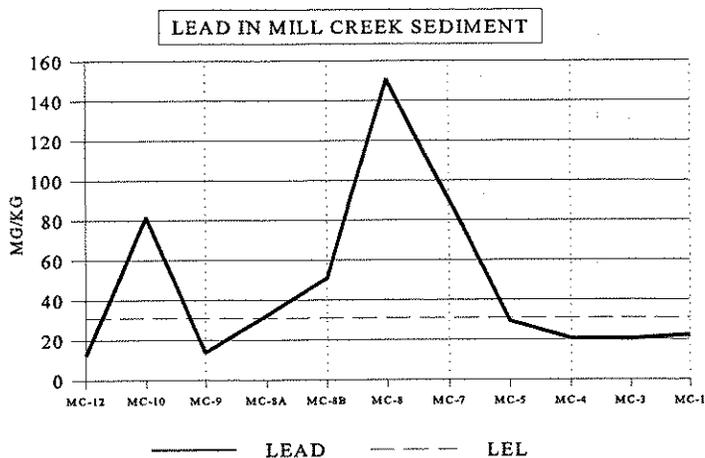
Lead was persistent in Mill Creek sediments and ranged from 12.4 to 151 mg/kg. The lead concentration profile for Mill Creek sediment also indicates urban impacts within Marysville. The increasing concentrations downstream of Town Run (MC-8B and MC-8A) suggest some impacts from Town Run, but other possible non-point source stormwater runoff and Ray Lewis & Sons discharge water may account for the higher concentrations at MC-8 and MC-7, respectively.

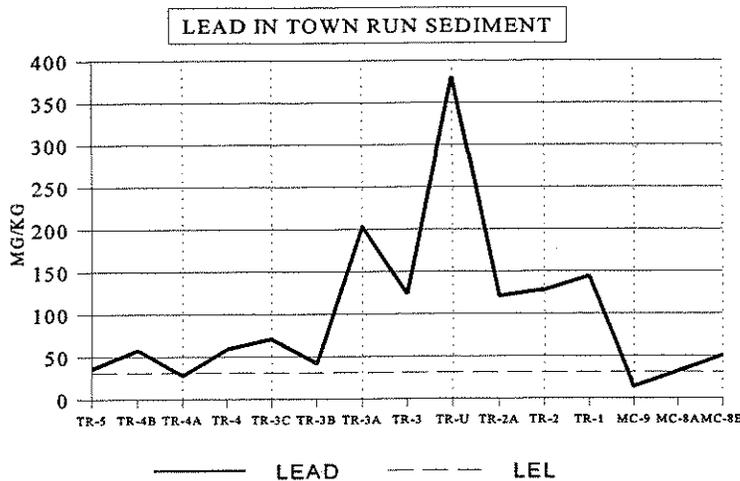
Lead ranged in concentration from 27.9 to 381 mg/kg in Town Run sediment. The LEL was exceeded in all but one sample. In addition, one sample (TR-U) in the culverted portion of the stream exceeded the SEL. In Town Run, the concentration profile shows the highest concentrations are located

in downstream portions of Town Run in the most urbanized areas. Downstream migration from known lead contamination at the former Eljer Plumbingware facility may be the source of this contaminant. In addition, urban non-point sources may also contribute to these concentration levels.

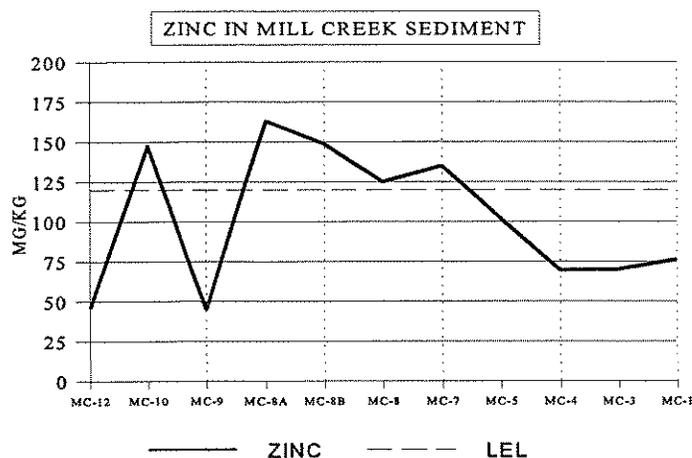
Zinc ranged from 44.8 to 163 mg/kg in Mill Creek sediment. The concentration profile for zinc in Mill Creek sediment, once again shows elevated concentrations due to urban impacts in Marysville. Unknown urban impacts are present at MC-10. Impacts from Town Run are apparent in downstream samples MC-8B and MC-8A.

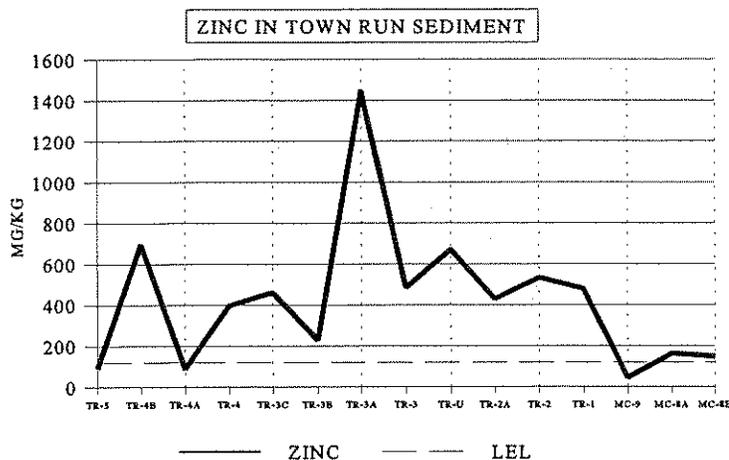
Zinc concentrations ranged from 88.8 to 1450 mg/kg in Town Run sediment. The lowest concentrations were found in the background (upstream) sample and at TR-4A where sediment removal activities were conducted. The LEL screening value was exceeded in 10 of 12 samples. One sample (TR-3A) exceeded the SEL. The former Eljer Plumbingware facility is the major source of zinc to Town Run. Additional urban sources or differential sediment migration may account for the highest concentration at TR-3A.

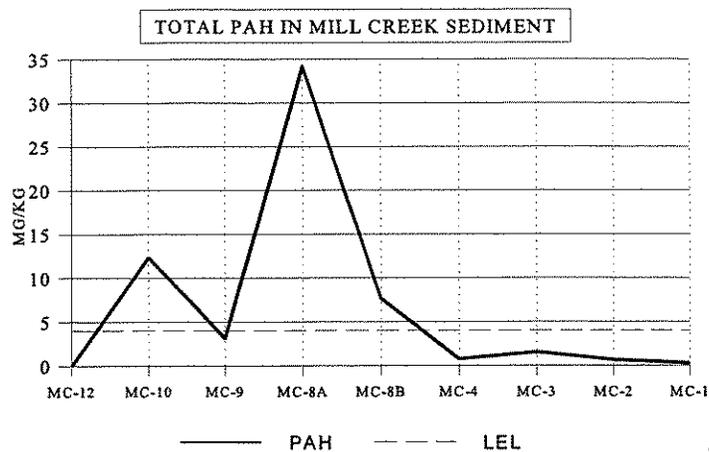
Table 3 and 4 provide a summary of semivolatile compounds in Mill Creek and Town Run. Elevated levels of total polynuclear aromatic hydrocarbons (PAHs) were found within sediment samples where Mill Creek flows through Marysville. Total PAH concentrations ranged from below detection limits to 34.29 mg/kg.

Impacts from PAH migration from Town Run are apparent in the PAH profile for Mill Creek.

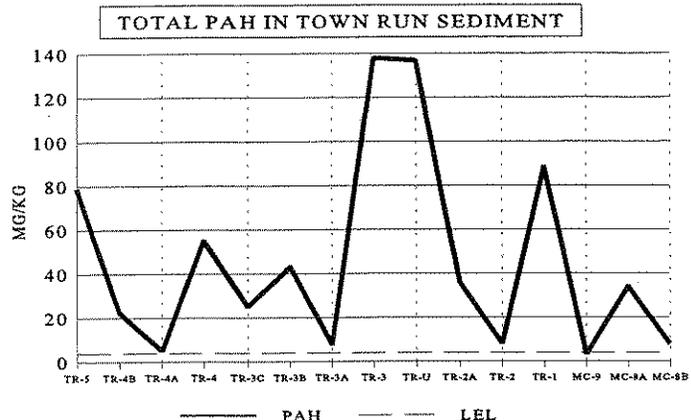
As determined in the September 1998 GI Report, elevated levels of PAHs are persistent in Town Run. Total PAH concentrations ranged from 5.15 to 136.89 mg/kg. Levels fluctuated downstream suggesting various inputs from storm sewers and non-point sources. All exceed the LEL screening levels suggesting likely biological community impairment. PAH compounds may also be indicators of non-point source urban contamination since PAHs are commonly found in oil and their persistence and elevated levels may represent street runoff.

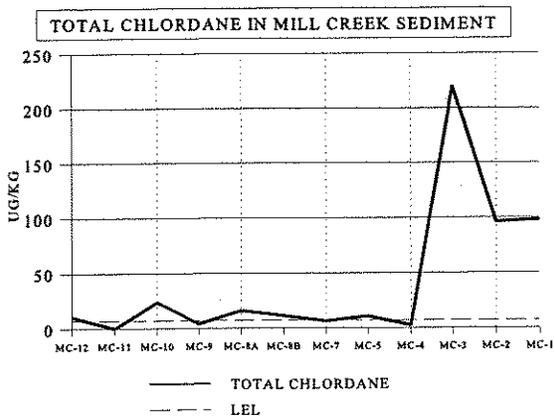
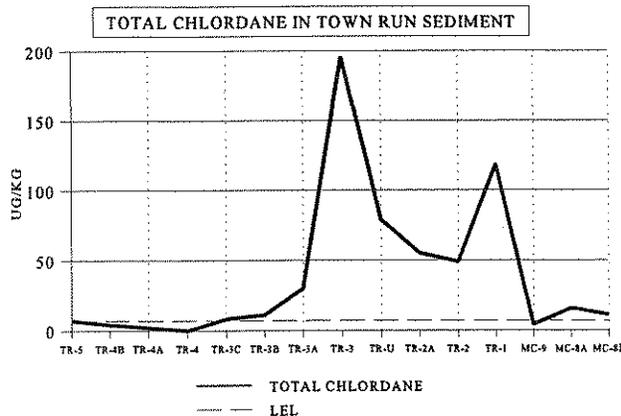
Tables 5 and 6 provide a summary of pesticides and PCBs identified in Mill Creek and Town Run. Low levels of pesticides were detected in all Mill Creek and Town Run sediments. Direct correlation to a point source is not evident and concentrations are likely a result of their prevalent use historically for both agricultural and urban pest control purposes. Concentration profiles for chlordane in both Mill Creek (BDL to 220 ug/kg) and Town Run (BDL to 196 ug/kg) show areas of elevated concentrations and significant LEL screening level exceedances.

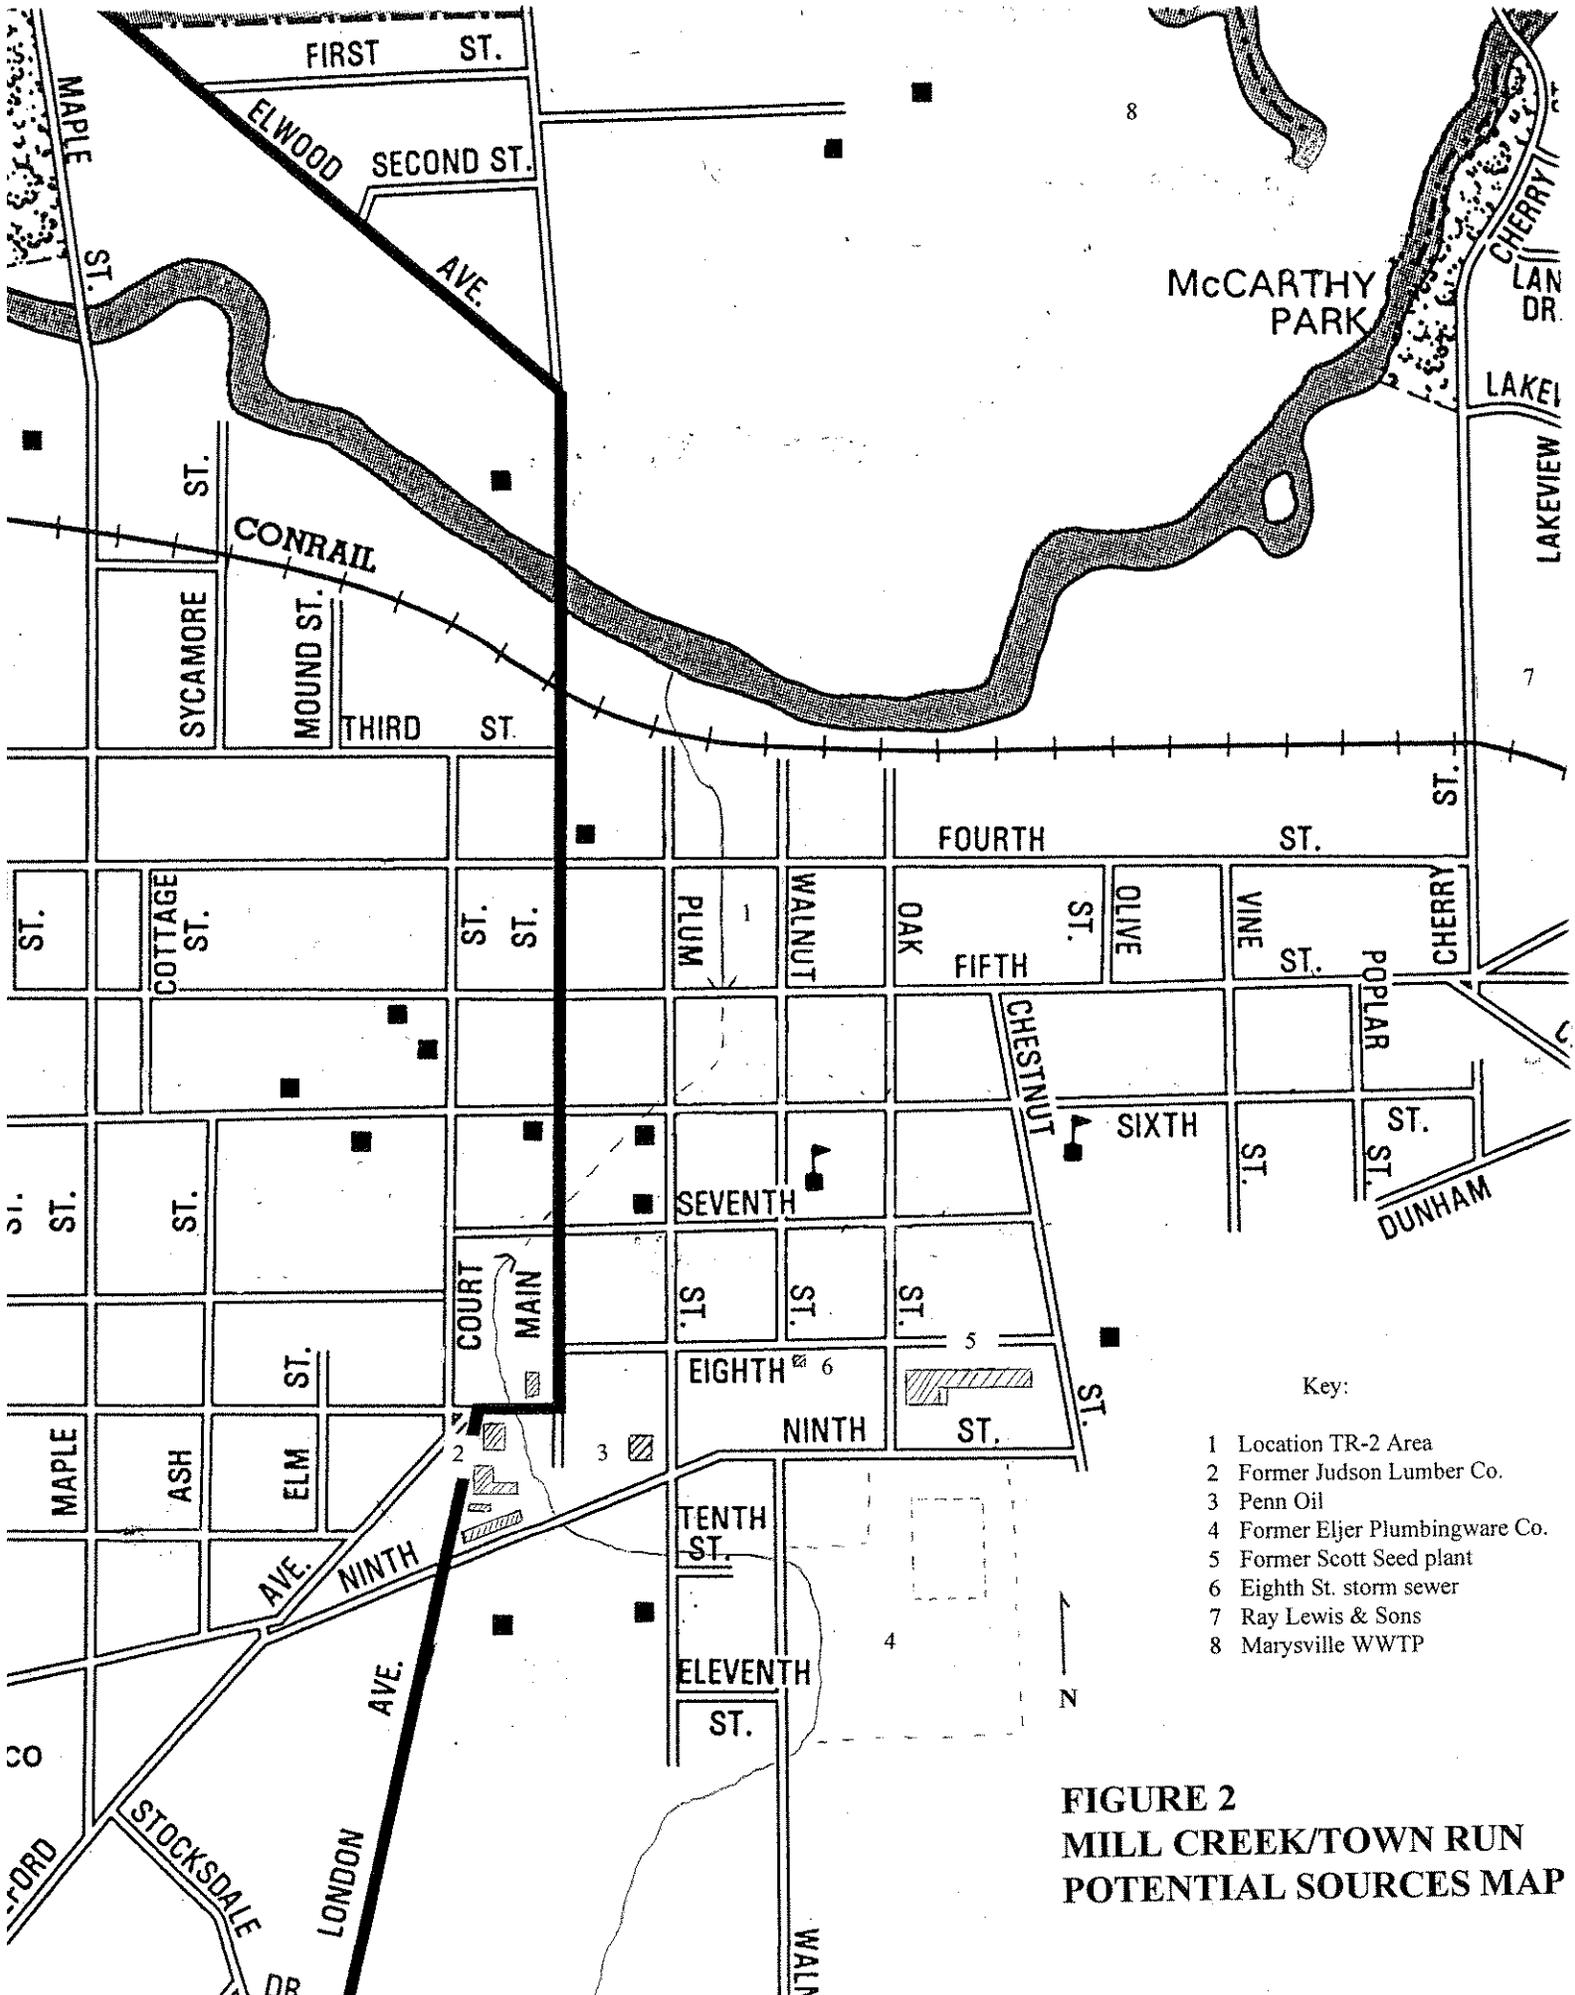
FIGURE 2
MILL CREEK/TOWN RUN
POTENTIAL SOURCES MAP

- 1 Location TR-2 Area
- 2 Former Judson Lumber Co.
- 3 Penn Oil
- 4 Former Eljer Plumbingware Co.
- 5 Former Scott Seed plant
- 6 Eighth St. storm sewer
- 7 Ray Lewis & Sons
- 8 Marysville WWTP

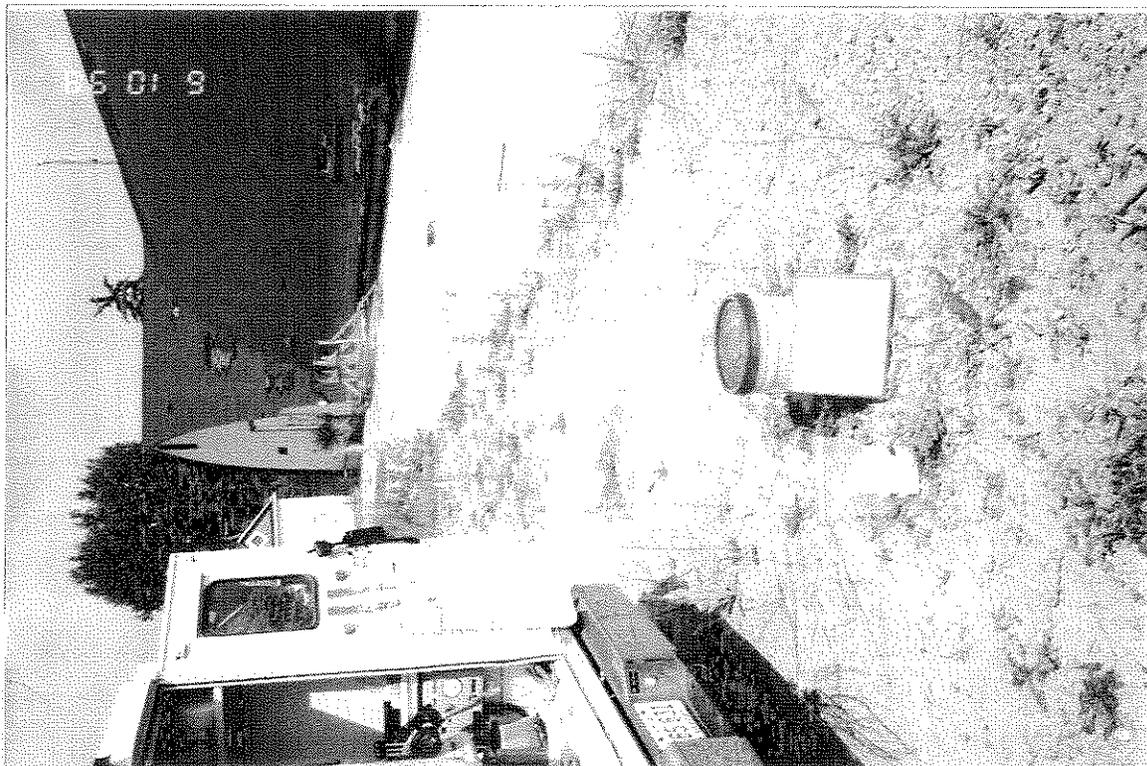
Photo No: 1 Sample No: ECGK/MEBKAO Date: June 10, 1998
Orientation: Northwest
Description: Geoprobe soil sample collected from former Judson Lumber Company (GP1).

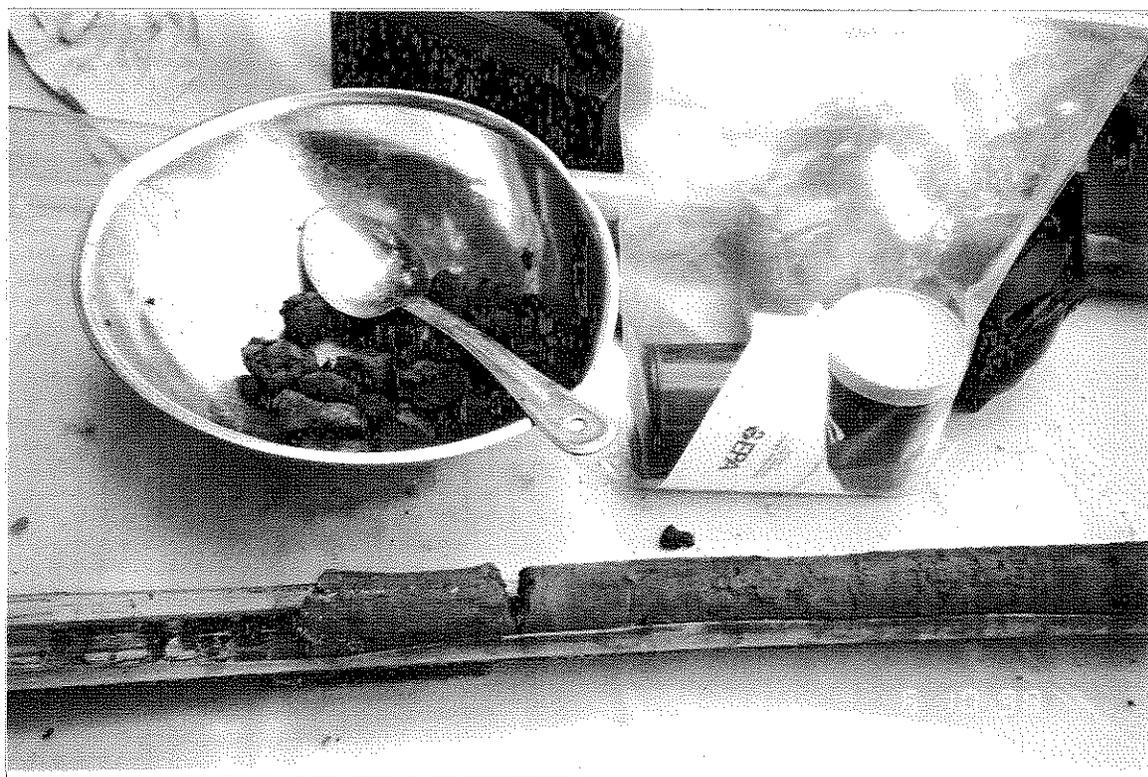
Photo No: 2 Sample No: ECGK/MEBKAO Date: June 10, 1998
Orientation:
Description: Close up view of core and sample (GP1).

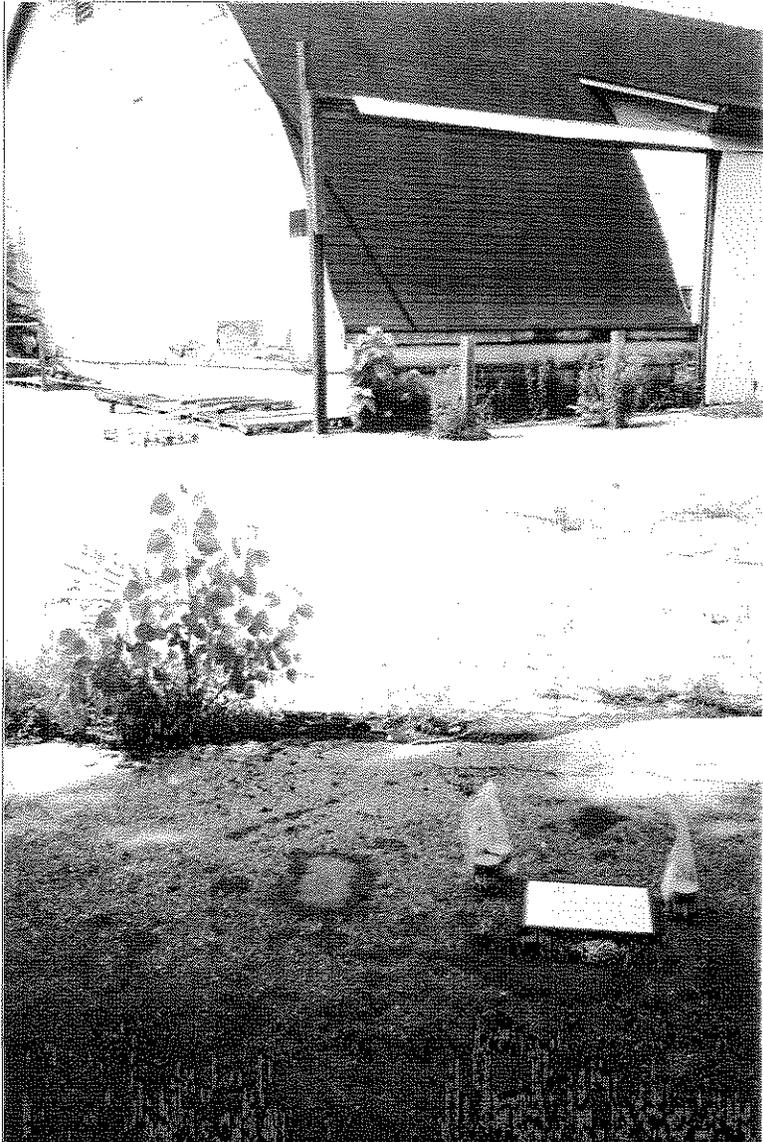
Photo No: 3
Sample No. ECGK/MEBKA1
and 2
Date: June 10, 1998
Orientation: Northwest
Description: Geoprobe soil
samples collected from former
Judson Lumber Company
(GP2A and GP2B).

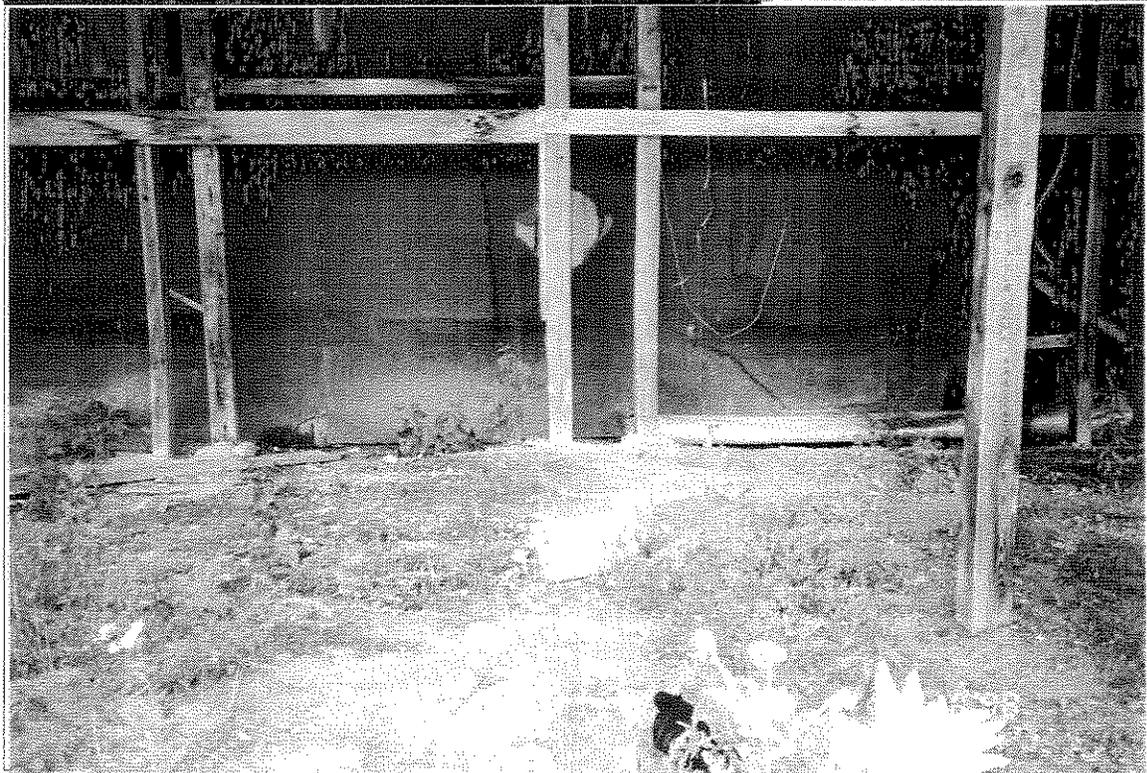
Photo No: 4
Sample No: ECGK/MEBKA3
Date: June 10, 1998
Orientation:
Description: Geoprobe soil
sample collected from former
Judson Lumber Co. (GP3).

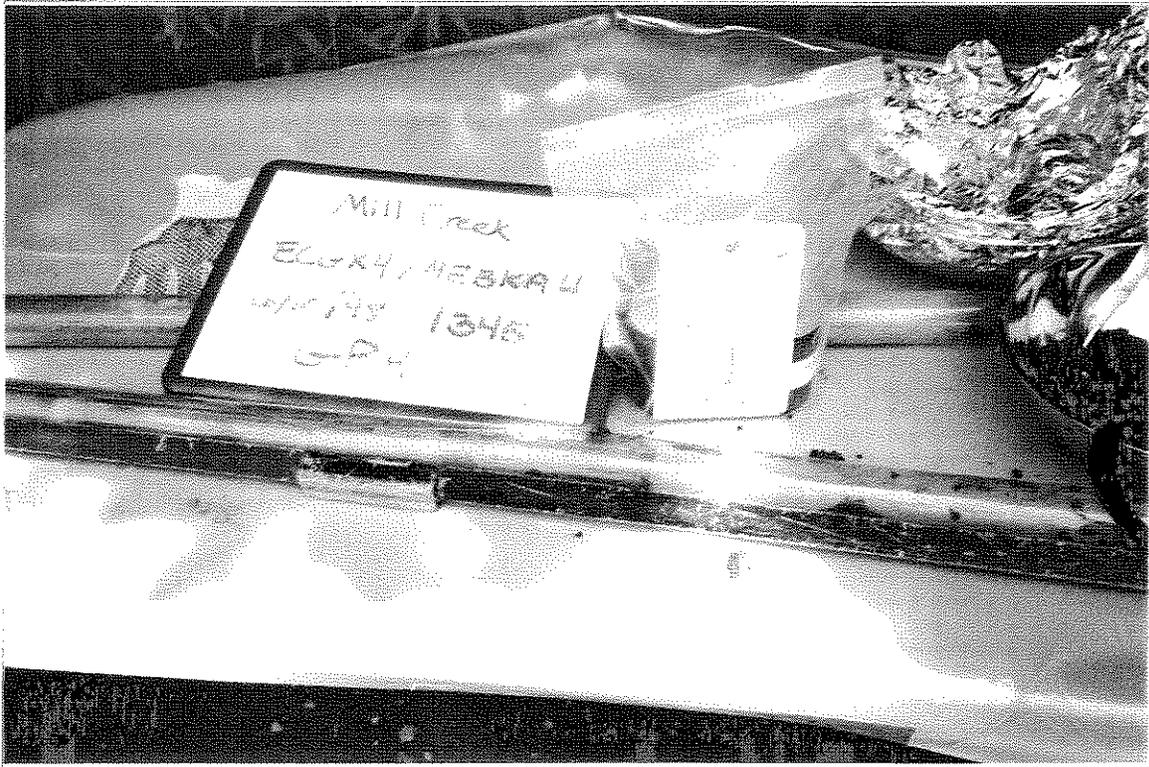
Photo No: 5

Description: Geoprobe soil sample collected from former Judson Lumber Company (GP4).

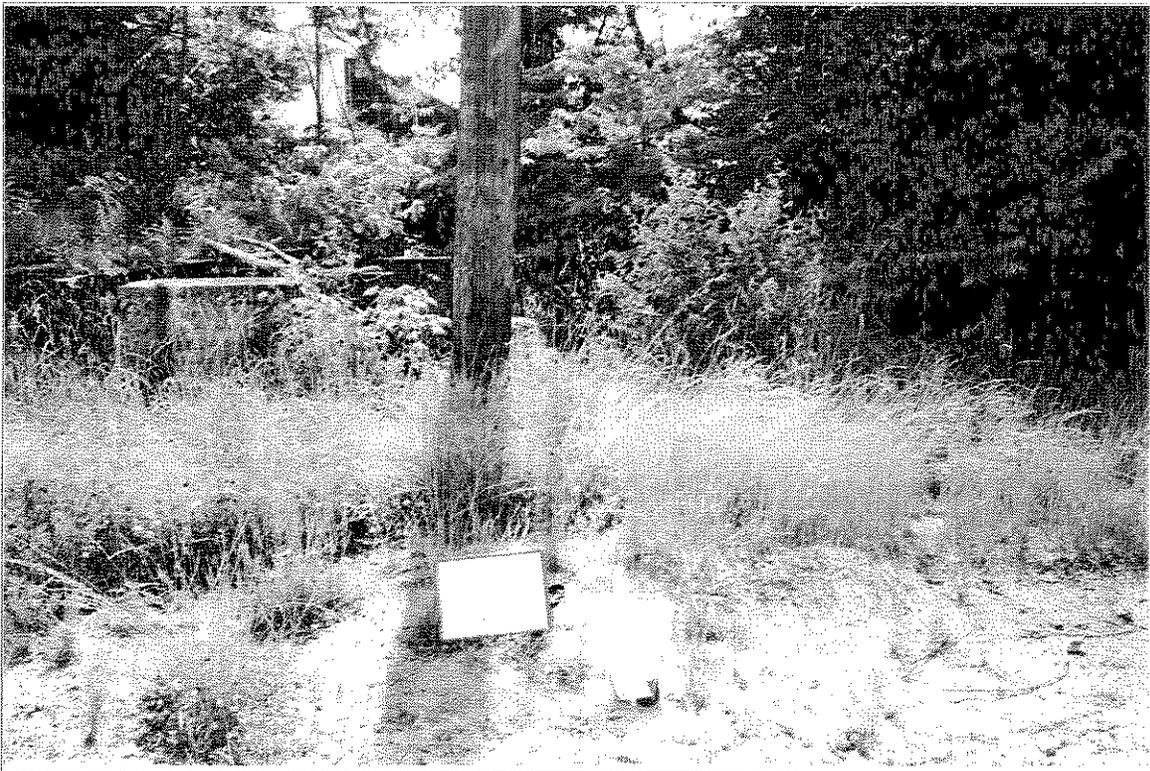
Photo No: 6

Description: Soil sample collected from Penn Oil area across Town Run (East side) from Judson Lumber Co.

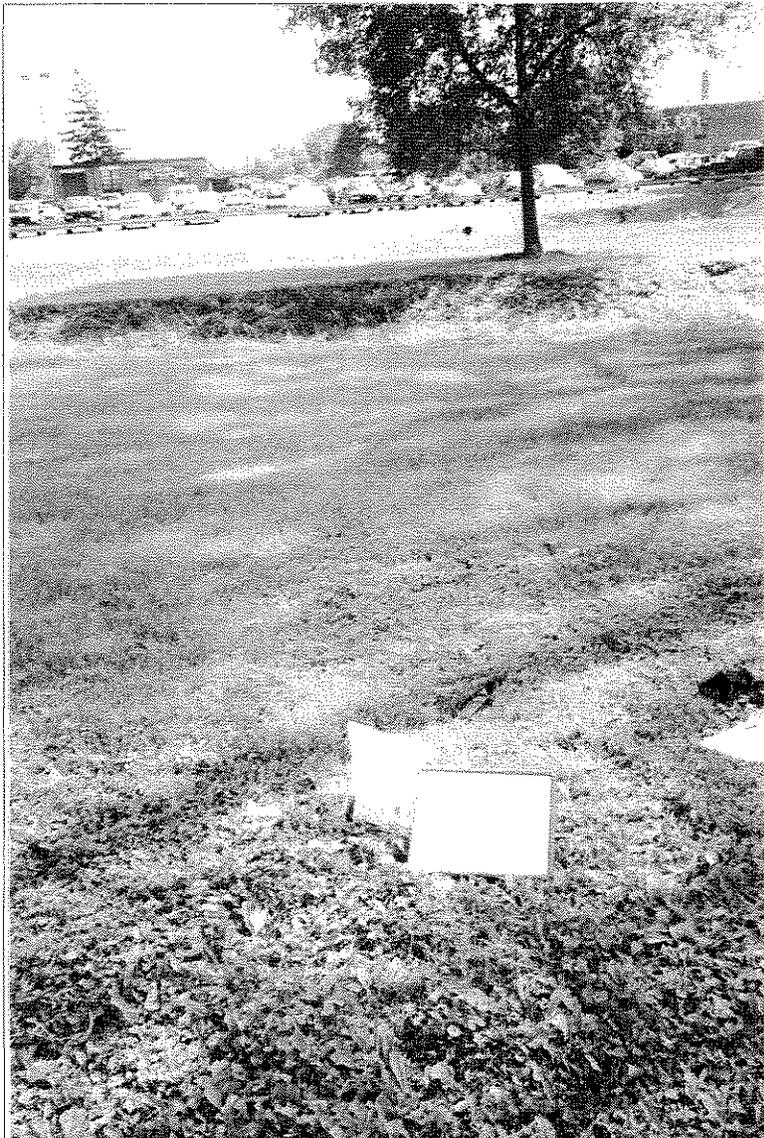
Photo No: 7
Sample No. ECGK/MEBKA5
Date: June 10, 1998
Orientation: Southwest
Description: Background soil sample collected in vacant, park-like area southeast of site on East side of Town Run.

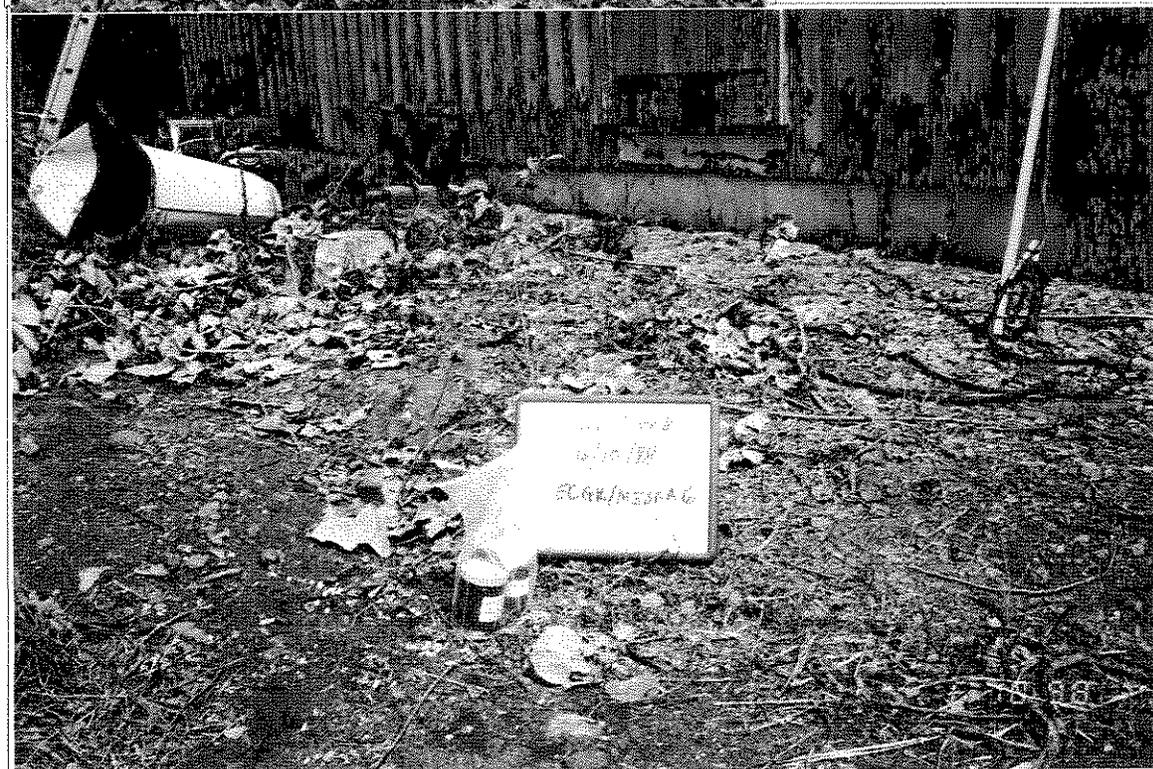
Photo No: 8
Sample No: ECGK/MEBKA6
Date: June 10, 1998
Orientation: Southeast
Description: Geoprobe soil sample collected from northwest corner of former Scotts Seed Elevator (GP5).

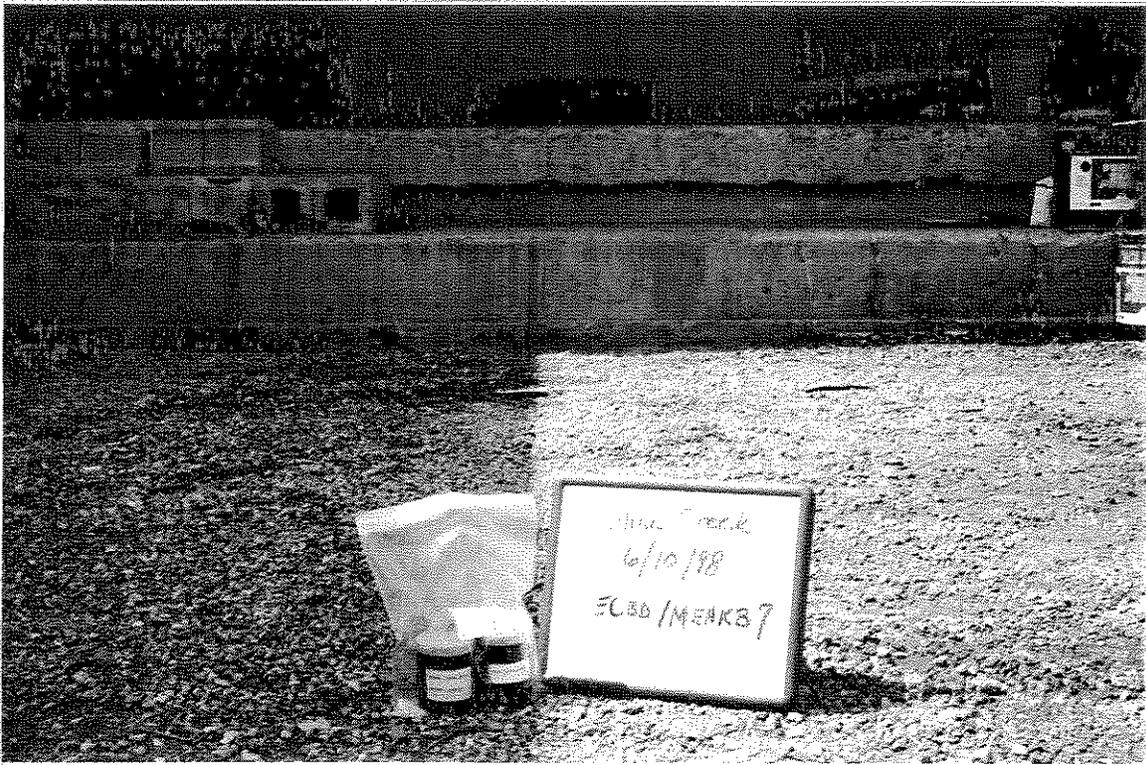
Photo No: 9 Sample No: ECBD/MEAKB7 Date: June 10, 1998
Orientation: North
Description: Geoprobe soil sample collected from loading dock area of former Scotts Seed Elevator building (GP6).

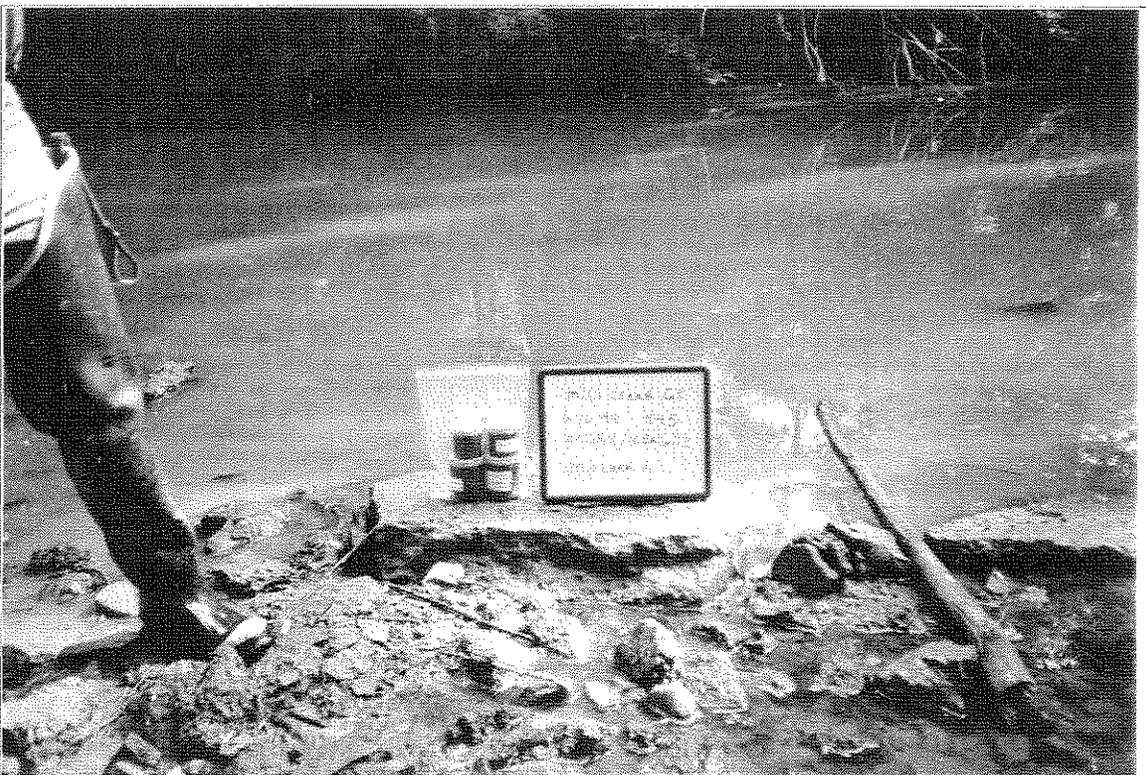
Photo No: 10 Sample No: EAJK/MEAGJ8 Date: June 10, 1998
Orientation:
Description: Sediment sample collected from Mill Creek downstream of Town Run.

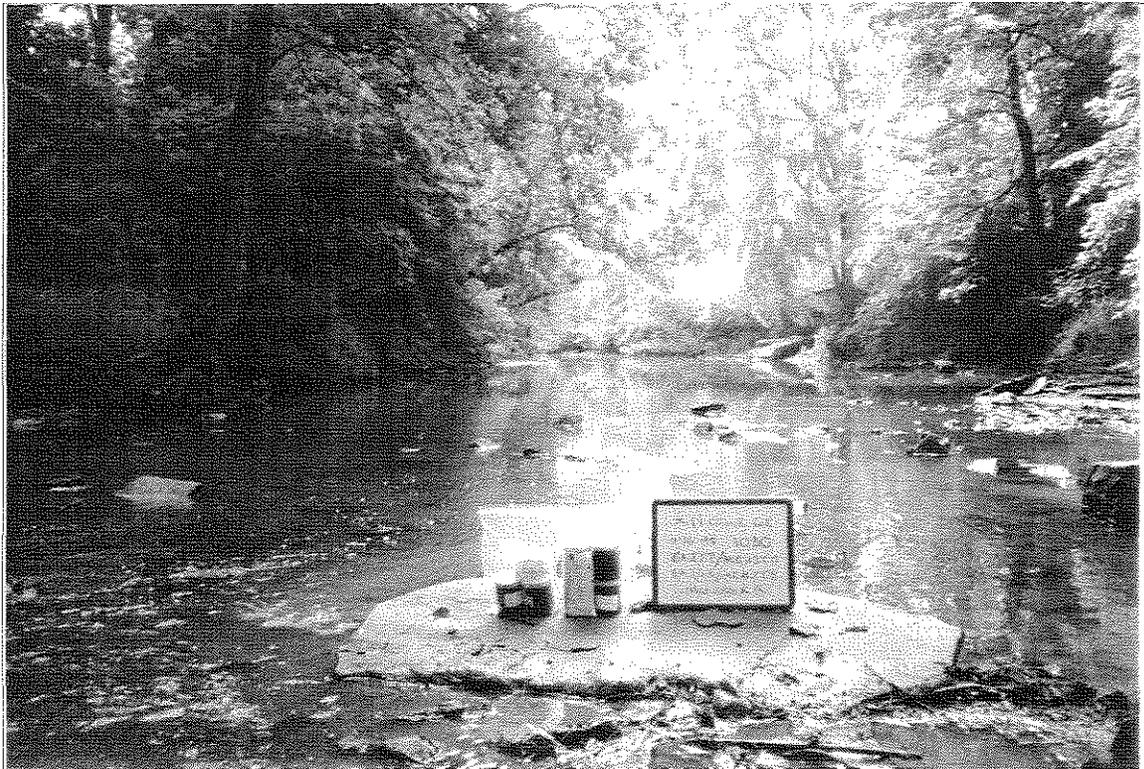
Photo No: 11 Sample No: EAJJ/MEBJT7 and 8 (Dup) Date: June 10, 1998
Orientation:
Description: Sediment sample collected from Mill Creek approx. 200 feet downstream of
EAJK/MEAGJ8.

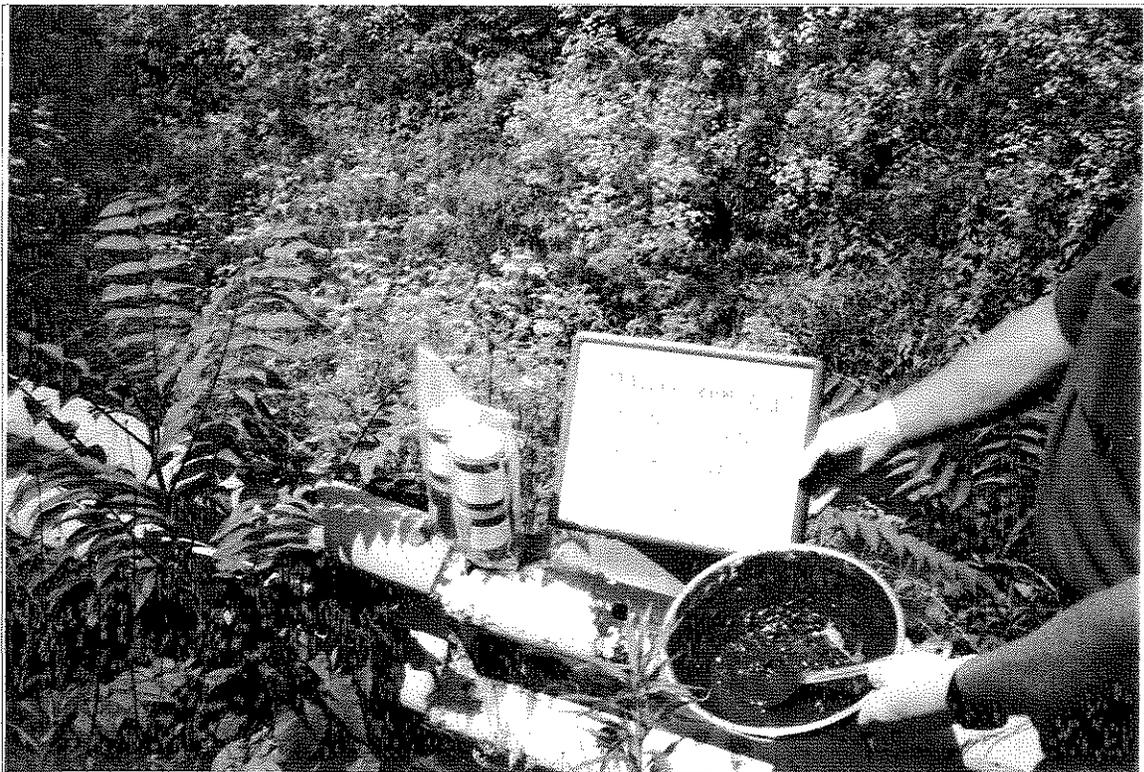
Photo No: 12 Sample No: EAJJ/MEBJT6 Date: June 10, 1998
Orientation:
Description: Sediment sample collected from Town Run between National City Bank & BP.

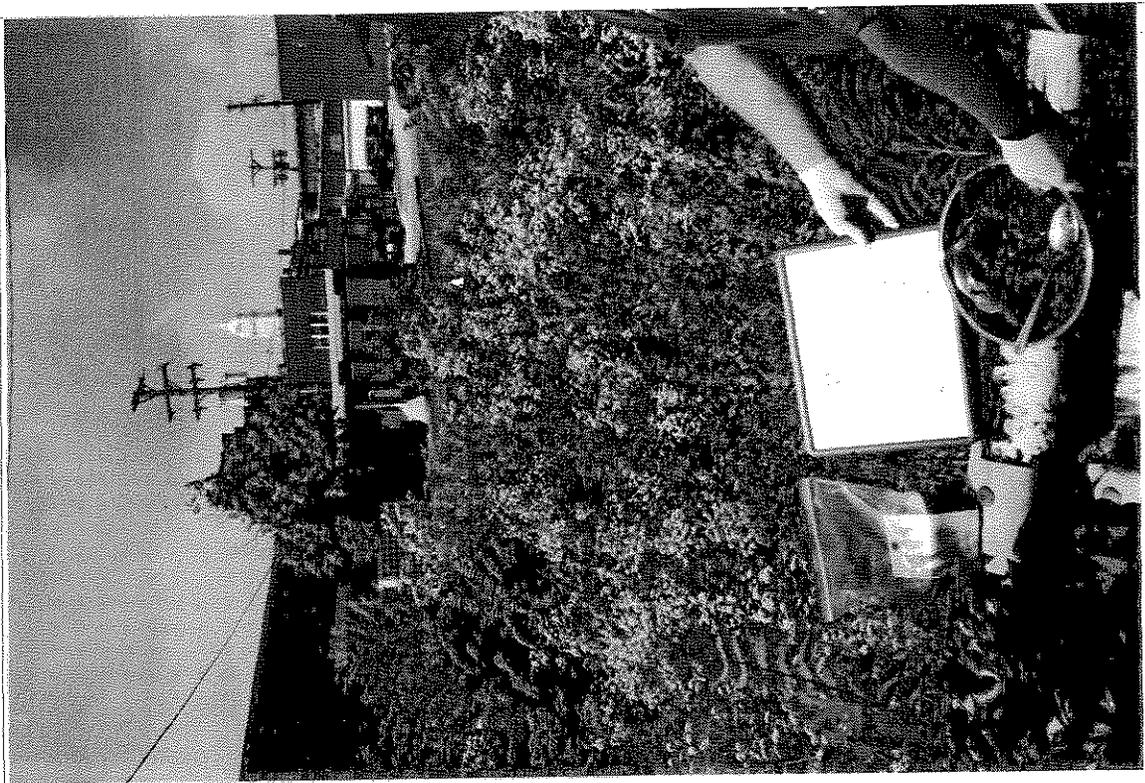
Photo No: 13 Sample No: ECGK/MEBKA7 & 8 (Dup) Date: June 10, 1998
Orientation:
Description: Soil sample collected from west bank of Town Run adjacent to sediment sample location for EAJJ/MEBJT6.
