**MILL CREEK GEOGRAPHIC INITIATIVE
PHASE II**

MILL CREEK WATERSHED
LOGAN, UNION, DELAWARE COUNTIES
and
MARYSVILLE, OHIO AREA

JANUARY 1999

Dan Tjoelker
Ohio Environmental Protection Agency
Division of Emergency & Remedial Response
Central District Office
Columbus, Ohio

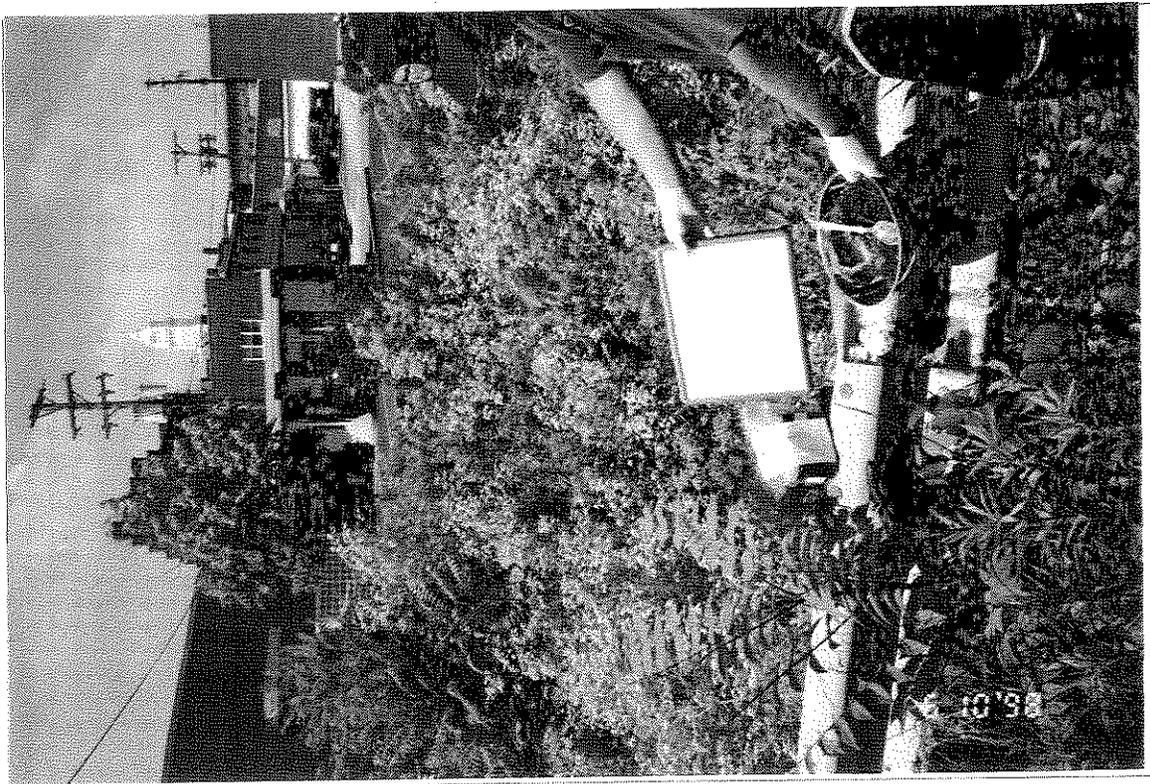
Photo No: 14 Sample No: Date: June 10, 1998
Orientation:
Description: Soil sample collected from east bank of Town Run north of sample location EAJJ/MEBJT6 (angle of photo is incorrect, but location is accurate).

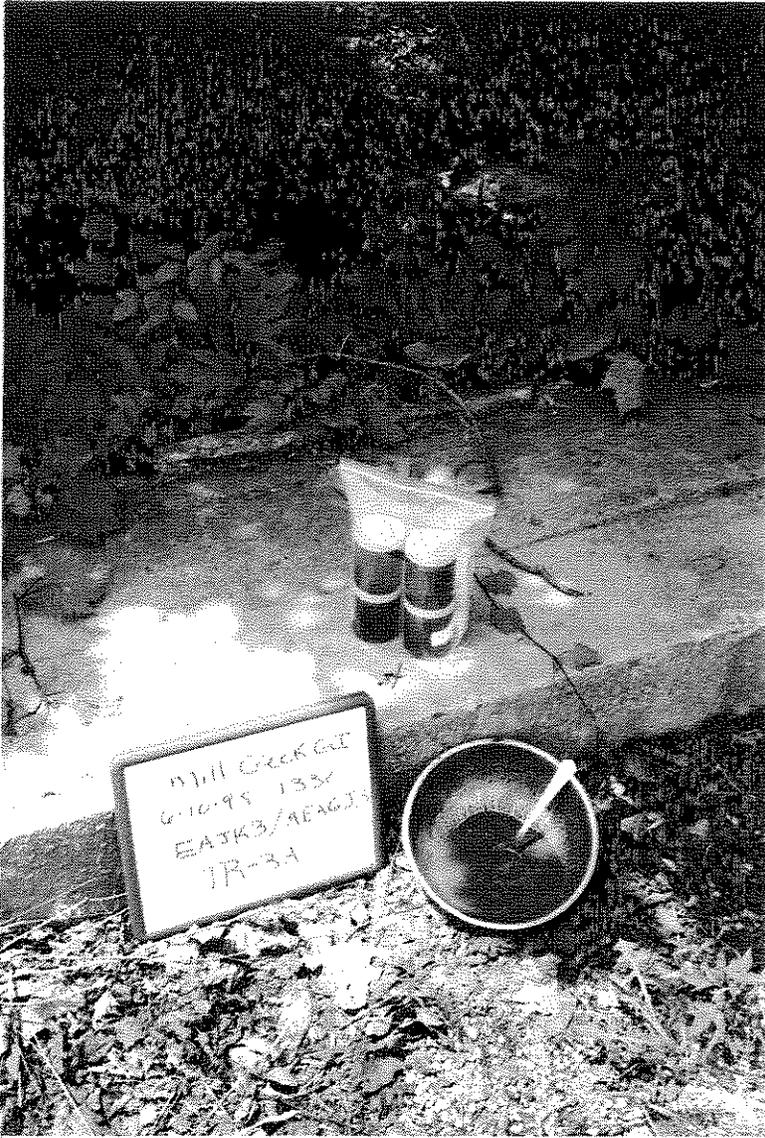
Photo No: 15
Sample No. EAJK/MEAGJ3
Date: June 10, 1998
Orientation:
Description: Sediment sample collected from Town Run near the intersection of Main Street and Eighth Street.

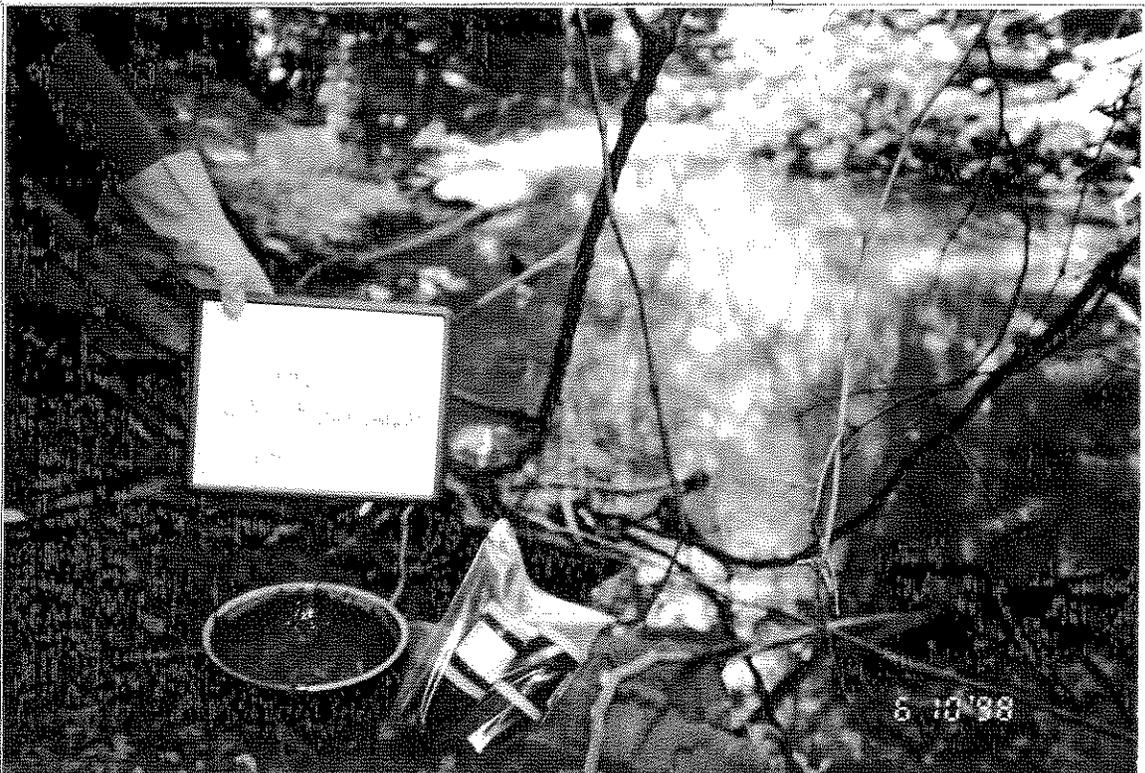
Photo No: 16
Sample No: EAJK/MEAGJ4
Date: June 10, 1998
Orientation:
Description: Sediment sample collected from Town Run near Judson Lumber culvert.

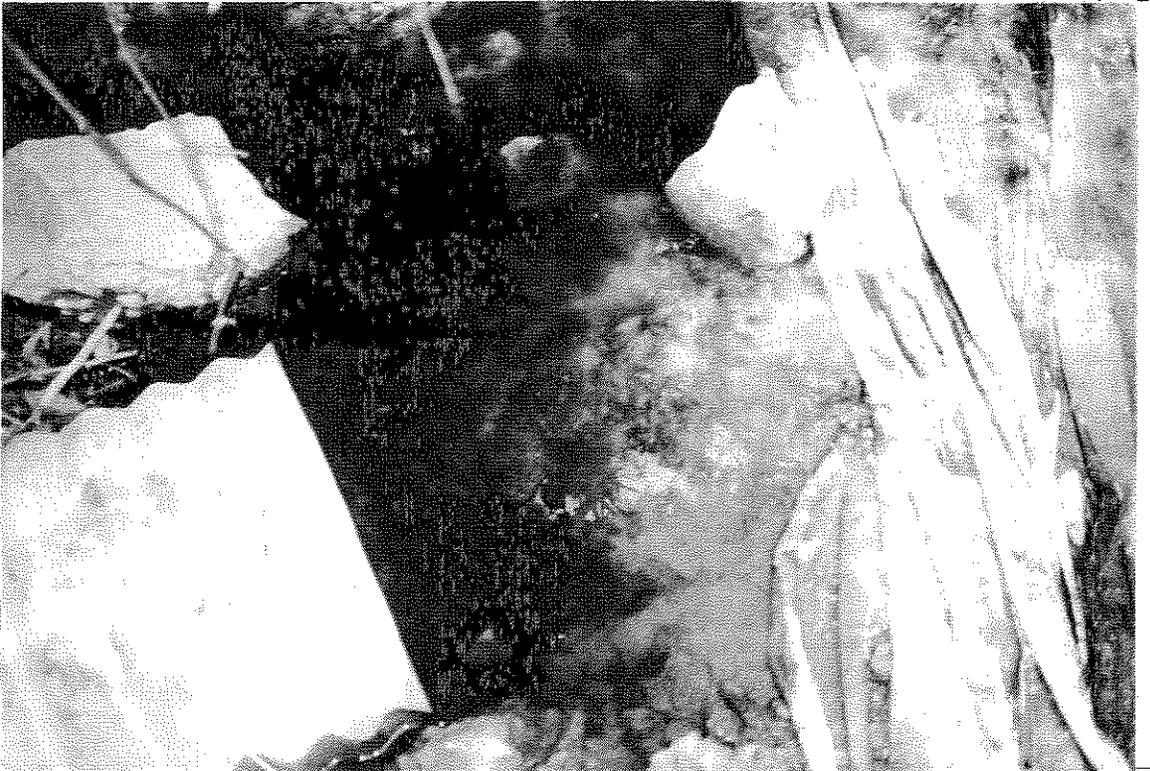
Photo No: 17 **Sample No:** EAJK/MEAGJ4 **Date:** June 10, 1998
Orientation:
Description: Culvert near sample location appeared to be draining sanitary sewage.

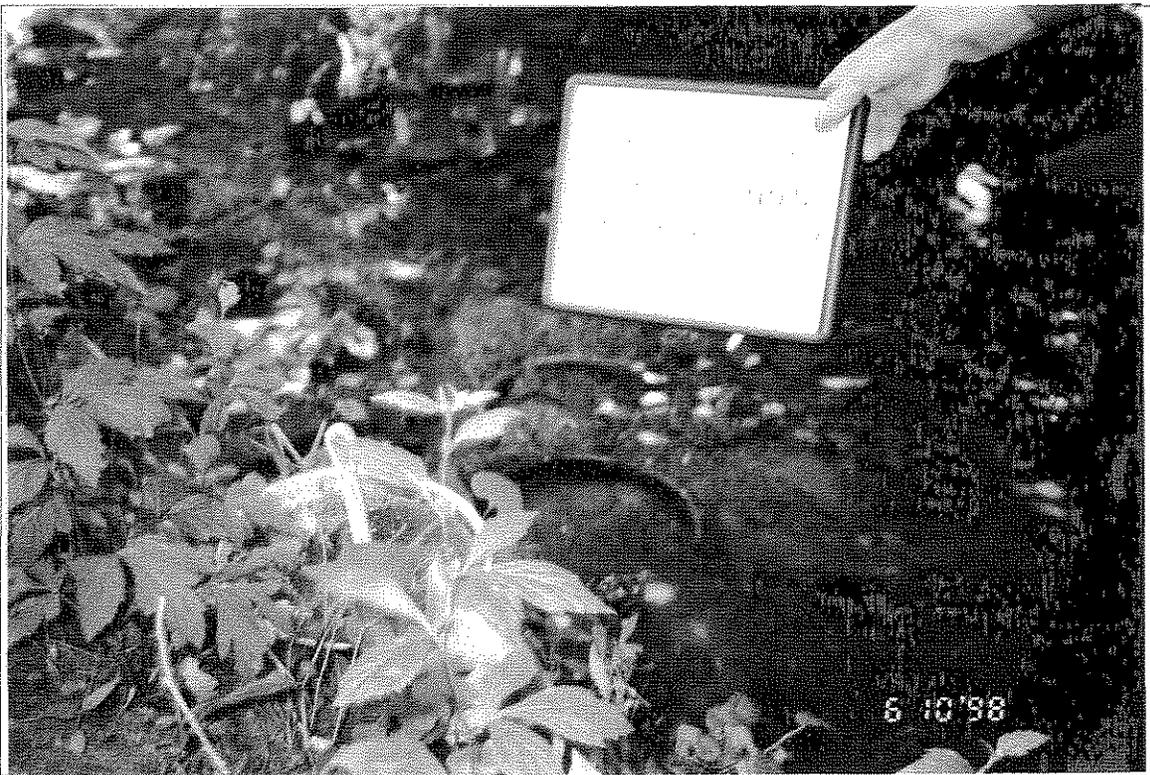
Photo No: 18 **Sample No:** EAJK/MEAGJ5 **Date:** June 10, 1998
Orientation:
Description: Sediment sample collected from Town Run adjacent to Judson Lumber, but upstream of EAJK/MEAGJ4 near Penn Oil.

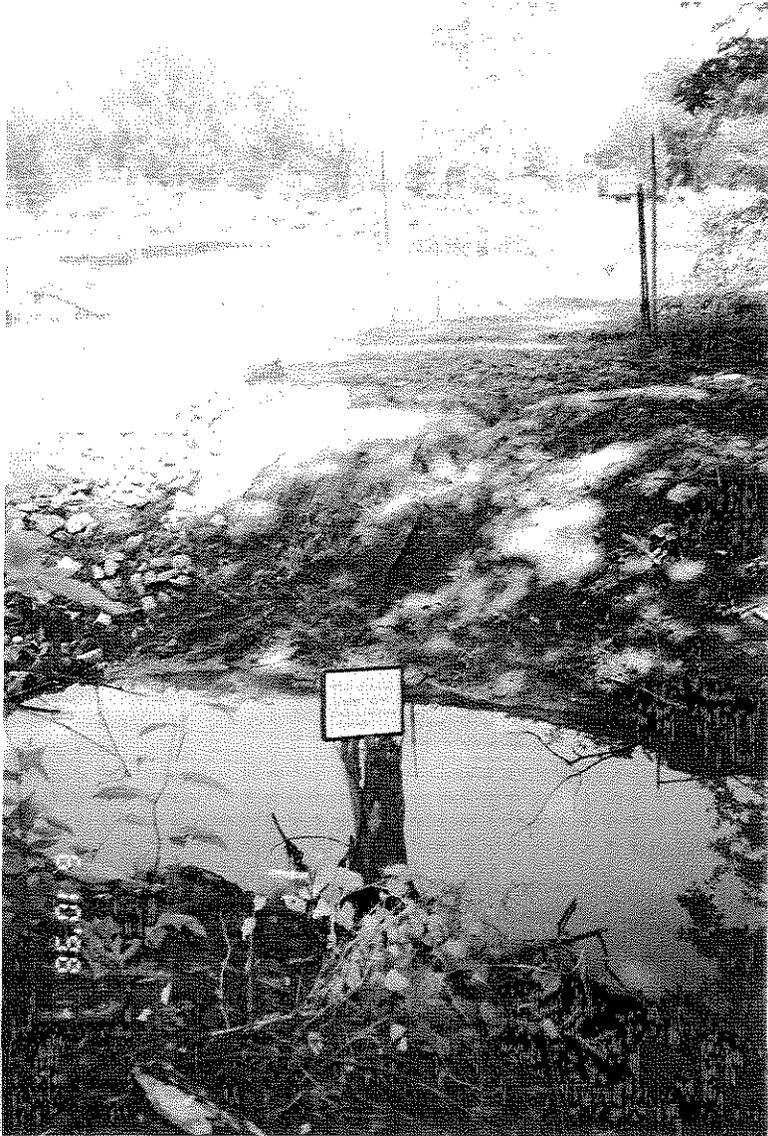
Photo No: 19
Sample No. EAJK/MEAGJ6
Date: June 10, 1998
Orientation:
Description: Sediment sample collected from Town Run adjacent to former Eljer Plumbingware property, upstream of Eljer retention pond.

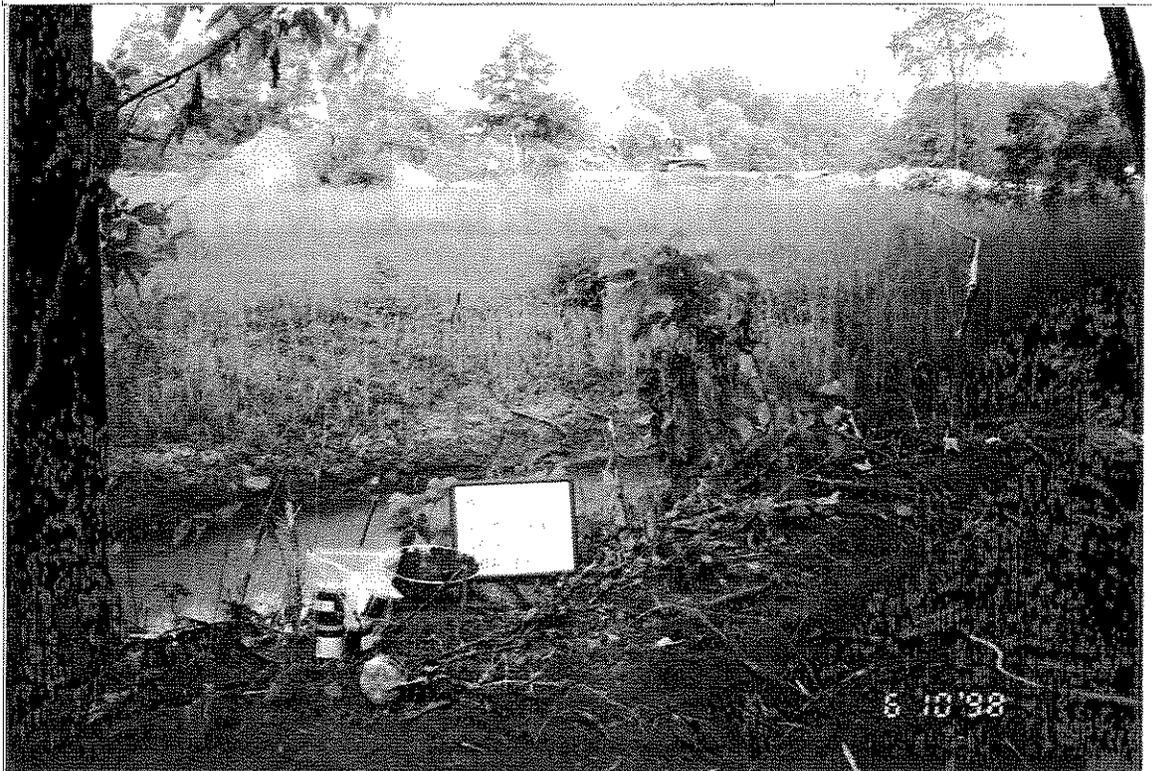
Photo No: 20
Sample No: EAJK/MEAGJ7
Date: June 10, 1998
Orientation:
Description: Sediment sample collected from Town Run adjacent to Eljer, downstream of retention pond.

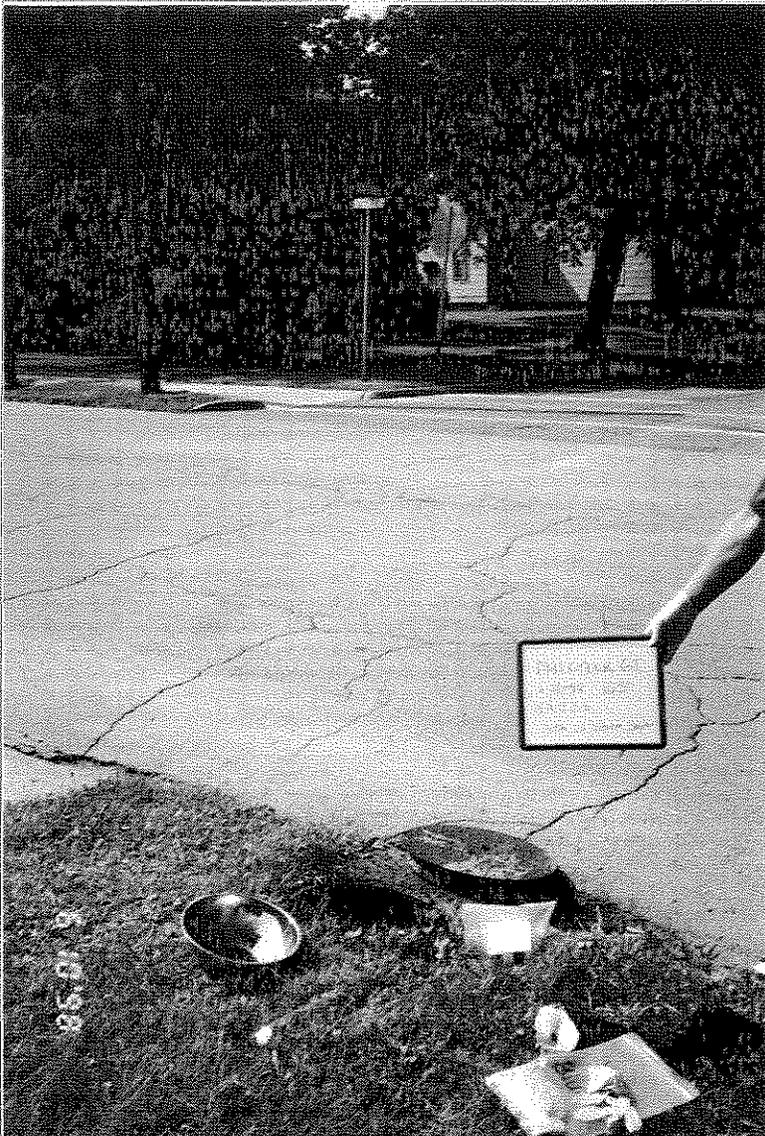
Photo No: 21
Sample No. EAJJ5
Date: June 10, 1998
Orientation:
Description: Sediment sample collected from storm sewer locate on 8th Street near Walnut Street intersection, downstream of former Scotts Company seed & fertilizer warehouses.

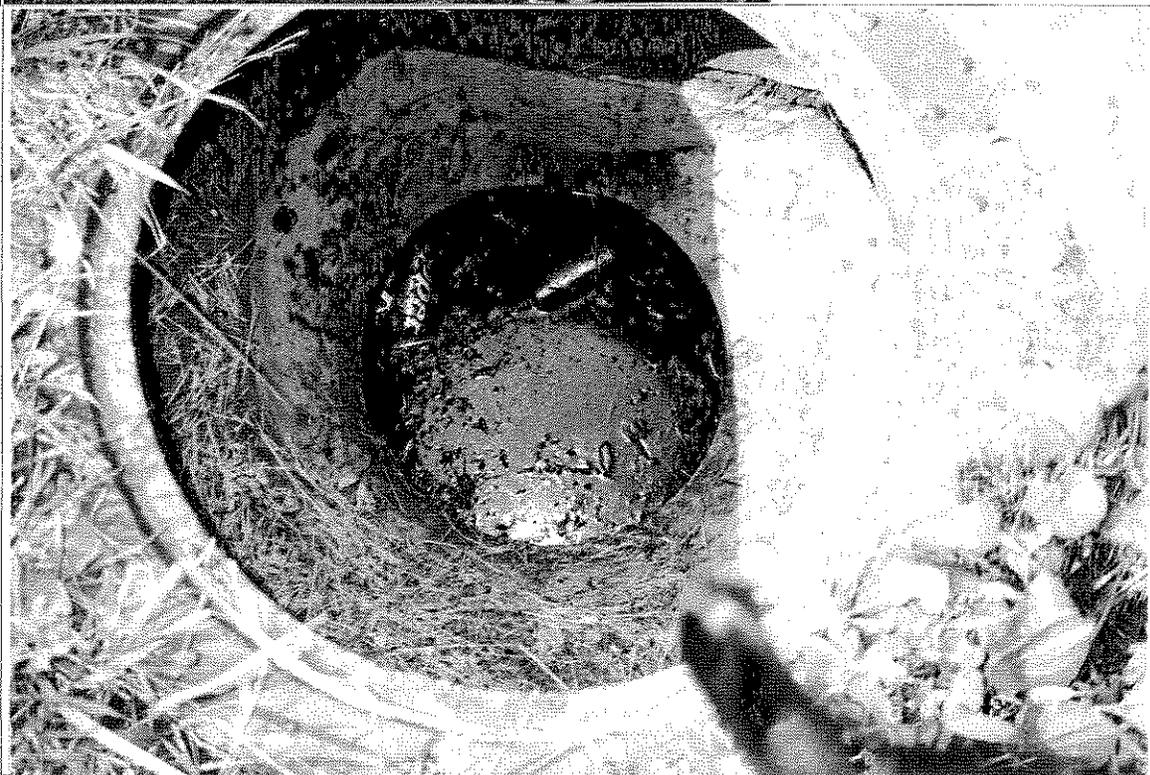
Photo No: 22
Sample No: EAJJ5
Date: June 10, 1998
Orientation:
Description: Close up view of storm sewer.
