**Biological and Water Quality
Study of the Blanchard River
Putnam, Hancock, Seneca, Allen, Wyandot, and
Hardin Counties, OH**

EAS/2007-6-2

Biological and Water Quality Study
of the Blanchard River and
Selected Tributaries
2005

June 28, 2007
OEPA Technical Report EAS/2007-6-2

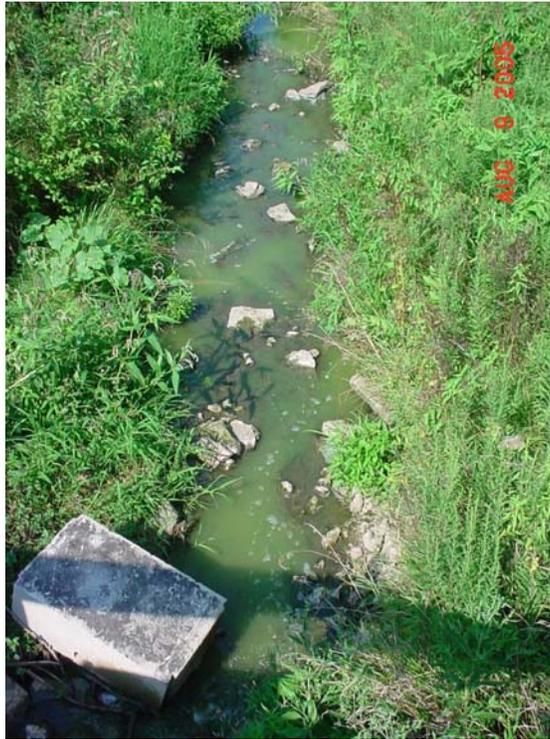
Figure 1i. Forest-Simpson Ditch at TR 195 downstream of Forest WWTP lagoons.

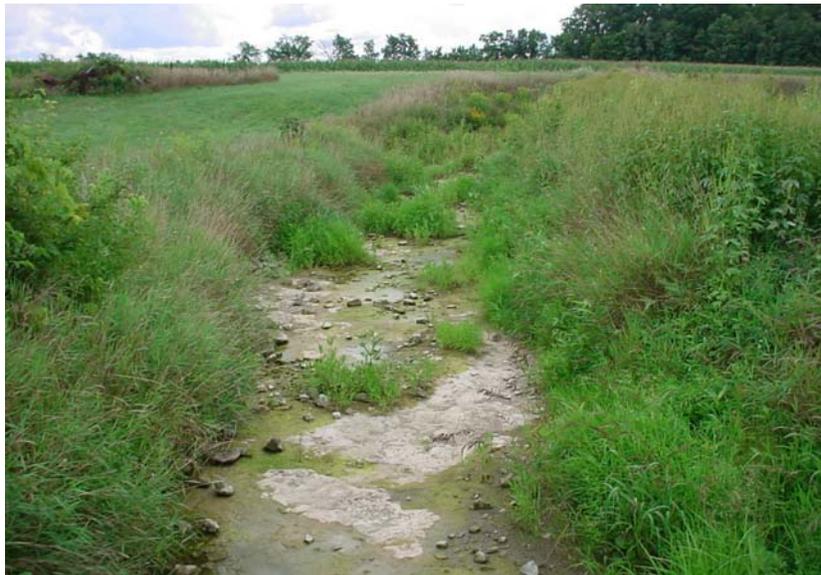
Figure 4f. Dry creek bed found in Tiderishi Creek at Eagle TR 44 (RM 4.57) on August 23.

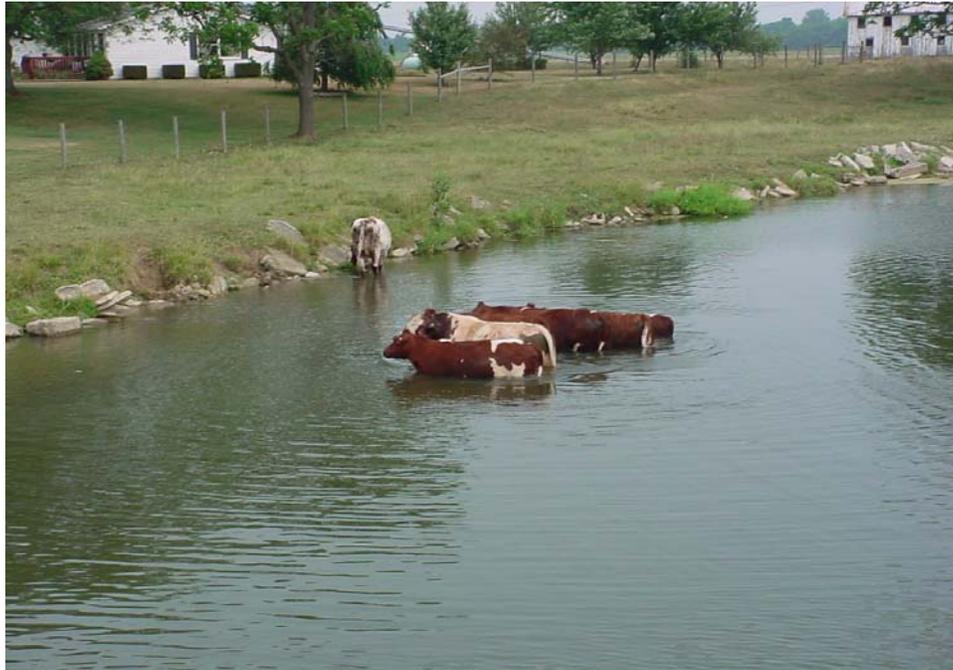
Figure 5b. Unrestricted livestock showed wading in Riley Creek at Riley TR Q (RM 7.52).

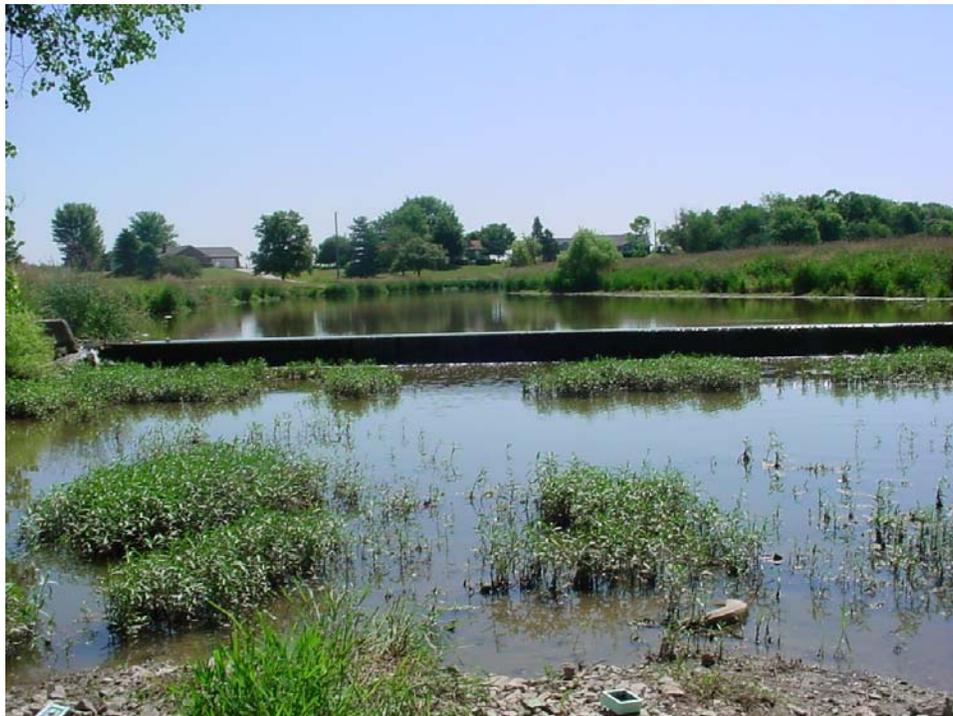
Figure 5c. Low head dam on Riley Creek below the Village of Pandora near Putnam CR 6.
