**Lake Erie Unit
Division of Surface Water**

Biological and Water Quality Study of Furnace Run Watershed

February 2007
NEDO/2007-02-01

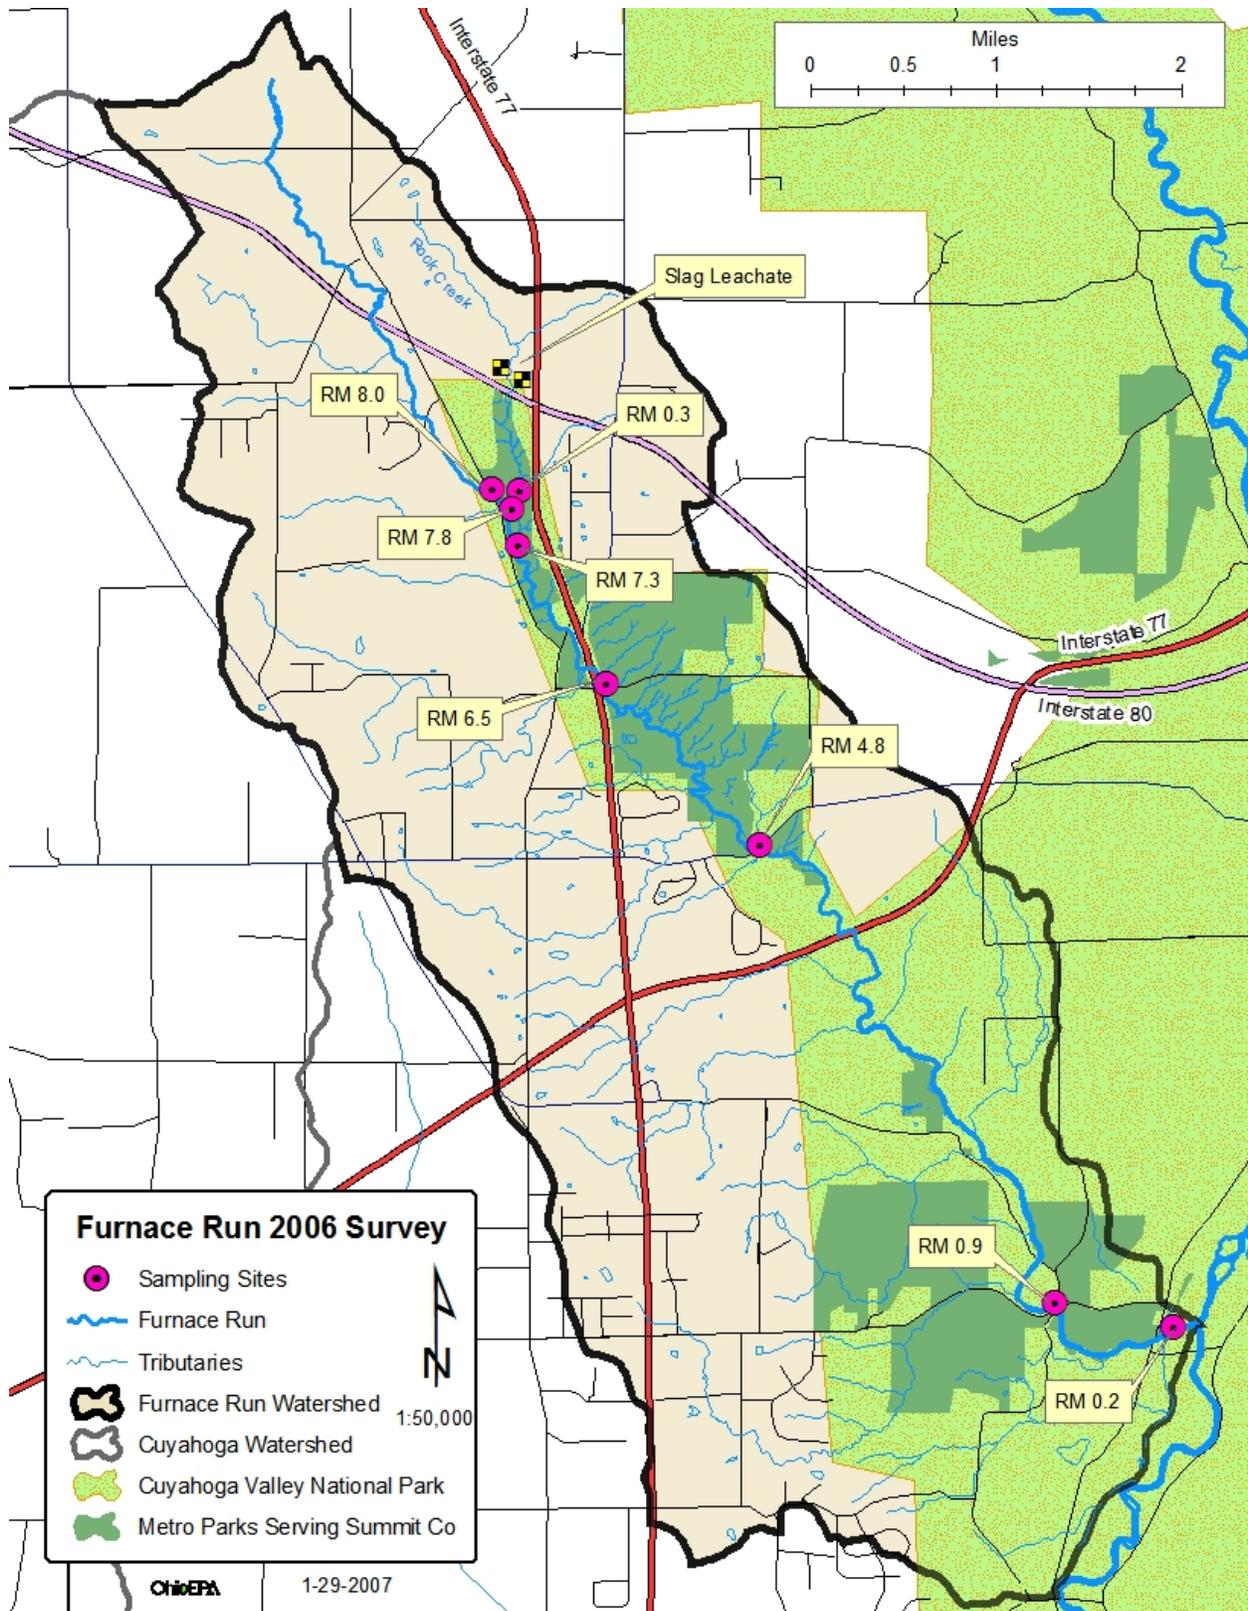
Figure 1. Furnace Run Watershed - 2006 Survey Sampling Locations

The Ohio EPA collected aquatic life community data, habitat information and water quality samples at seven sites within the Furnace Run watershed. Additional fish community data were collected at one site at the mouth of Furnace Run as part of a separate project. Figure 1 contains a map of the sampling area and collection sites.

The Ohio EPA collected fish community data from seven of the eight sites in the watershed (Figure 1). The fish sampling at each site was from zones, each between 150 and 200 meters in length. Two passes or collections were made during the survey at six of the sites; only one pass was completed at the site located at the mouth of Furnace Run (RM 0.20) as part of a separate project. Electro-fishing gear was utilized for fish collection. Fish were identified to species, counted, weighed (only at RM 0.2) and checked for deformities, eroded fins, lesions and external tumors (DELTs).

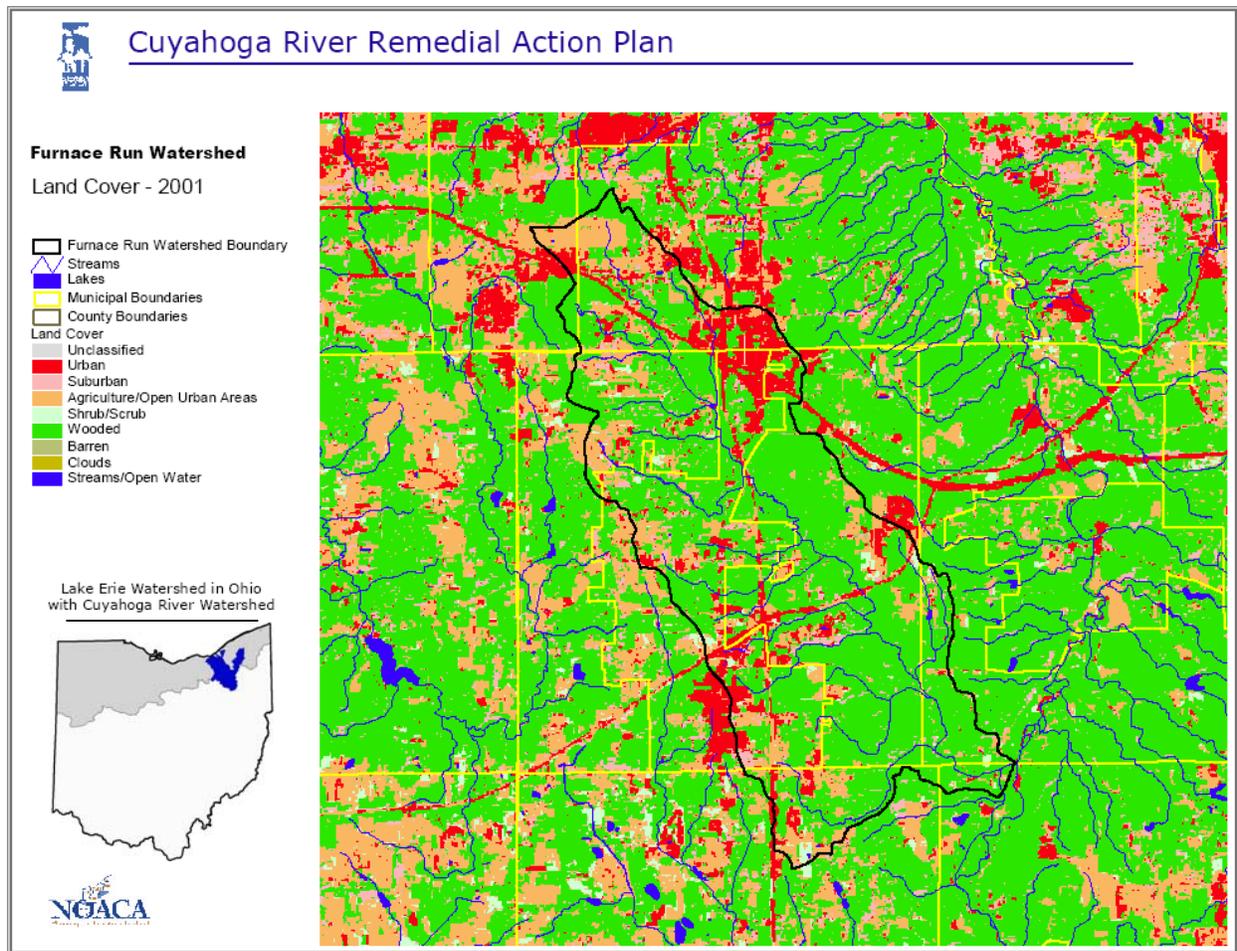
Figure 2. Land Cover map of Furnace Run watershed

Furnace Run originates in Brecksville, Broadview Heights and Richfield in northern Summit and southern Cuyahoga counties in northeast Ohio. It flows approximately 10.4 miles southeast through Bath and Boston townships to meet the Cuyahoga River at river mile (RM) 33.08. It drains approximately 35 square miles of predominately suburban lands. A 2001 satellite land cover analysis determined that approximately 14 % of the watershed is considered urbanized with generally impervious surfaces (Figure 2). The remaining 86 % of the watershed is comprised primarily of wooded (47%), grass/agricultural (34%) shrub/scrub (7%) cover (Cuyahoga River RAP, 2004).

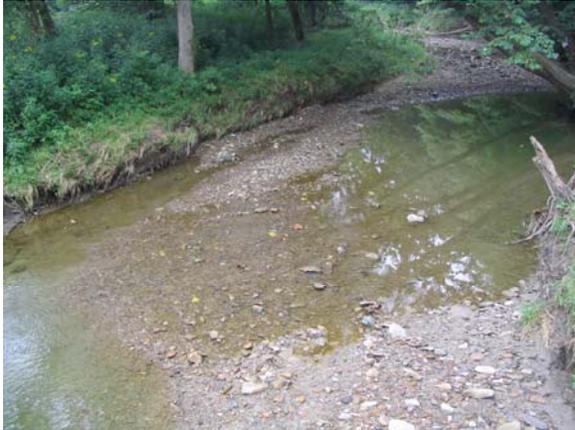
Additionally, the physical habitat in Furnace Run sites at RM 6.5, 4.8, and 0.9 appeared to have been influenced by high flow events during 2006 and previous years. Significant bank erosion is occurring in lower Furnace Run based on visual observations of banks at sampling sites along with excessive amounts of silts/clays covering the stream bottom (Photo 1 and 2). The stream bottom at RM 4.8 was covered with gray silts which clearly appeared to have eroded from the stream banks.

Photo 1. Eroding streambank at RM 6.5
D. Altfater

The Furnace Run watershed should continue to be monitored on a regular basis to ensure that the restoration targets continue to be met and that the watershed remains in attainment with Ohio biological and water quality criteria. It is recommended that local political jurisdictions within the watershed implement riparian protection strategies and storm water management programs to maintain the current level of biological and water quality, as noted in the Lower Cuyahoga River Total Maximum Daily Loads (TMDL) Report (Ohio EPA, 2003). Communities within the Furnace Run watershed are also regulated under Ohio EPA Phase 2 Storm Water National Pollutant Discharge Elimination System System (NPDES) Permits which require the implementation and enforcement of these storm water management programs by early 2008.

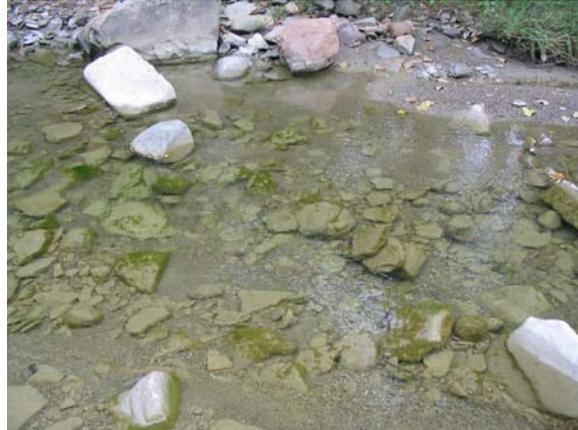
Photo 2. Silt covered stream bottom
D. Altfater

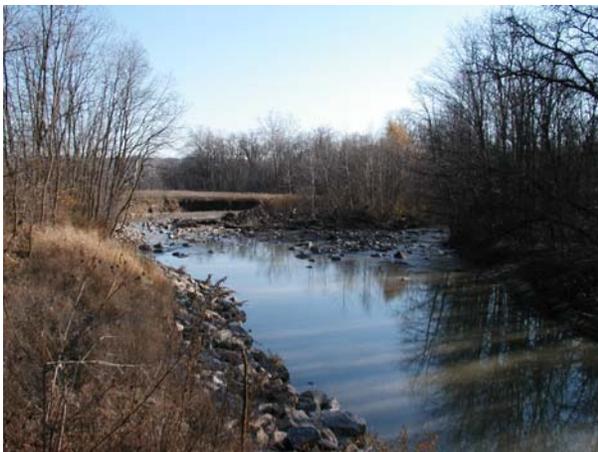
Sites near the mouth of Furnace Run (RM 0.2 and 0.9) were observed to have been recently impacted from heavy rains and high rates of erosion (Photo 3 and 4). This may have contributed to a drop in ICI scores at these sites over previous years (Table 4).

Photo 3. Furnace Run DST Everett Road.
Note heavy farm field erosion at far left.
K. Rogers

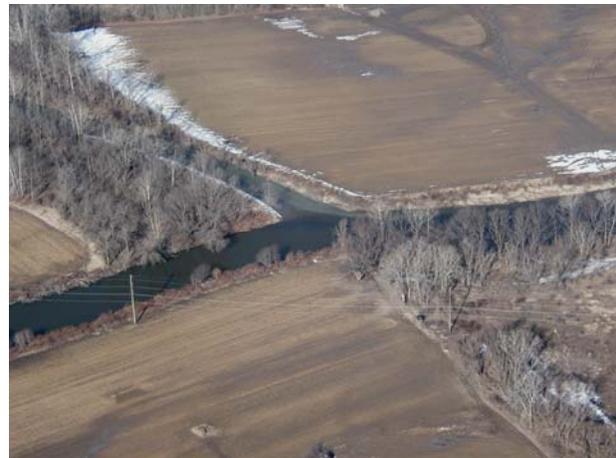
Photo 4. Mouth of Furnace Run. Note sediment plume into Cuyahoga River.
K. Rogers
