Biological and Water Quality Study of Kyger Creek and Select Tributaries

OHIO EPA Technical Report EAS/2011-2-7

Biological and Water Quality Study
of Kyger Creek and
Selected Tributaries
2008

Gallia and Meigs Counties, OH

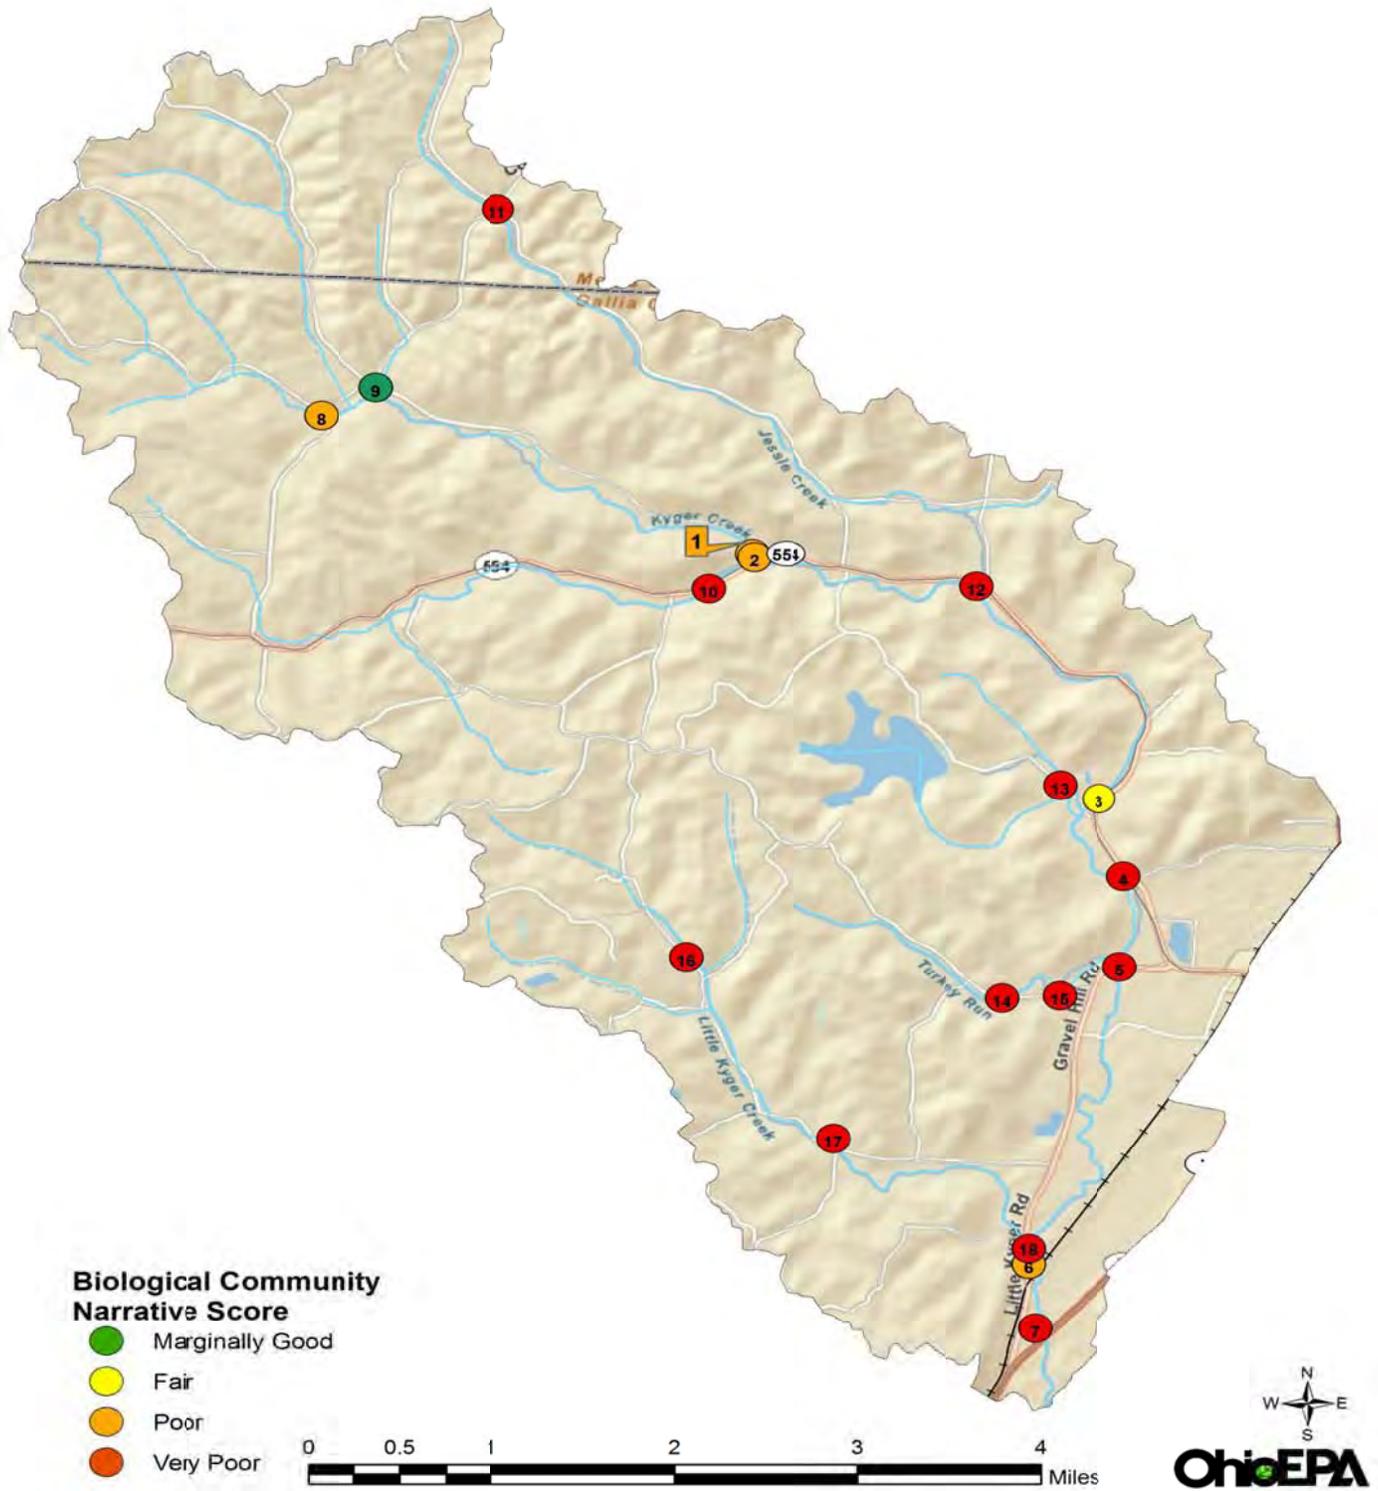
Figure 1. Kyger Creek basin sampling locations and biological community performance, 2008. Site numbers correspond to Table 1.

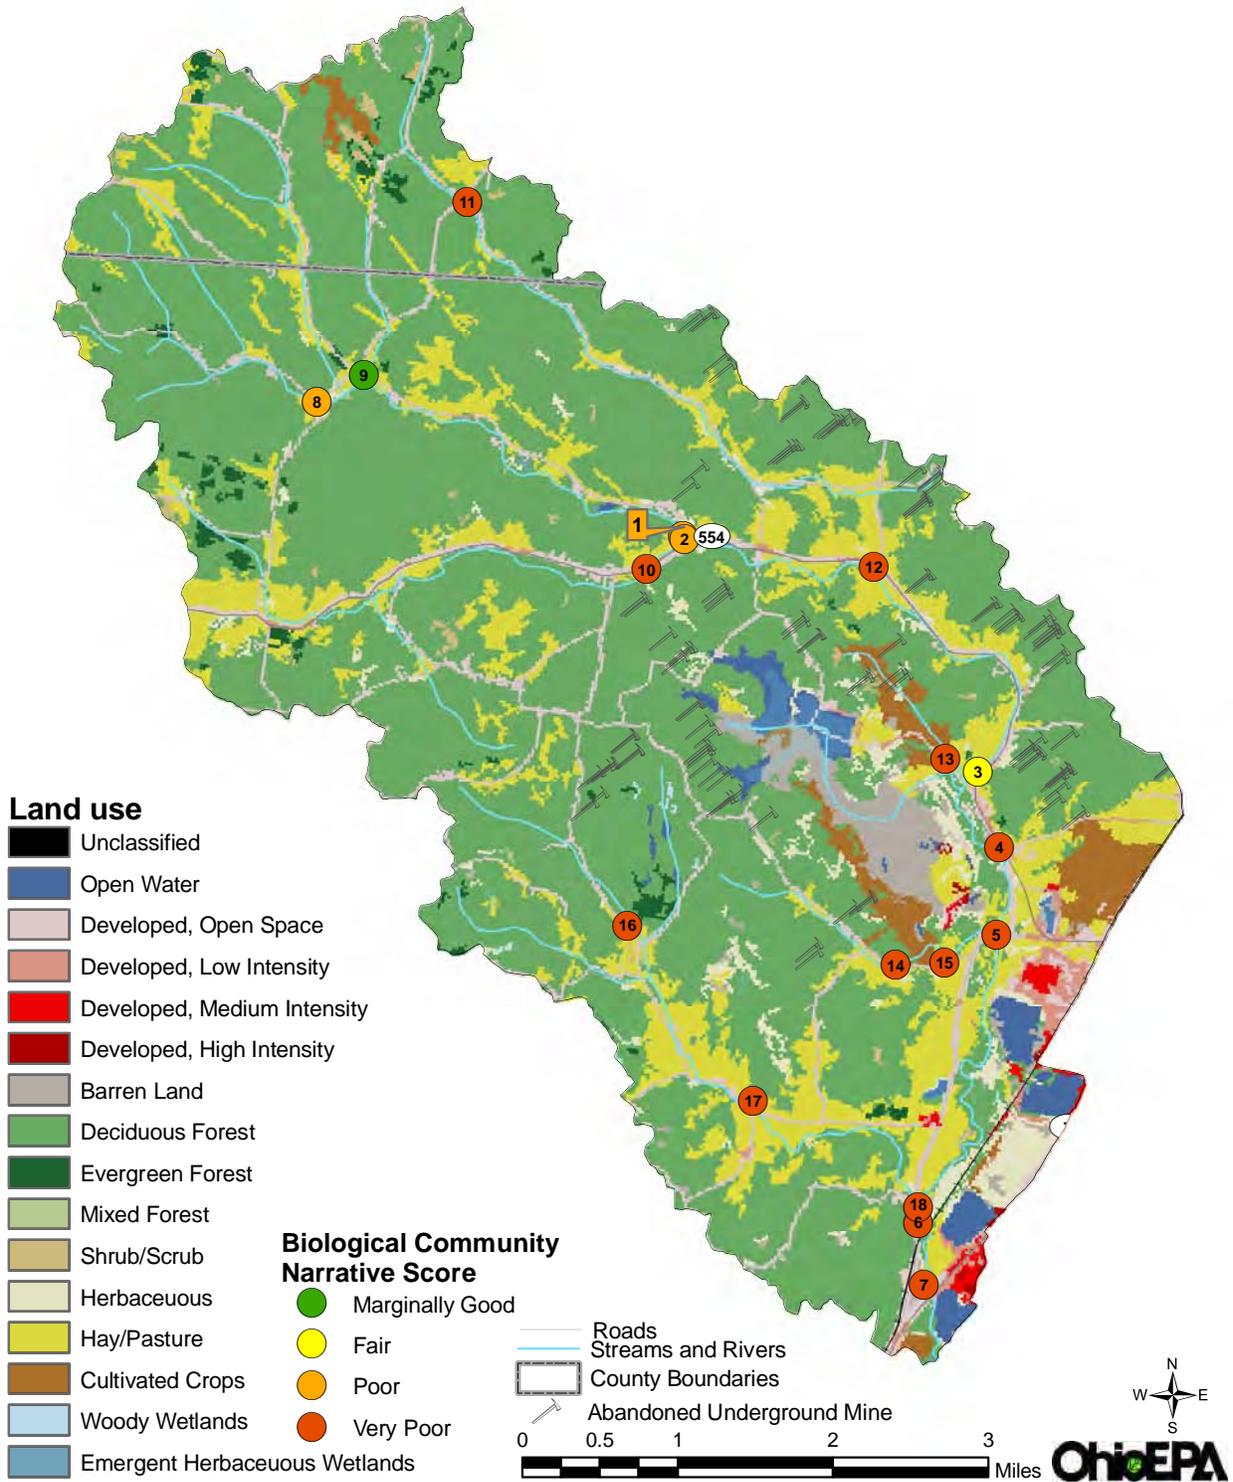
Figure 3. Land use, biological community narrative scores and abandoned mines in the Kyger Creek study area, 2008.

The Kyger Creek study area was confined to one Watershed Assessment Unit (HUC 05030202 09 01) (Figure 3). Fish and macroinvertebrate sampling was conducted at 18 locations in the Kyger Creek watershed ranging in drainage area from 0.6 mi² to 30.7 mi² (Figure 3 and Table 1). The survey assessed aquatic life use attainment at 17 sites. Three sites fully met the existing aquatic life use, while the remaining 14 sites did not attain either their designated or recommended use (Figure 4).

Large portions of the Kyger Creek study area contain abandoned coal mines (Figure 3) and much of the watershed was mined before reclamation laws were instituted. Prior to 1977, coal mining did not have to return the ground to its original condition, and instead large piles of coal waste (gob) were left along with highwalls, mine pits of toxic water and underground mine discharges to surface waters. These remaining mining wastes and discharges contribute large amounts of AMD which can include high levels of acidity, iron, aluminum, manganese, nickel, zinc, total dissolved solids, and low pH levels.

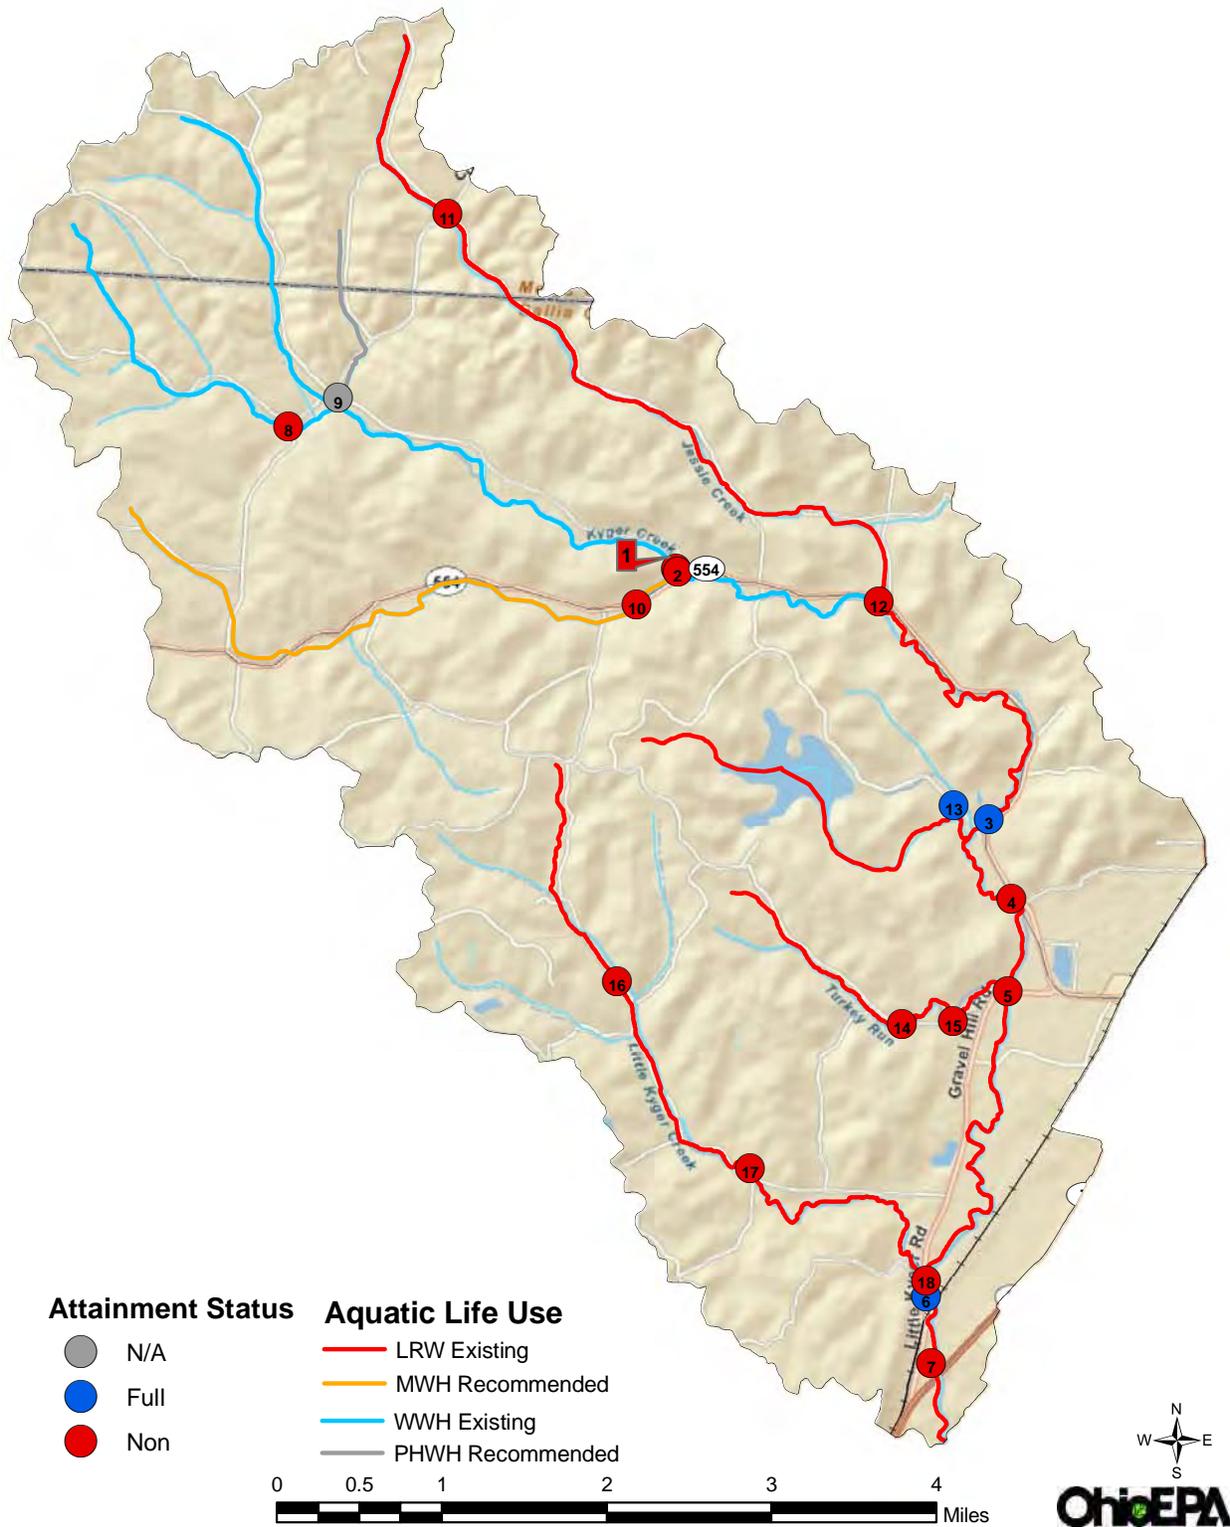
Figure 4. Aquatic life use designations and attainment status of sampling locations within Kyger Creek survey area, 2008.

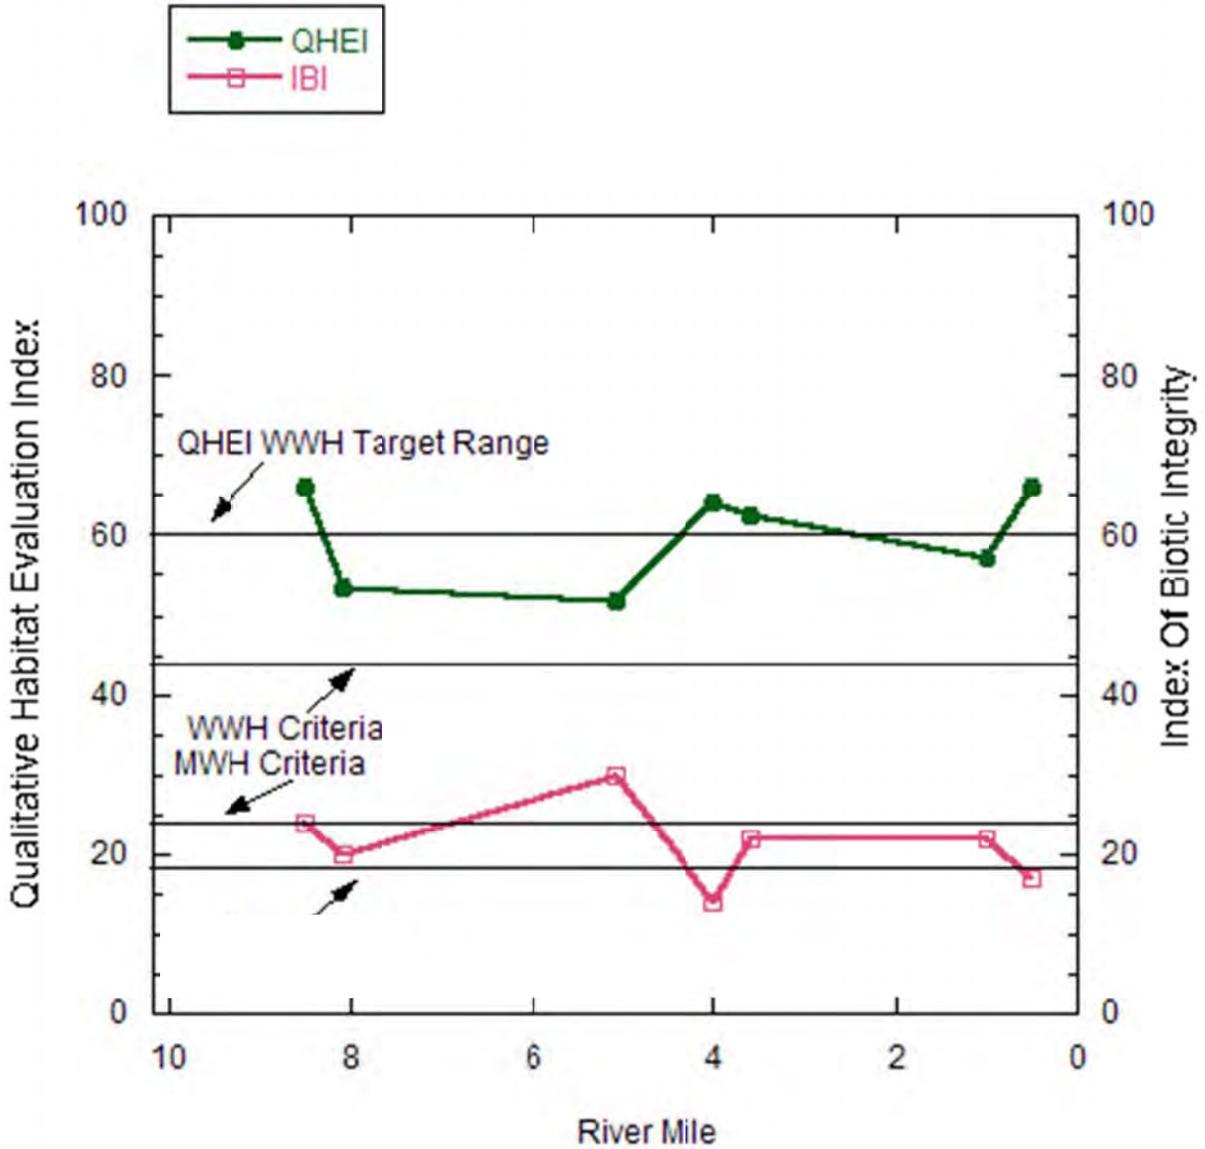
Figure 5. Kyger Creek IBI and QHEI scores from 2008. The fish community consistently underperforms the habitat available.

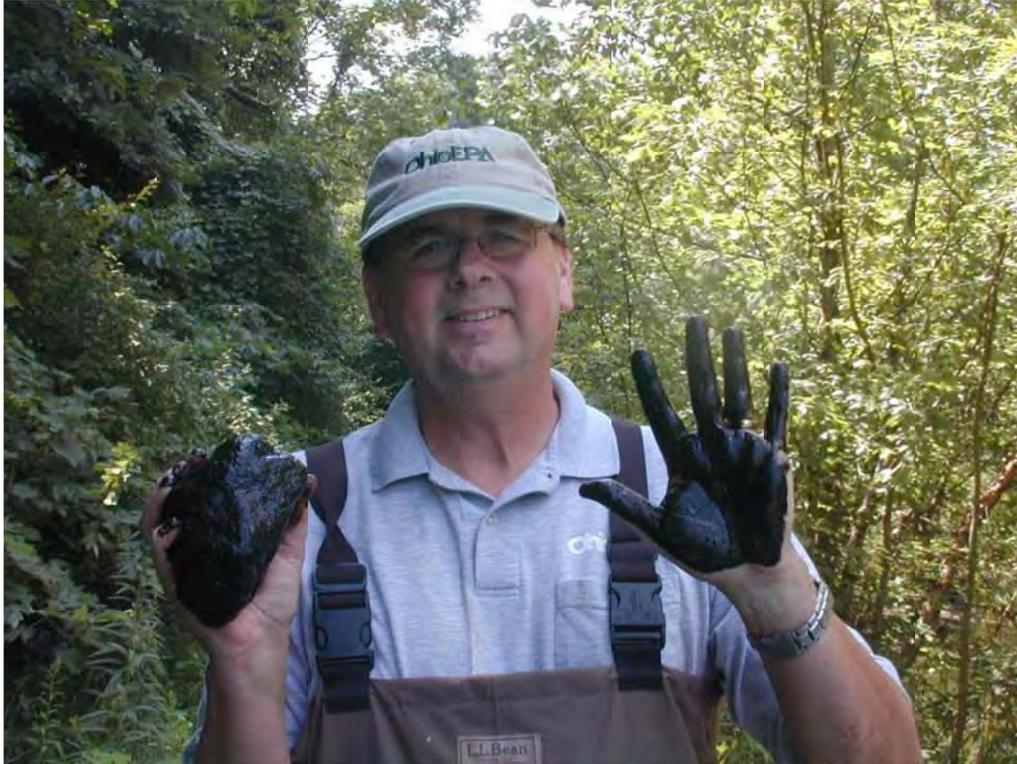
Excessive sedimentation originating in the AMD impacted tributaries extended downstream into Kyger Creek; substrates in the lower reach were almost entirely composed of loose, iron-stained sands with coal fines and a thin, but pervasive layer of silt and yellow-boy precipitate. Localized deposits of coarse rubble or boulders were encountered at RM 4.0 and RM 3.0, and a large amount of rip-rap was deposited under the SR 7 Bridge at RM 0.5. However, these larger substrates were often embedded by sand and, in the case of RM 0.5, were caked with flocculent, grey solids. Substrates at RM 3.0 and RM 4.0 were often covered with a crusty layer of black sulfite-like mineral deposits, commonly observed in mine drainage streams. These encrusted substrates offered a very poor colonizing surface for macroinvertebrates (Figure 6). Under most circumstances, deployment of artificial substrate samplers tends to dampen the influence of sedimentation in collections, as the samplers are tied to a cinder block and suspended in the water column, above the stream bed.

Figure 6. A rubble substrate from Kyger Creek RM 4.0 covered with a black, sulfite-like crust. The site was downstream from Jessie Creek, Stingy Run and the Gavin 008 landfill leachate outfall.

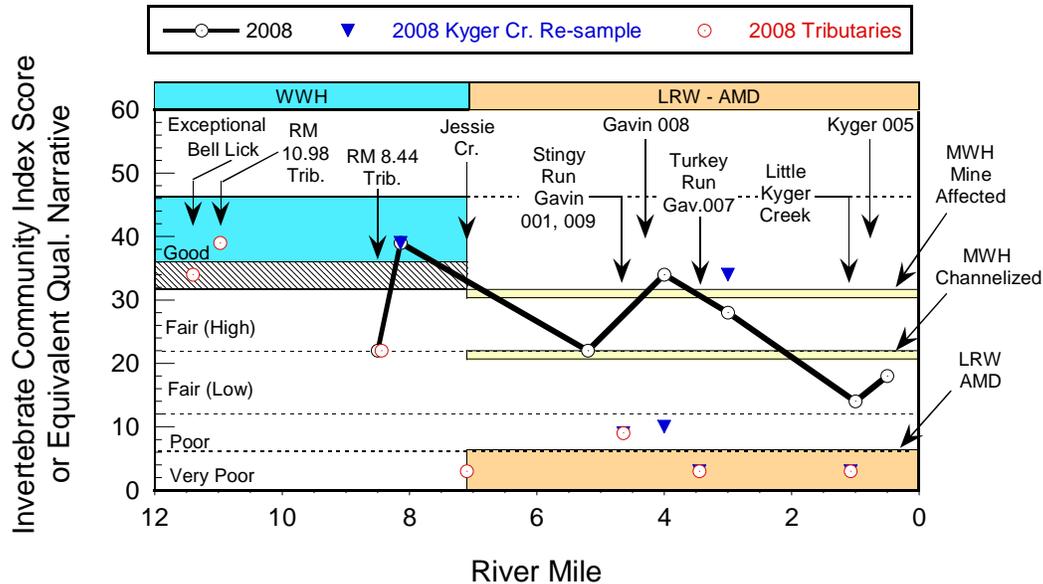
Figure 7. Macroinvertebrate community health and ICI scores from the Kyger Creek basin, 2008. Where only qualitative data were collected, an ICI score based on the narrative equivalent has been inserted.

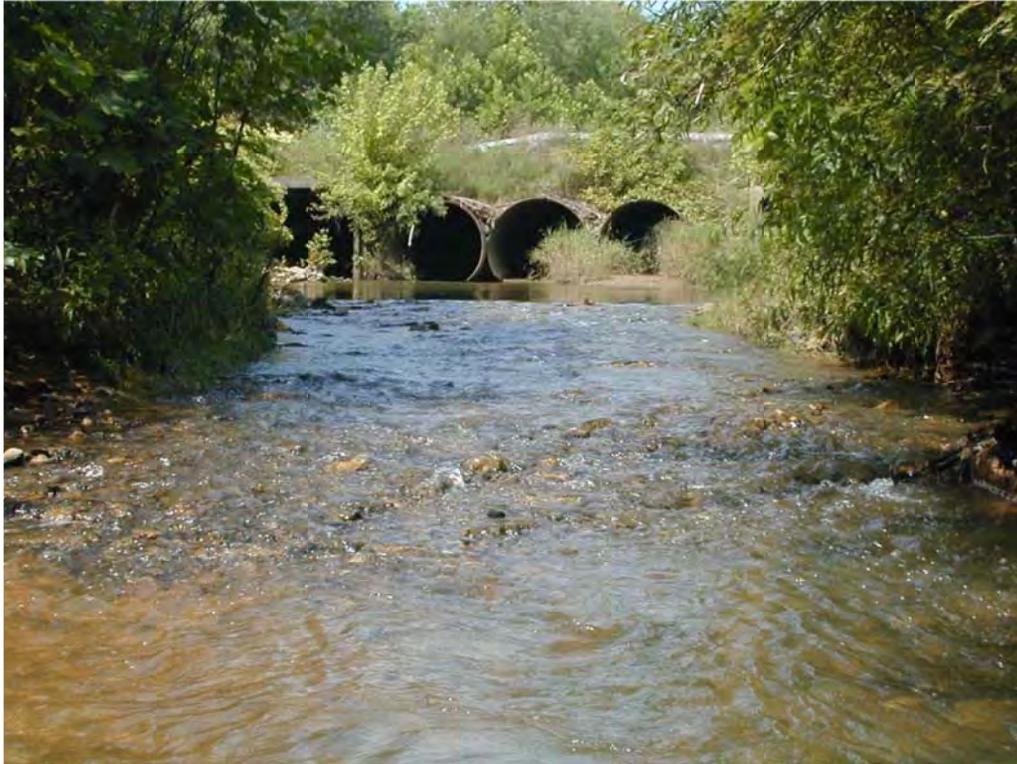
Figure 8. Riffle habitat at Kyger Creek RM 3.0, looking upstream towards haul road bridge on Gavin Plant property. Note series of galvanized metal culverts that carry flow under bridge.

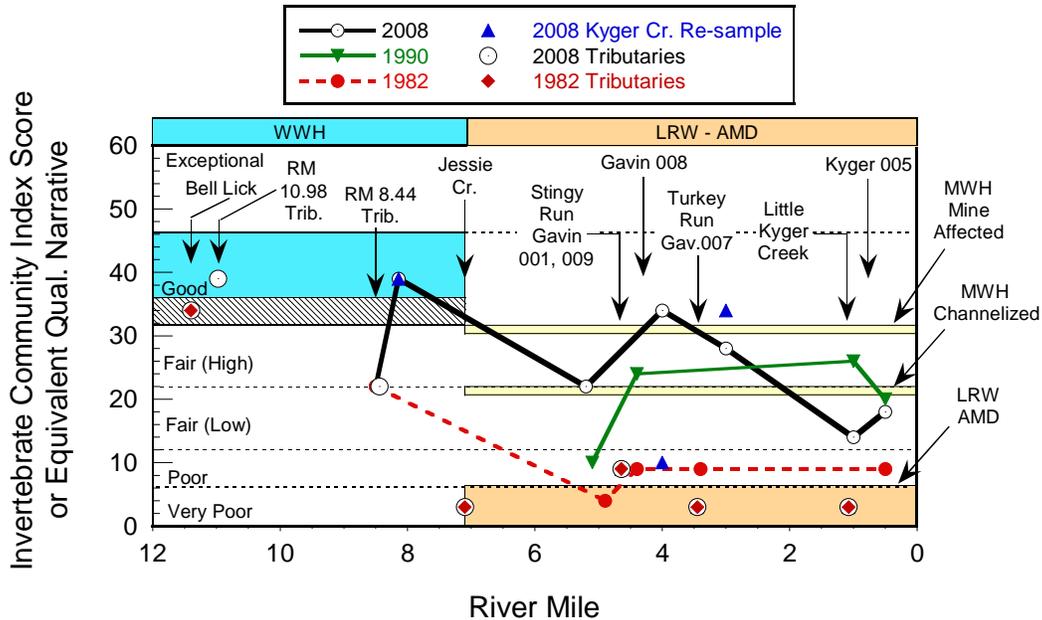
Historical sampling in the Kyger Creek basin included a qualitative survey of ten sites in the mainstem and tributaries from 1982 and artificial substrate collections at four mainstem sites in lower Kyger Creek between RM 5.1 and the mouth in 1990 (Figure 9).

Figure 9. Macroinvertebrate community trends in the Kyger Creek basin, 1982-2008. Where only qualitative data were collected, an ICI score based on the narrative equivalent has been inserted. **Note:** Due to the late November sampling period, changes in taxonomy and sampling methodologies, plus time and manpower constraints, historical results from 1982 may not be directly comparable to the more intensively conducted sampling in 1990 and 2008.

Lowest quality communities and least improvement in lower Kyger Creek was found downstream from Little Kyger Creek and the Kyger Creek 005 fly ash discharge. ICI scores from both 1990 and 2008 were in the fair range but lower in 2008 (Figure 9).

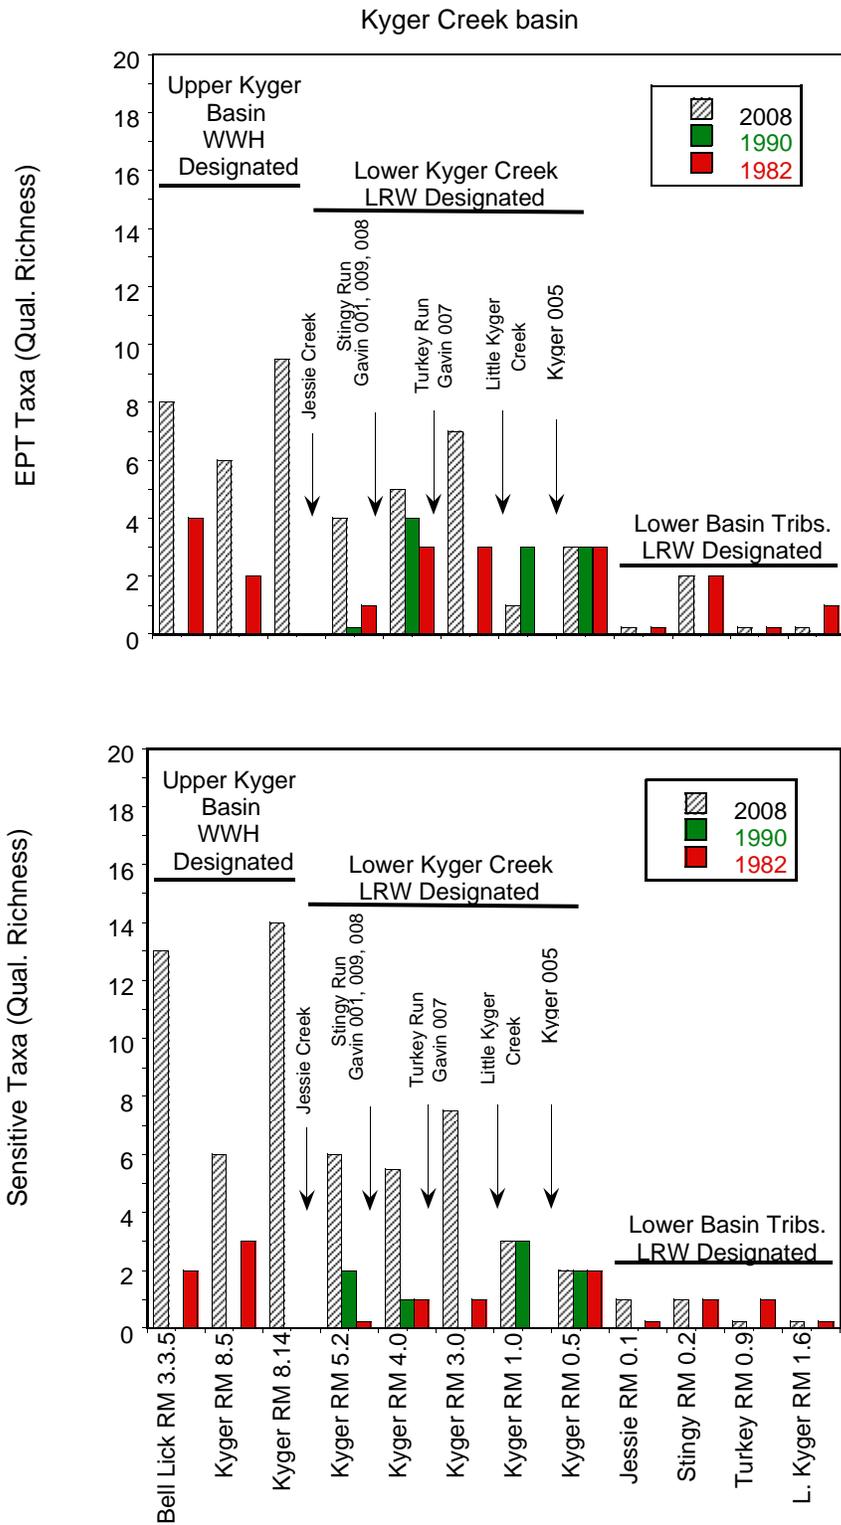
Figure 10. Pollution sensitive and EPT (Ephemeroptera, Plecoptera, and Trichoptera) taxa richness trends from qualitative (natural substrate) collections at the Kyger Creek basin sites, 1982-2008.

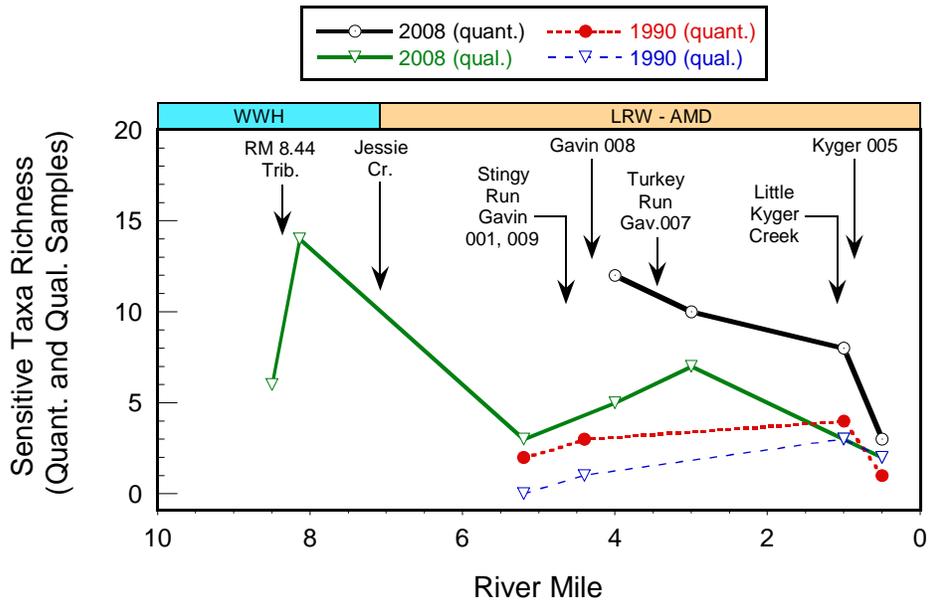
Figure 11. Longitudinal trends in pollution sensitive taxa richness from quantitative (artificial substrate) and qualitative (natural substrate) collections at Kyger Creek sites from 1990 and 2008.

Qualitative collections from RM 0.5 show little change since 1982 with low total taxa (15 to 7), low sensitive taxa (2; Figure 11) and low EPT taxa richness (3) during each survey. Mine drainage and point source loading in the lower mile continue to impact the reach with no significant improvements over historical results.
