Re: RCRA 3013 Administrative Order on
Consent
U.S. EPA ID No. OHD 004 281 598

Re: AK Steel Corporation, Zanesville, OH

IN THE MATTER OF:)	ADMINISTRATIVE ORDER ON CONSENT
)	
AK Steel Corporation)	U.S. EPA Docket No:R3013-5-03-001
1724 Linden Avenue)	
Zanesville, Ohio 43701)	
)	
EPA ID#: OHD 004 281 598)	Proceeding under Section 3013 of the Resource
)	Conservation and Recovery Act, as amended,
RESPONDENT.)	42 U.S.C. § 6934.

Appendix B

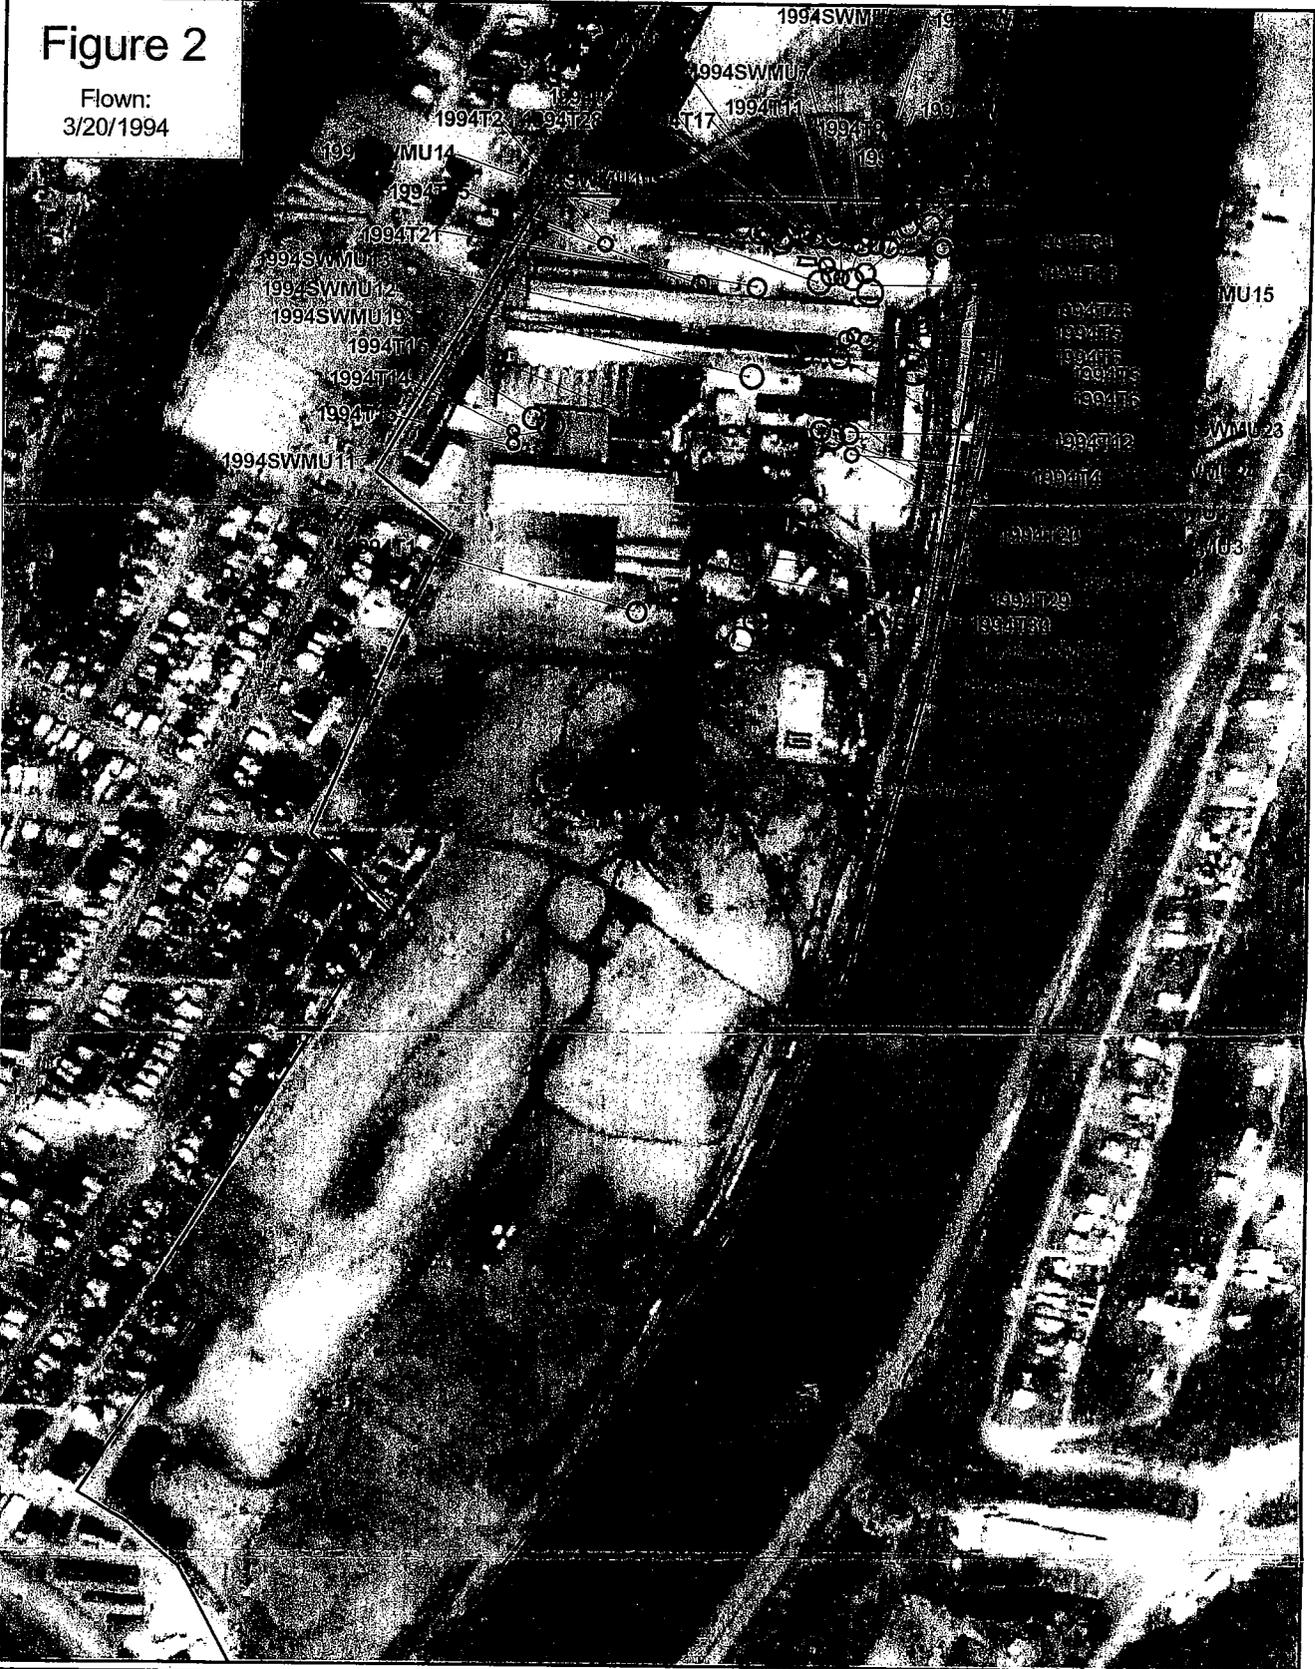
In 1998 EPA contracted for a Preliminary Assessment/Visual Site Inspection (PA/VSI) at the AK Steel (Armco) Zanesville, Ohio plant. This PA/VSI concentrated on solid waste management units (SWMUs) proximate to the main production facilities. Figure 2 indicates the location of the SWMUs identified during that site inspection.

Areas of disturbed ground (DG) were observed to the northeast of the buildings, near the railroad tracks (1942DG4), and southeast of the buildings, including the plant yard and the area between the plant and the agricultural land (1942DG1), subsequently referred to as the industrial buffer area. Small areas of disturbed ground are also seen adjacent to the residential area, south of the roundhouse (1942DG2) and east of the roundhouse (1942DG3).

Several stained areas (S) were present associated with stockpiles. Additional stains were noted in the disturbed soil area southeast of the plant and yard (1942S2, 1942S3, and 1942S4) and south of the southwestern plant building (1942S1).

Tanks (T) were also noted in two areas in the air photograph. One area was to the northwest of the plant buildings (1942T2), while another was south of the southwesternmost building and east of the roundhouse (1942T1).

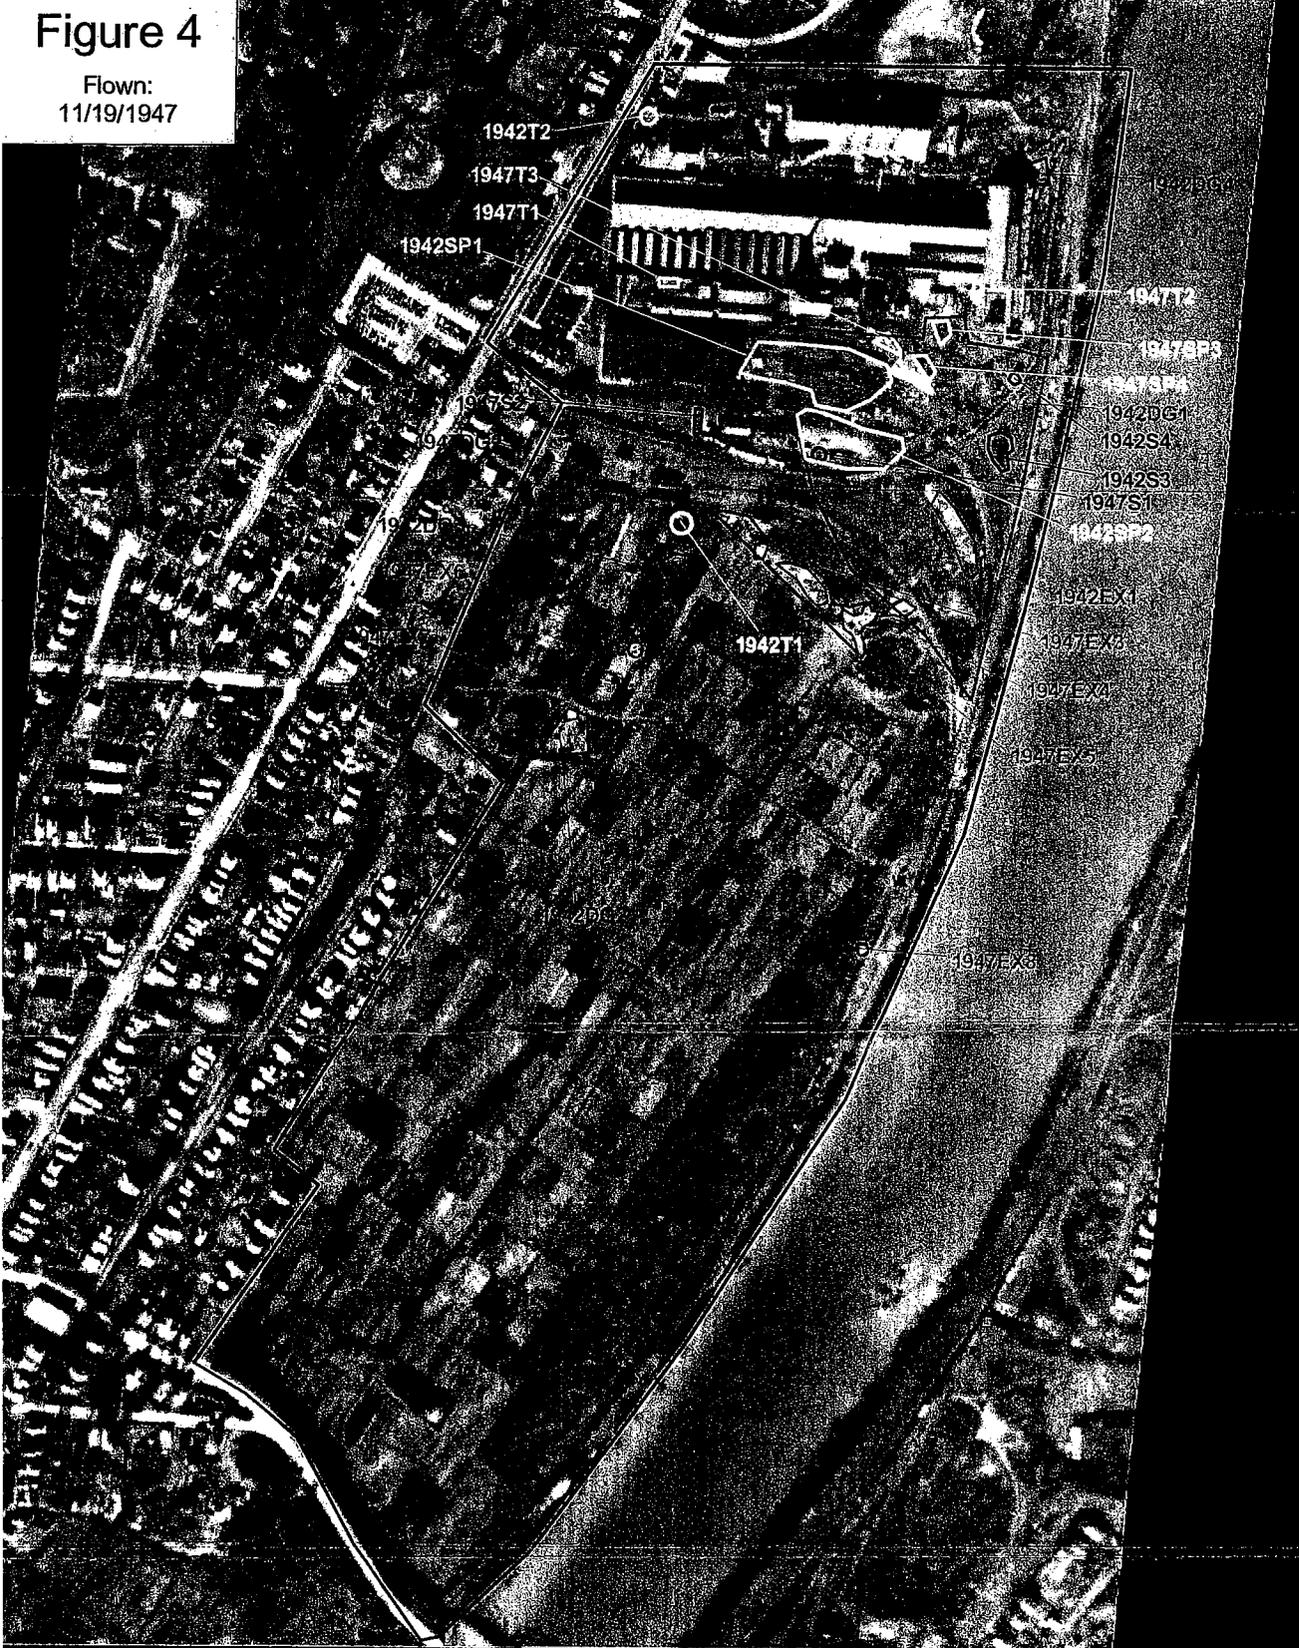
Figure 4

Additional excavation was also noted in the vicinity of 1947DG2 (1947EX3, 1947EX4, and 1947EX5) and in two small areas (1947EX6 and 1947EX7) in the agricultural field south of the roundhouse. One of these excavations was in an area identified as disturbed ground in 1942.

Two new areas of stained soil (1947S1 and 1947S2) were apparent on the southern side of the yard area. However, two other areas of stained soil identified in 1942 (1942S1 and 1942S2) were no longer apparent.

Tanks were also noted for the first time in three locations (1947T1, 1947T2, and 1947T3); within the building complex on the western side of the plant, in the yard area between the 1942 and 1947 stockpile areas and in the northeastern yard area, adjacent to the buildings.

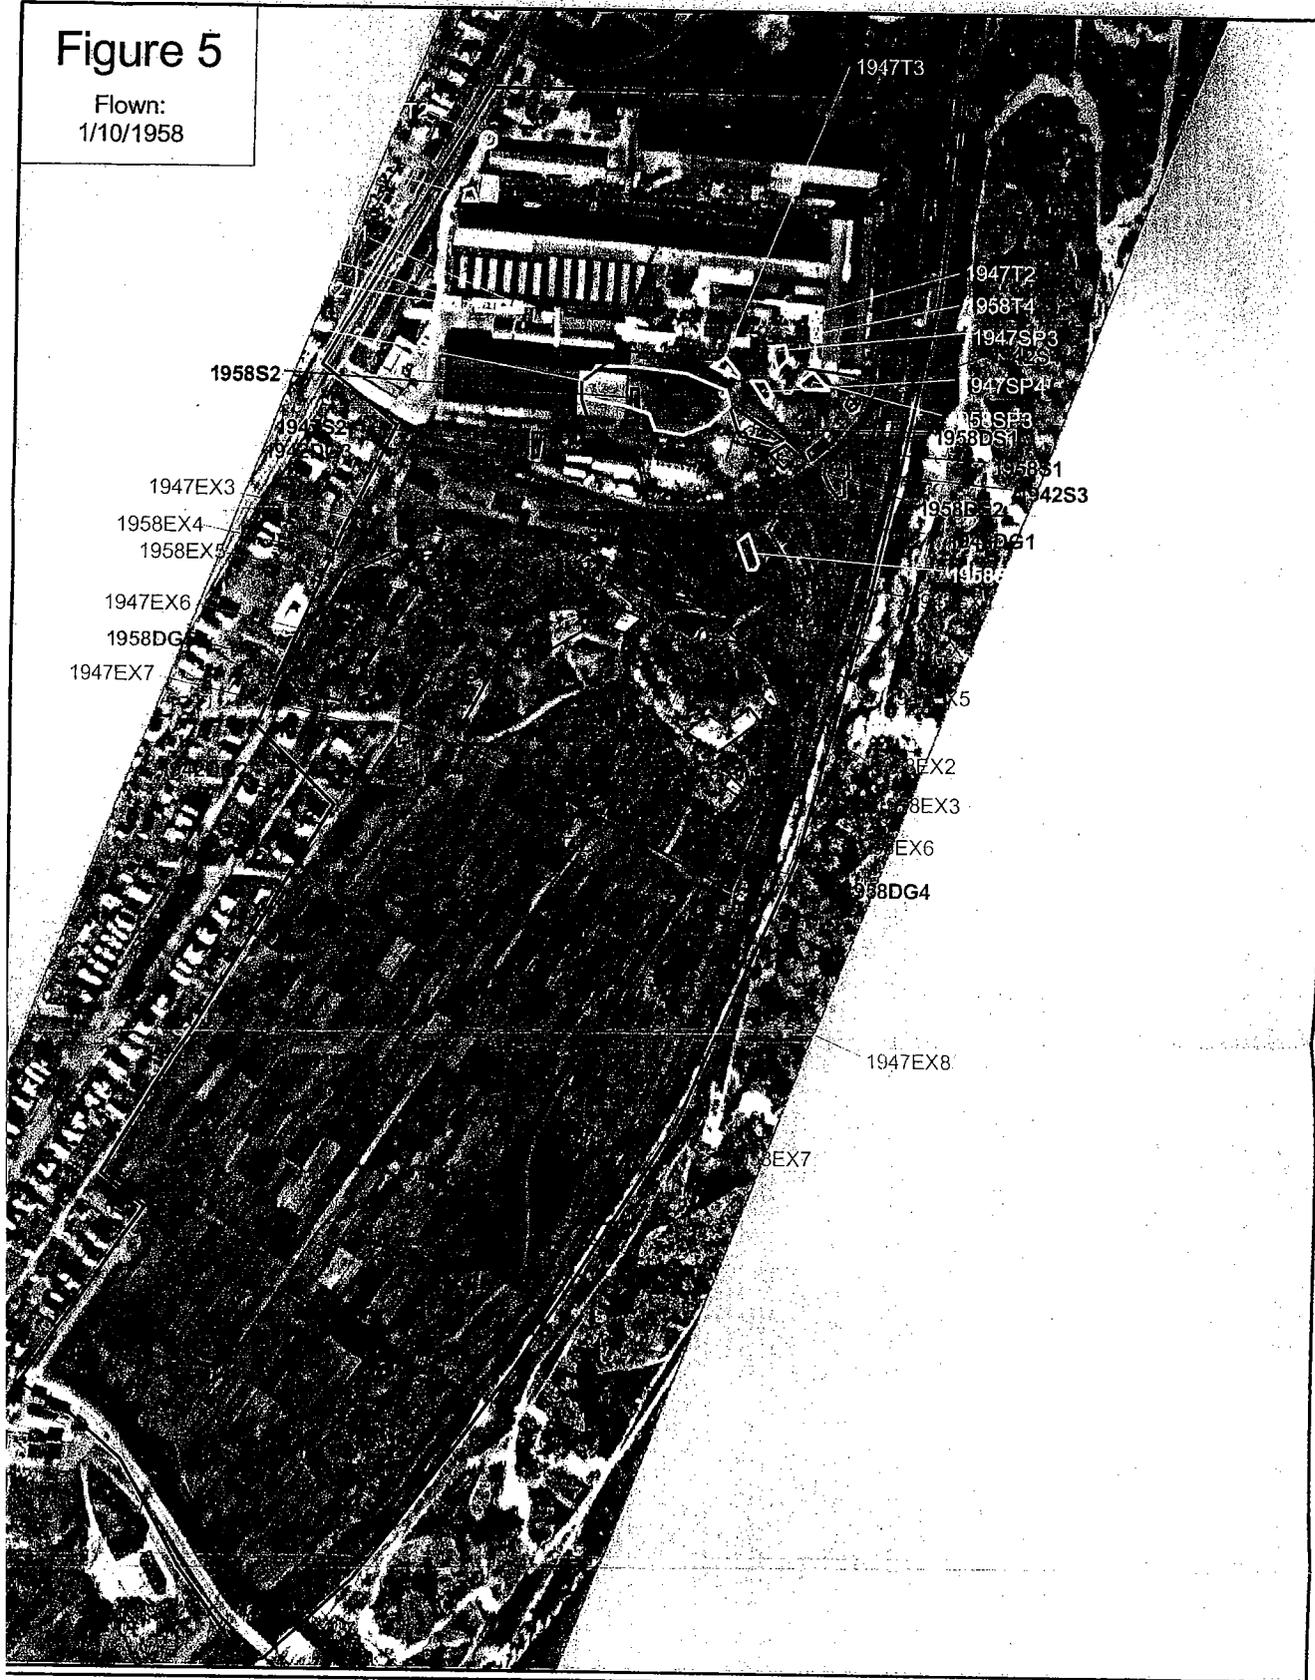
Figure 5

The areas of disturbed ground south of the plant (1958DG4) had grown significantly by 1958, as seen in Figure 5. The disturbed ground industrial buffer area had expanded to the west and south. A new area of disturbed ground (1958DG5) was also observed adjacent to and southwest of the roundhouse.

New areas of excavation (1958EX1, 1958EX2, 1958EX3, 1958EX4, and 1958EX5) were also noted in the industrial buffer near the areas of disturbed ground. 1947EX6 was no longer visible in 1958.

New stained soil features were seen adjacent to the eastern side of the southwestern building (1958S2) and along the former rail spur southeast of the yard area (1958S1). Except for the stained soil seen in 1947S1, areas that were identified on the 1947 photograph were still seen in the 1958 photograph.

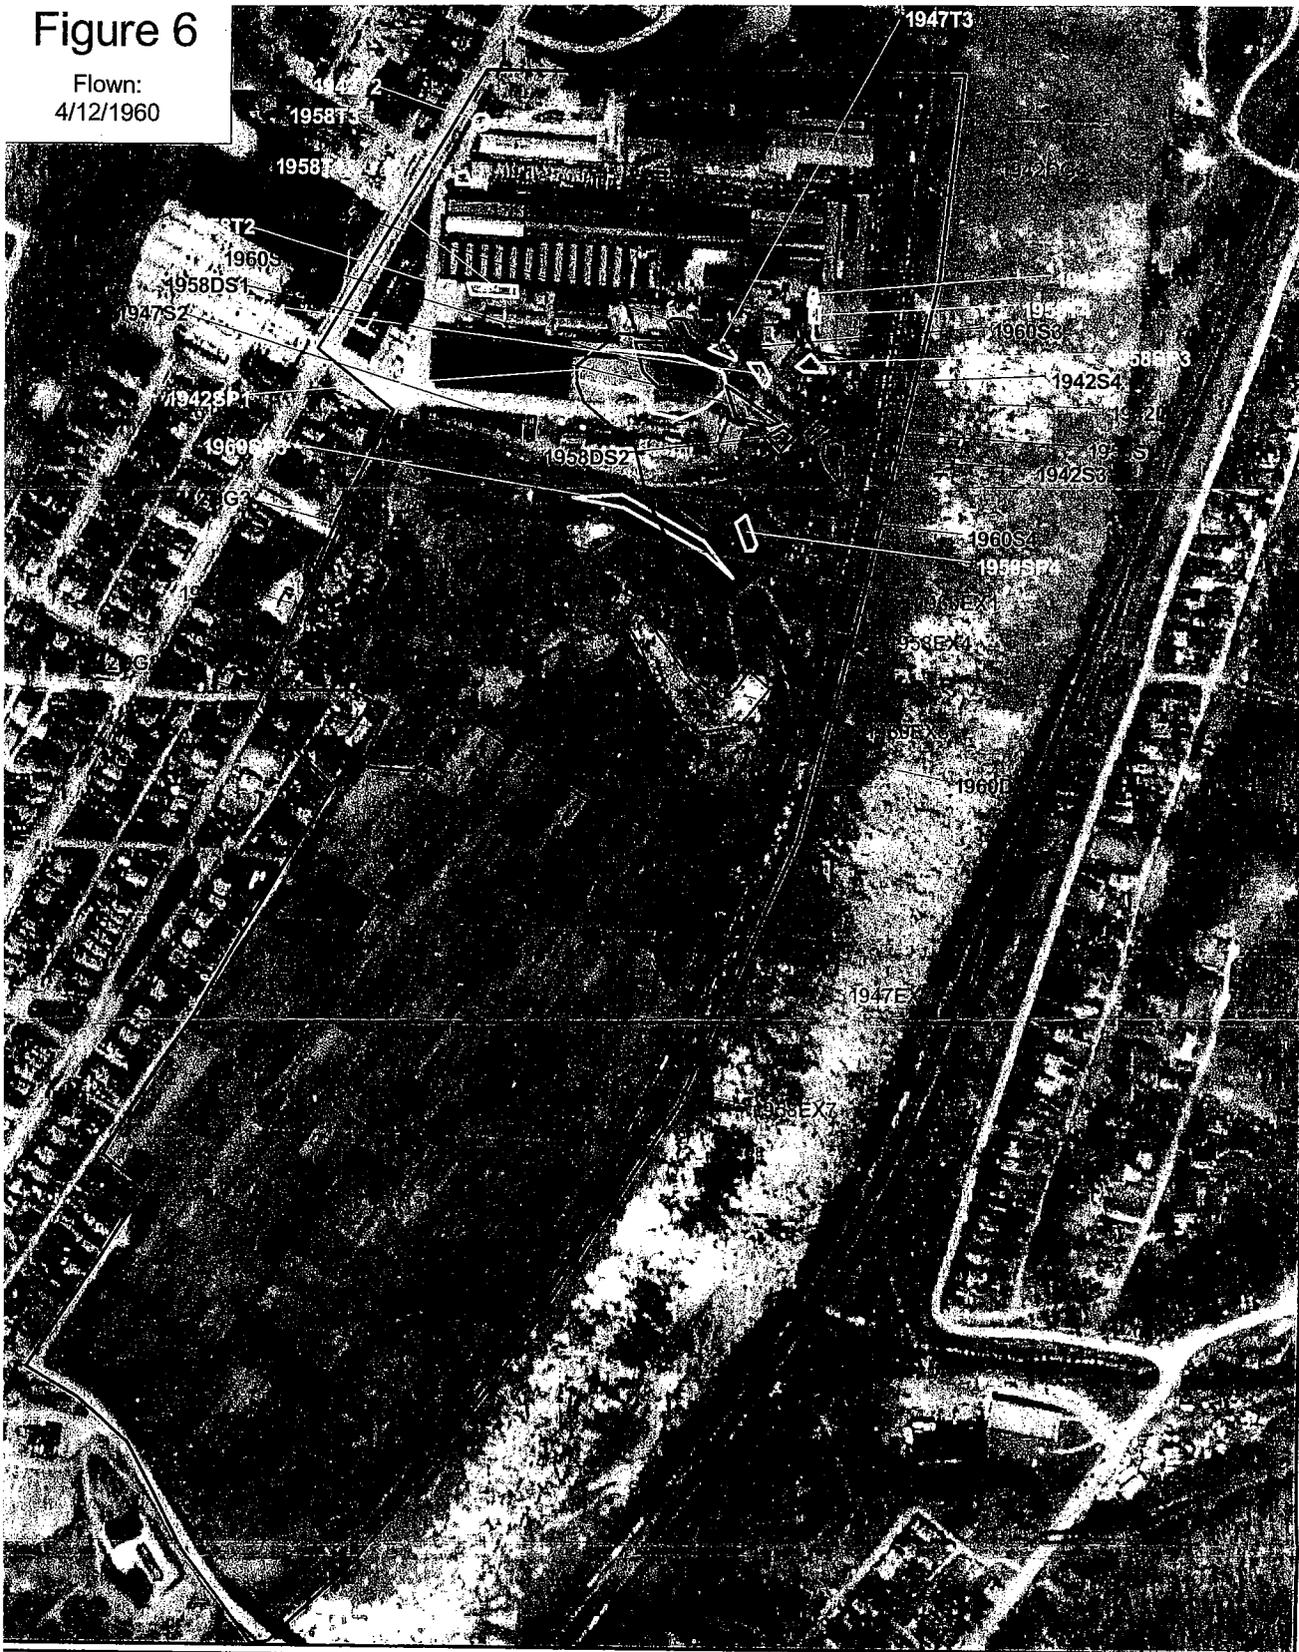
Figure 6

Disturbed ground was observed across the entire industrial buffer area south of the plant yard (1960DG5), effectively joining the disturbed ground identified in previous photographs (1947DG2, 1958DG4, and 1958DG5).

Excavation had also expanded in areas identified as excavated in the industrial buffer in previous photographs (1960EX3) and in a new location in the industrial buffer, just south of the yard area (1960EX1). Changes were noted in excavated areas 1942EX1, 1947EX1, 1947EX3, 1947EX4, 1947EX5, 1947EX7, 1958EX2, 1958EX3, 1958EX5, and 1958EX6.

Large stains in the yard area (1960S1, 1960S2, and 1960S3) were now visible near the central stockpile site. Some old stains persist, but some, such as 1947S1 and 1958S2, have disappeared by 1960. A new stain (1960S4) was also observed in the industrial buffer area.

A new stockpile (1960SP3) was observed in the northern area of the industrial buffer, just south of the yard. New buildings now covered the old stockpile from 1947 (1947SP3), which was located near the easternmost plant building. A building also covered a stockpile site from 1942 (1942SP2).

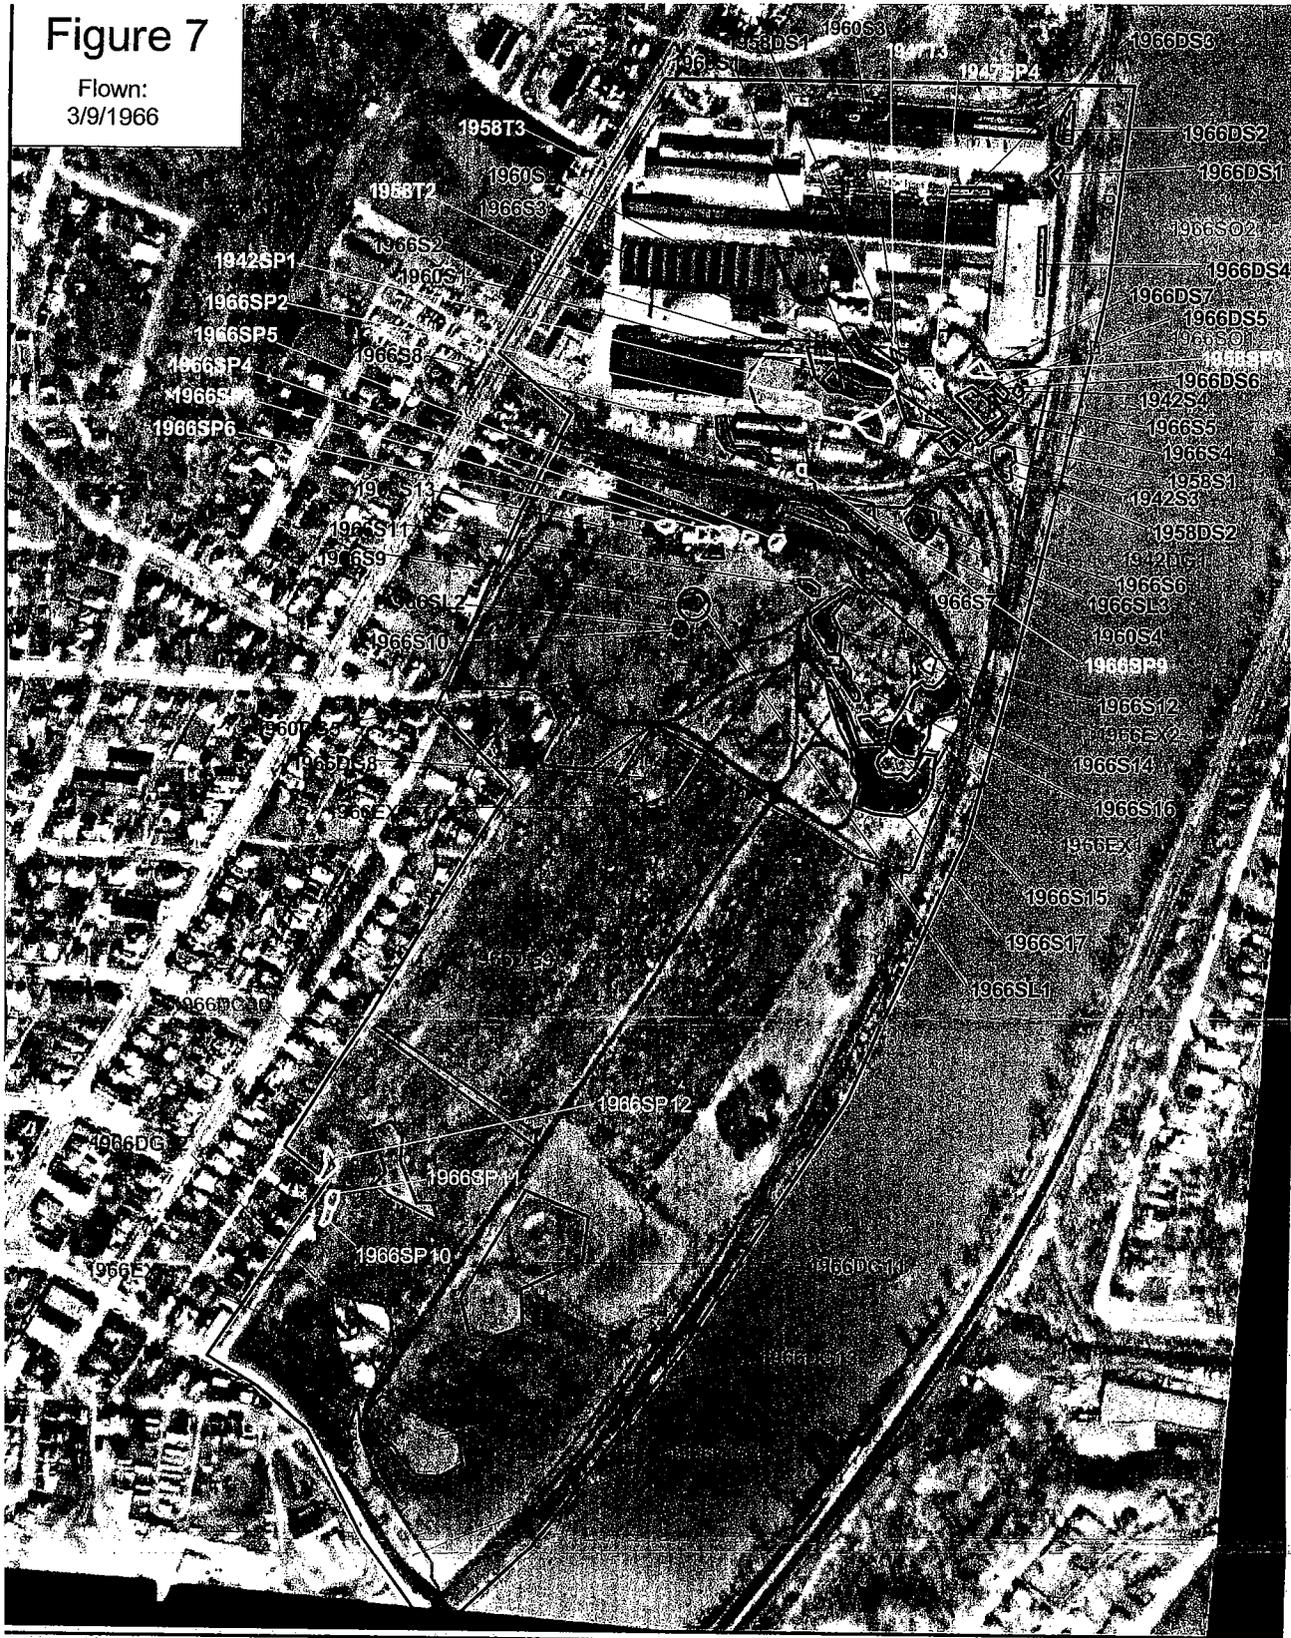
Figure 7

Disturbed ground was noted in an area adjacent to the road at the southern study area boundary (1966DG11, and 1966DG13). Later photographs show this area developed as a sports complex with three baseball diamonds. New disturbed ground was also seen in the agricultural land just to the south of the industrial buffer area (1966DG8), associated with road building activities in agricultural land area (1966DG9), and elsewhere in the southern half of agricultural land area (1966DG10, 1966DG12, and 1966DG14). Overall, disturbed ground in the industrial buffer area seems to have decreased when compared to previous years (1942DG2, 1942DG3, and 1942DG4) and may indicate that significant regrading and seeding had occurred.

Also, several new excavated areas were observed in the industrial buffer area (1966EX1) and in the agricultural land (1966EX2). One new group of excavations in the agricultural land toward the south of the study area (1966EX7) is visible in future photographs and appears to be gravel mining operations. Several old excavations that had been seen in earlier photographs

An additional small stockpile seen in the industrial buffer area in 1958 (1958SP4) was now only stained soil (1966S6) and standing liquid. Similarly, a stockpile seen in the 1960 photograph and located in the industrial buffer area (1960SP3) was now only stained soil (1966S4, 1966S5, and 1966S7). Many newly stained areas were observed in the industrial buffer area (1966S10, 1966S11, 1966S12, 1966S13, 1966S14, 1966S15, 1966S16, and 1966S17) and in the yard area (1966S2, 1966S3, and 1966S8). Several older stained soil areas identified in prior years were still apparent in 1966. Stained area 1947S2 was no longer seen by 1966.

By 1966, tank 1958T1, seen next to the western side of the plant area in earlier photographs, had been replaced by a building, while the tanks seen previously to the northwest of the buildings and in the yard area west of the easternmost plant building were no longer present in 1966 (1942T2, 1947T2, 1958T1, and 1958T4).

New stockpiles (1966SP3, 1966SP4, 1966SP5, and 1966SP6) were present south of the railroad spur that forms the southern plant yard boundary. Two additional stockpiles (1966SP2 and 1966SP9) were also observed in the yard area, while a building now covered a small stockpile observed in the plant yard area in 1947 (1947SP2). Three material stockpiles (1966SP10,

1966SP12, and 1966SP12) were also evident near and northwest of the gravel mining operation. A possible sewer outfall (1966SO1), first seen in the 1942 photographs, was seen again in 1966. A second possible sewer outfall (1966SO2) to the Muskingum River was also observed. Three areas of standing liquids (1966SI1, 1966SI2, and 1966SI3) were seen for the first and only time during this assessment in the industrial buffer area. Because these features were not noted in either earlier or later photographs, we assumed that the standing liquid could be casual water. New drum storage areas were seen toward the northeast (1966DS1 and 1966DS2), east (1966DS4), and northwest (1966DS3) of the easternmost plant building and on the southern side of the plant yard (1966DS6 and 1966DS7).

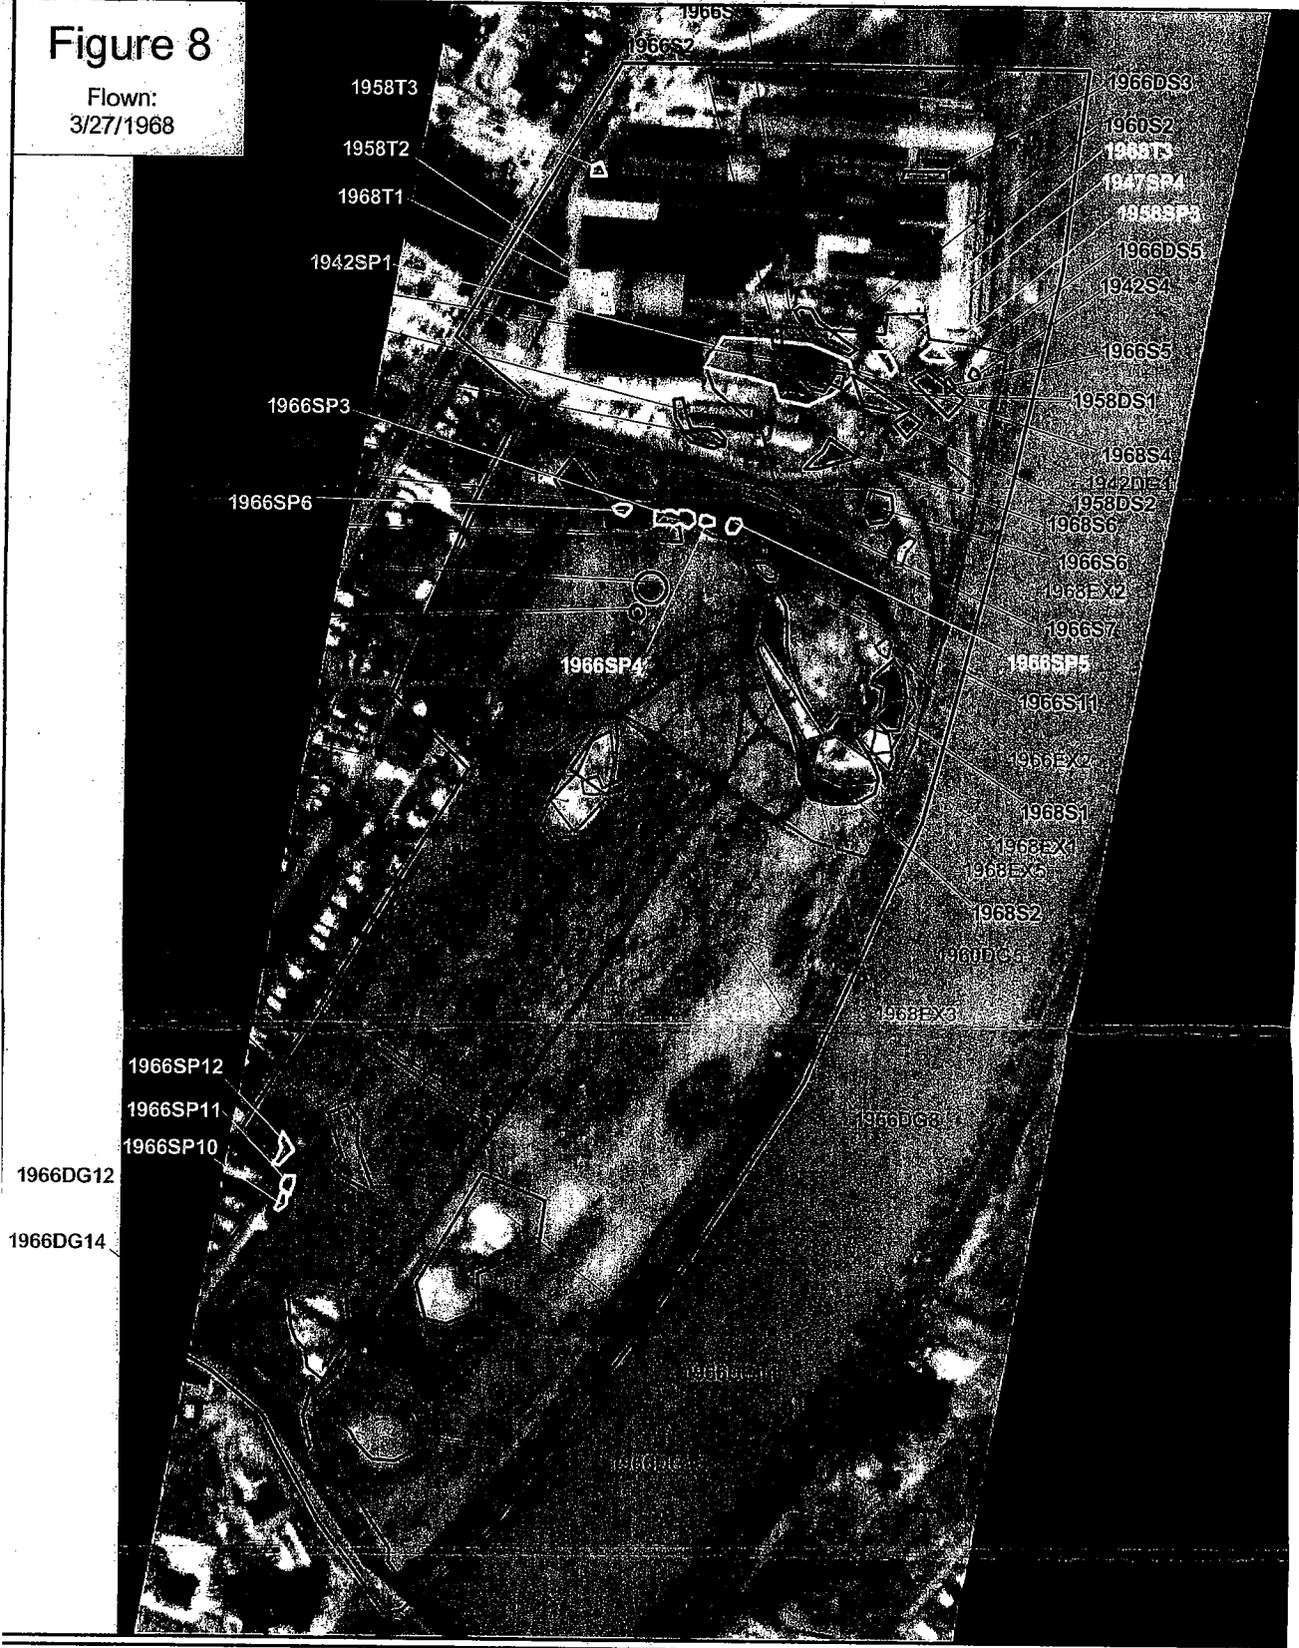
Figure 8

Changes were seen in previously identified stained soils at 1942S3, 1958S1, 1960S1, 1960S3, 1960S4, 1966S4, 1966S12, 1966S14, 1966S15, 1966S16, and 1966S17. New stains were identified at locations 1968S1, 1968S2, 1968S3, 1968S4, 1968S5, 1968S6, and 1968S7.

New tanks were observed in the plant yard area, adjacent to the western side of the easternmost building (1968T3) and at the western side of the plant buildings (1968T1). Tanks 1947T3 and 1958T4 were no longer present.

By 1968, the sewer outfalls identified previously (1966SO1 and 1966SO2) were no longer evident. The areas identified as standing liquid in 1966 (1966S11, 1966S12, and 1966S13) appeared as stains 1968S6, 1968S9, and 1968S10.

Two small stockpiles identified in 1966 (1966SP2 and 1966SP9) were now gone and were covered by buildings. The main stockpile in the plant yard (1942SP1) was still present, but had grown noticeably smaller. No new stockpiles were observed in 1968. Drum storage areas 1966DS1, 1966DS2, 1966DS4, 1966DS6, and 1966DS7 were no longer apparent.

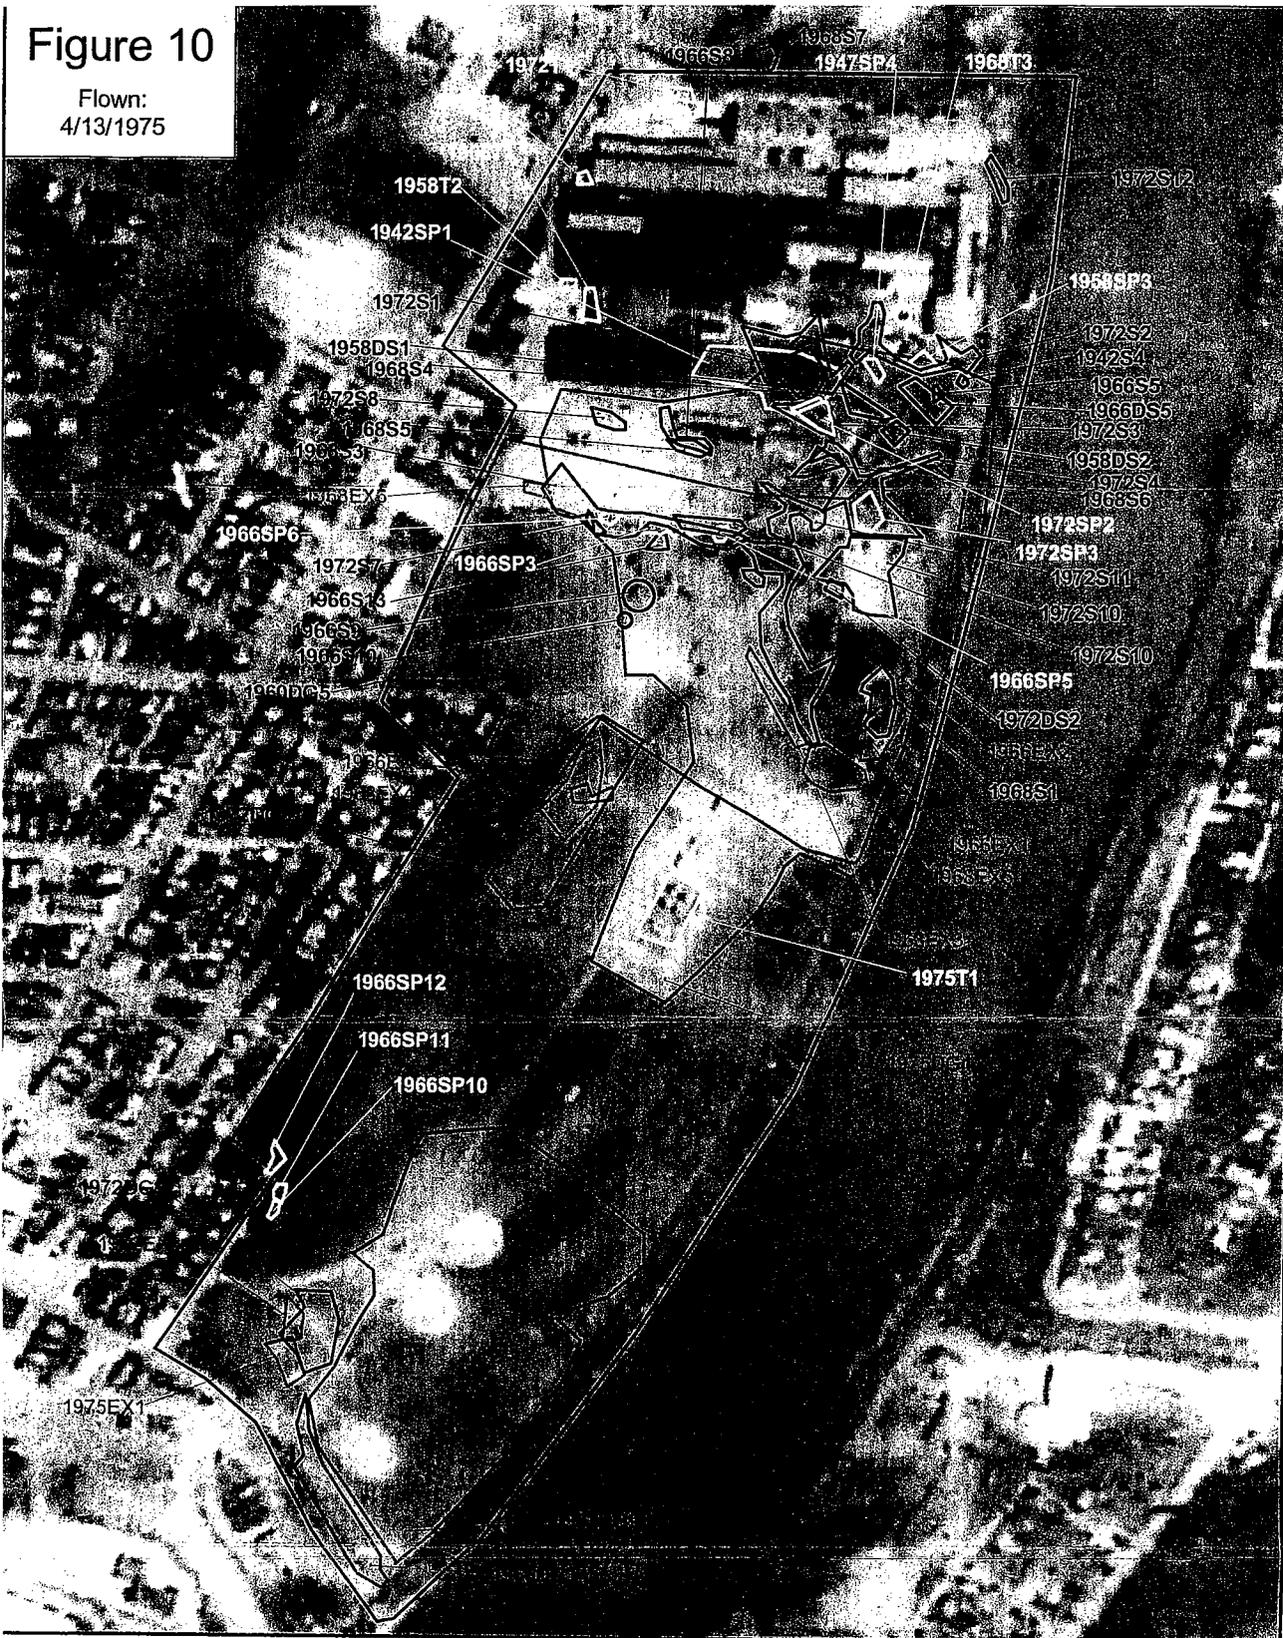
Figure 10

Disturbed ground moved to the south of the industrial buffer area (1975DG1). This activity may be caused by construction of a new tank farm, consisting of four aboveground tanks and associated pipeline and structures. 1942DG1 was removed from the overlay for display purposes and was combined with other areas of disturbed ground.

No additional soil staining was observed in the industrial buffer area.

The old road and bridge at the southern side of the site boundary had been replaced. The bridge for Interstate Highway I-70 now spanned the Muskingum River.

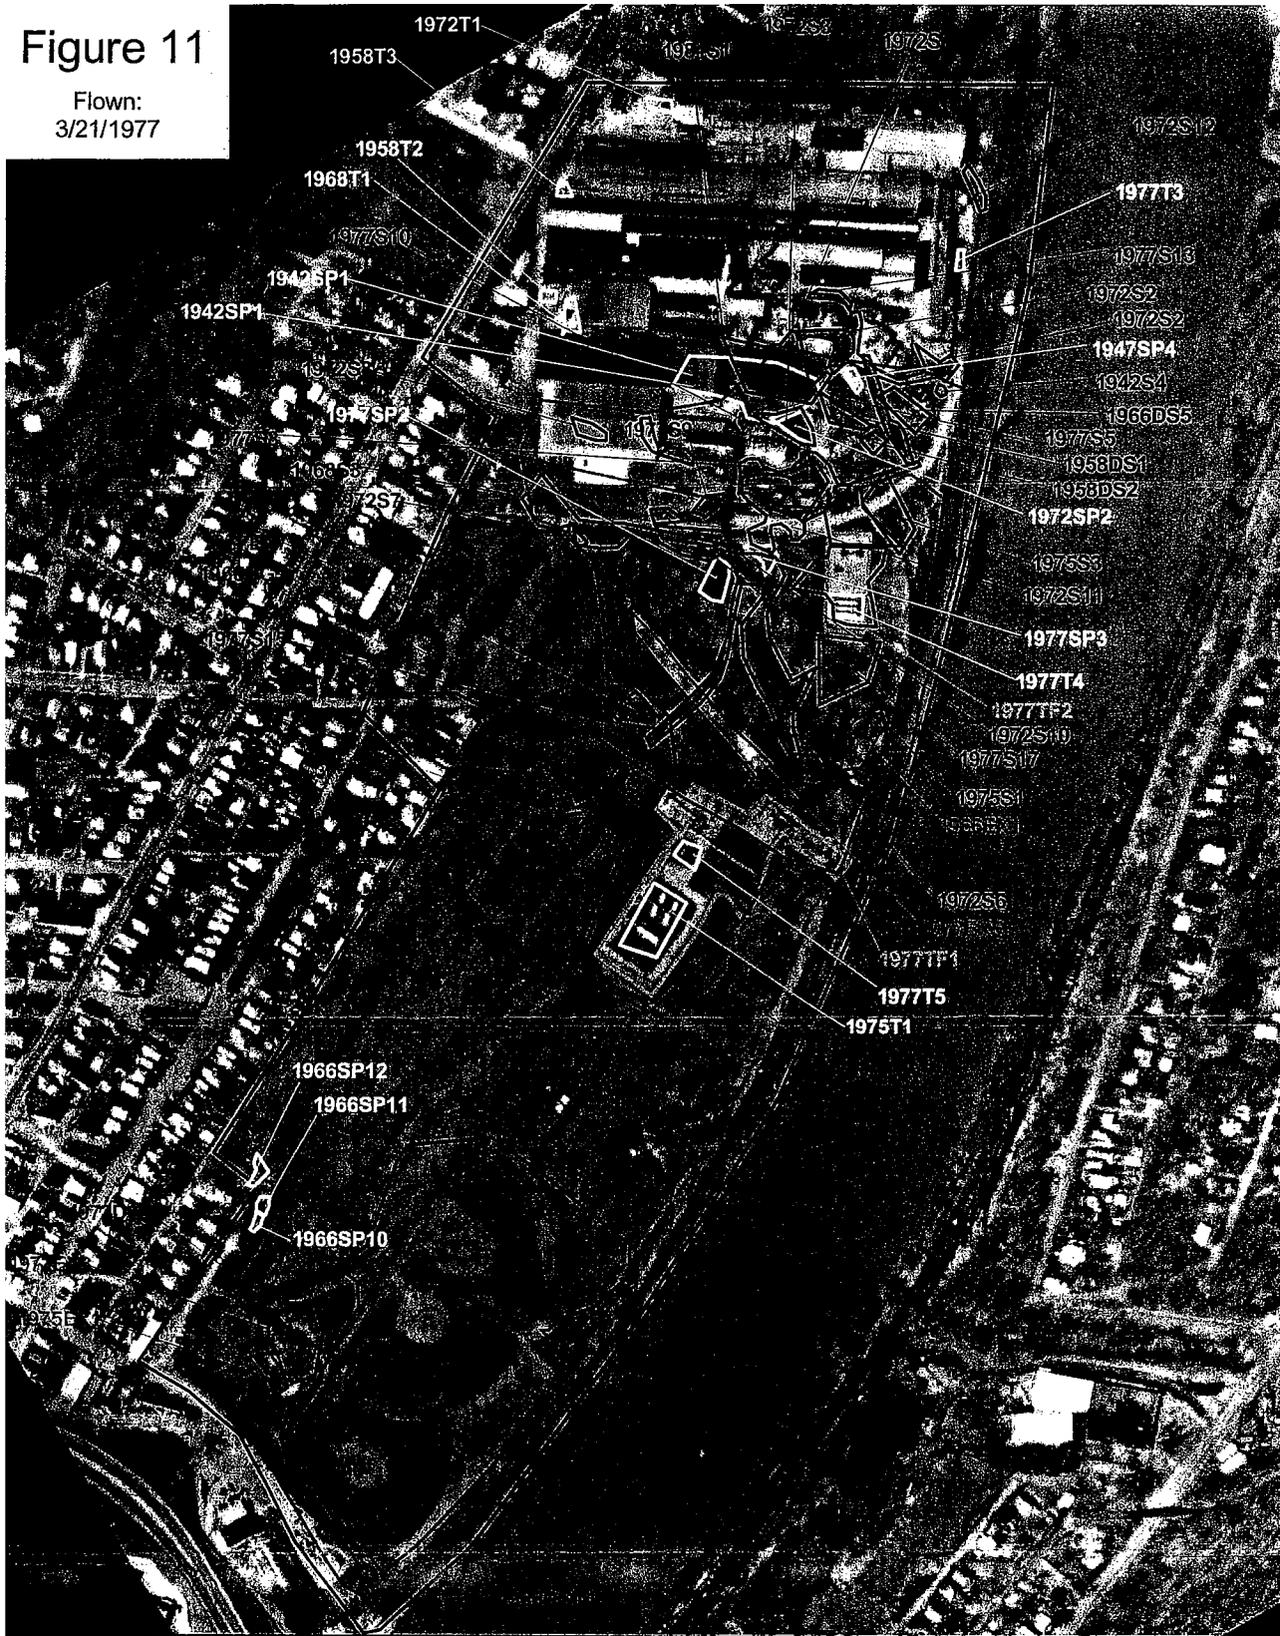
Figure 11

The photograph available for the site was dated March 21, 1977. The photographic quality was generally good to excellent. The 1977 photograph and interpreted features are shown as Figure 11.

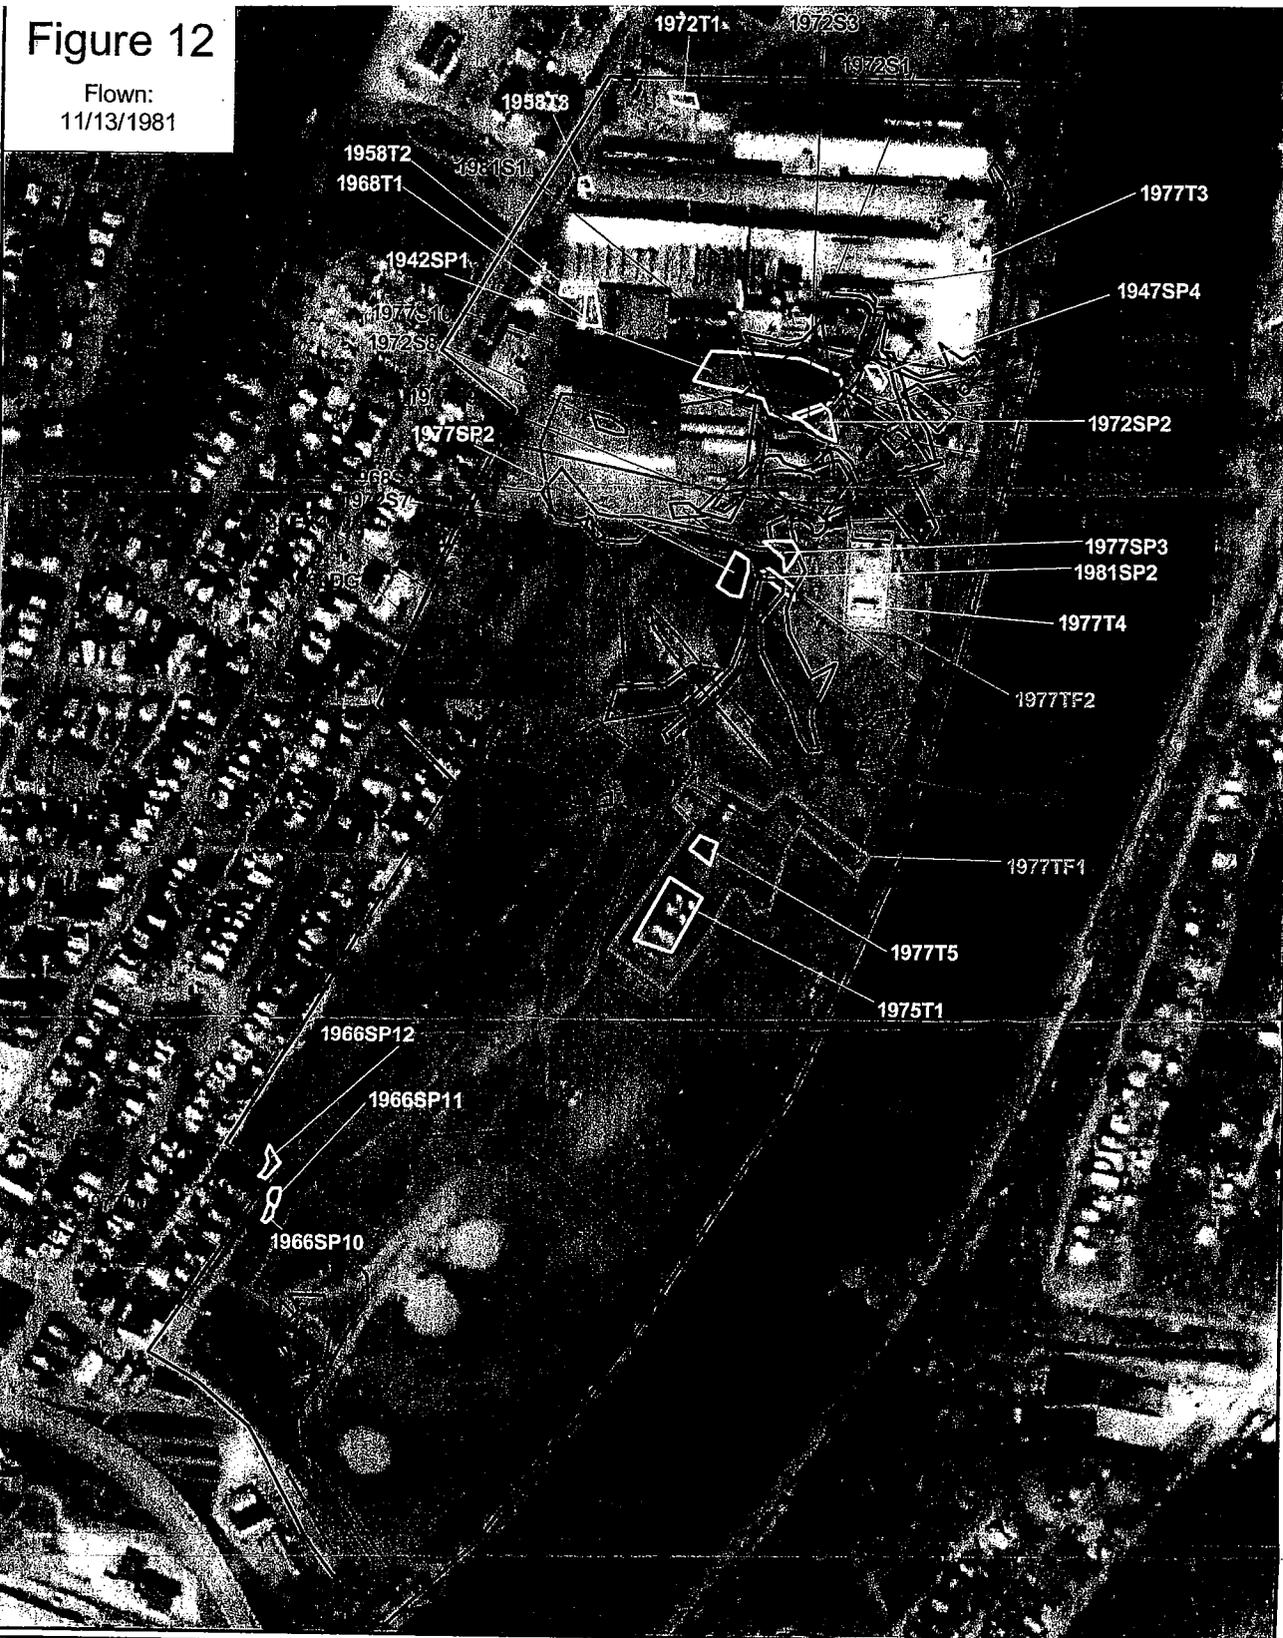
Figure 12

The photograph available for the site was dated November 13, 1981. The photographic quality was generally poor to fair. The 1981 photograph and interpreted features are shown as Figure 12. Some changes have occurred to the plant buildings, and additional small structures have been constructed in the plant yard area since 1977.
