Re: RCRA 3013 Administrative Order on
Consent
U.S. EPA ID No. OHD 004 281 598

Re: AK Steel Corporation, Zanesville, OH

IN THE MATTER OF:)	ADMINISTRATIVE ORDER ON CONSENT
)	
AK Steel Corporation)	U.S. EPA Docket No:R3013-5-03-001
1724 Linden Avenue)	
Zanesville, Ohio 43701)	
)	
EPA ID#: OHD 004 281 598)	Proceeding under Section 3013 of the Resource
)	Conservation and Recovery Act, as amended,
RESPONDENT.)	42 U.S.C. § 6934.

Appendix B

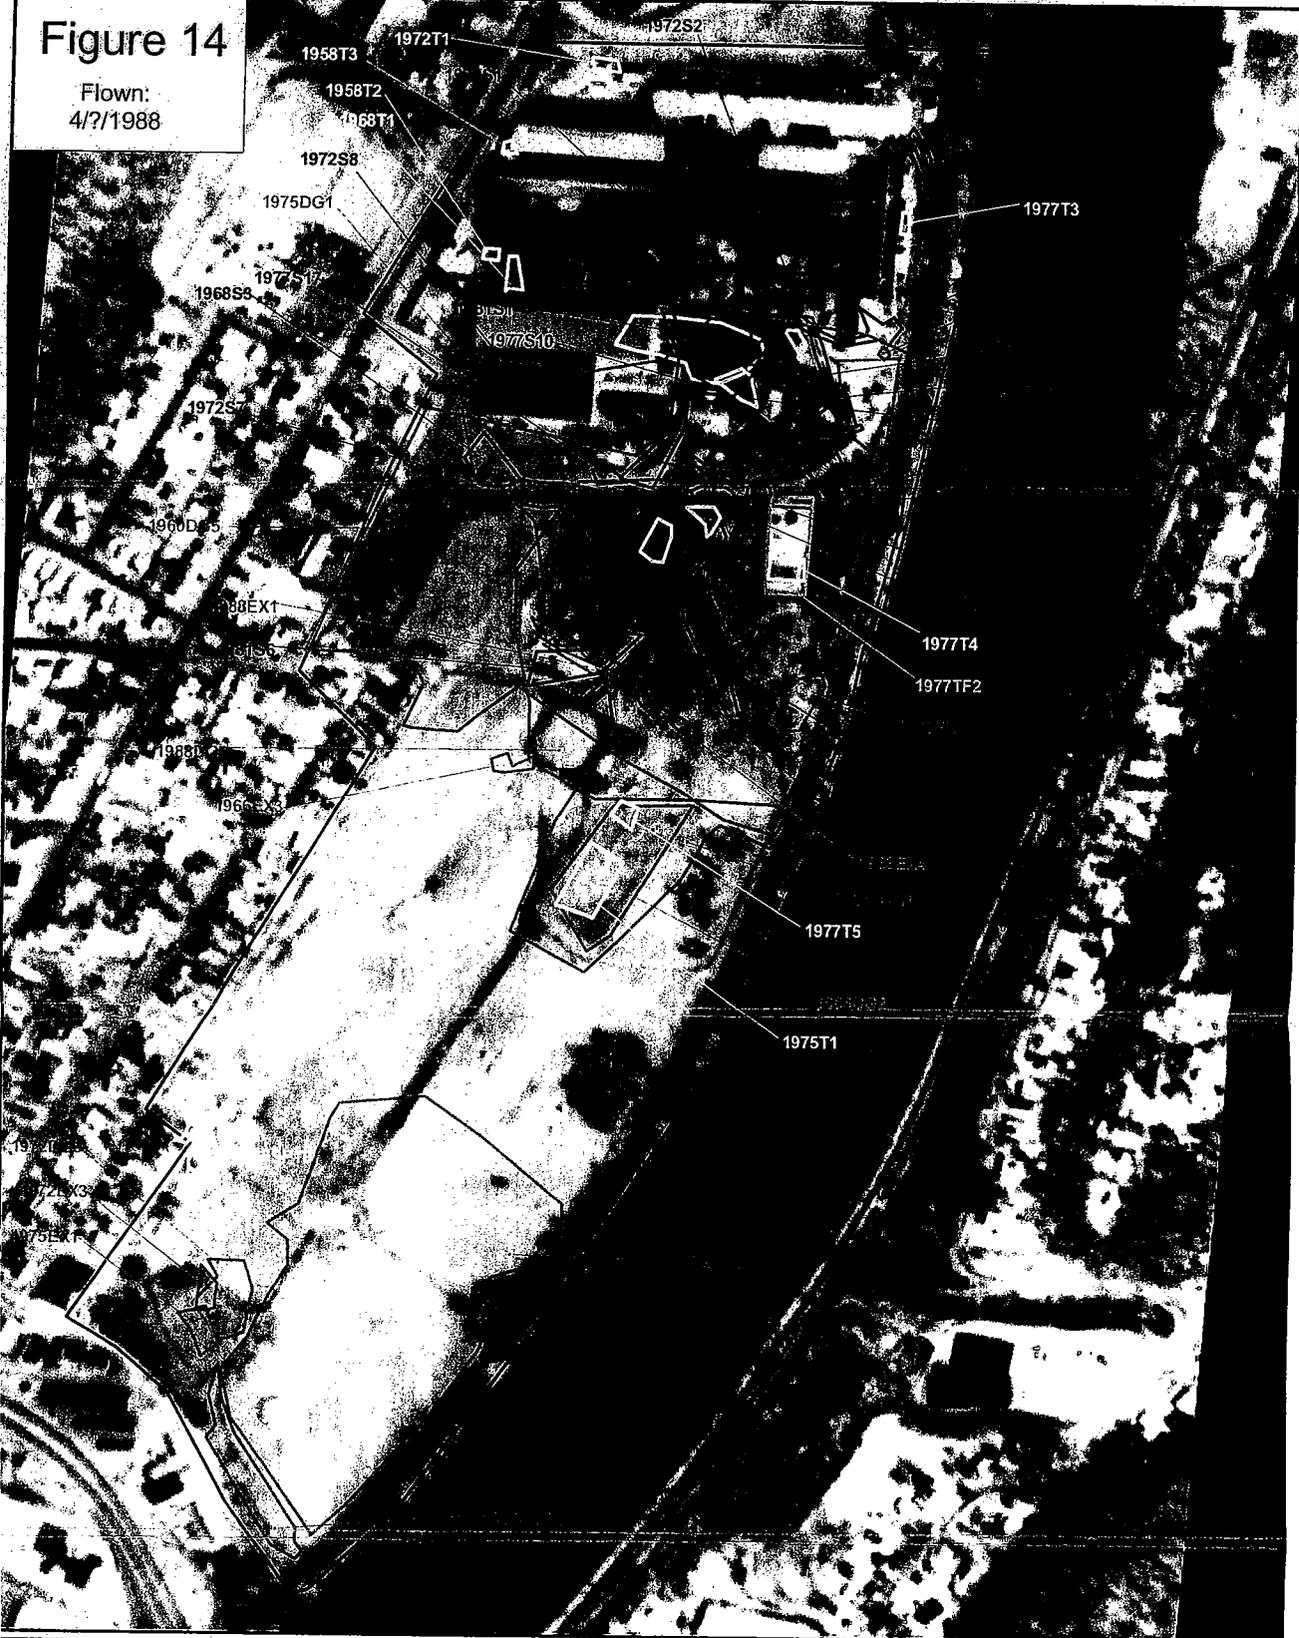
Figure 14

The photograph available for the site was dated April 17, 1988. The photographic quality was very poor, and the photograph apparently was taken just after sunrise. The 1988 photograph and interpreted features are shown as Figure 14.

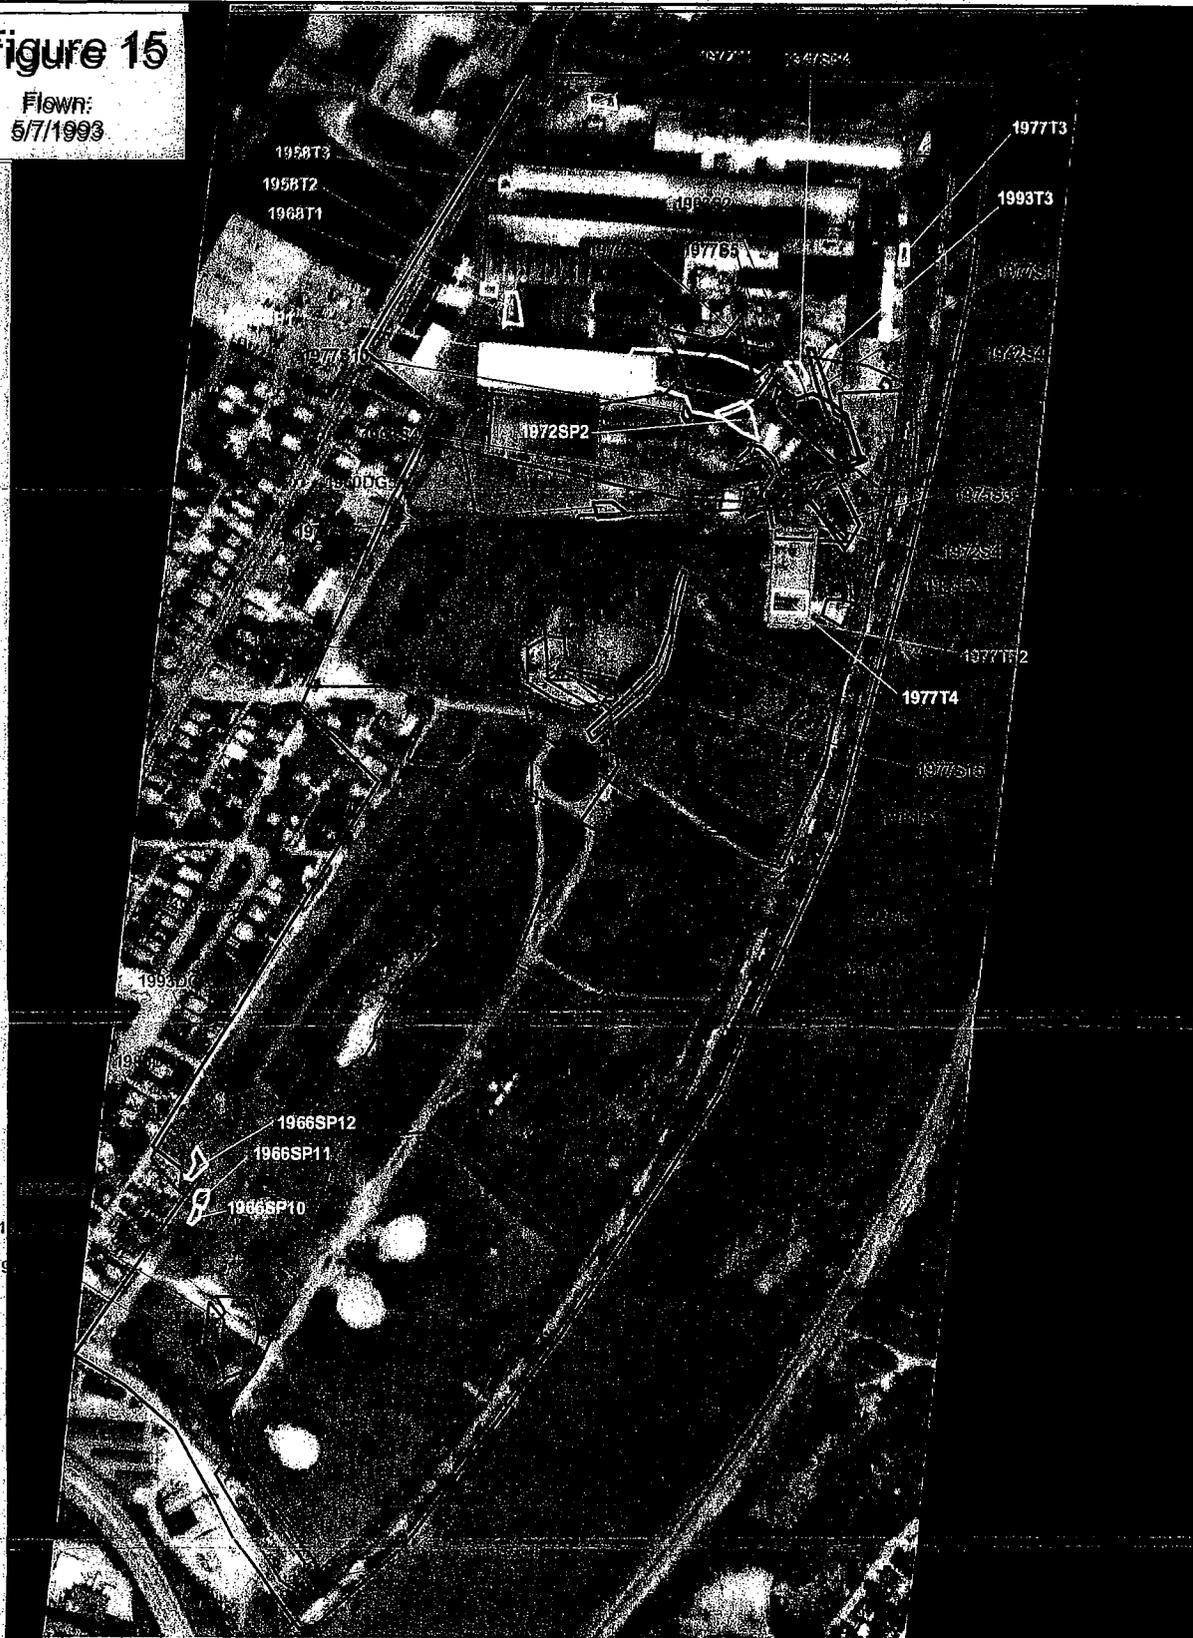
Figure 15

The photograph available for the site was dated May 7, 1993. The photographic quality was generally good to excellent. The 1993 photograph and interpreted features are shown as Figure 15. Compared to 1983, some small structures were constructed to the south of the plant yard sometime during the prior 10 years.
