Upper Sandusky River Watershed TMDLs

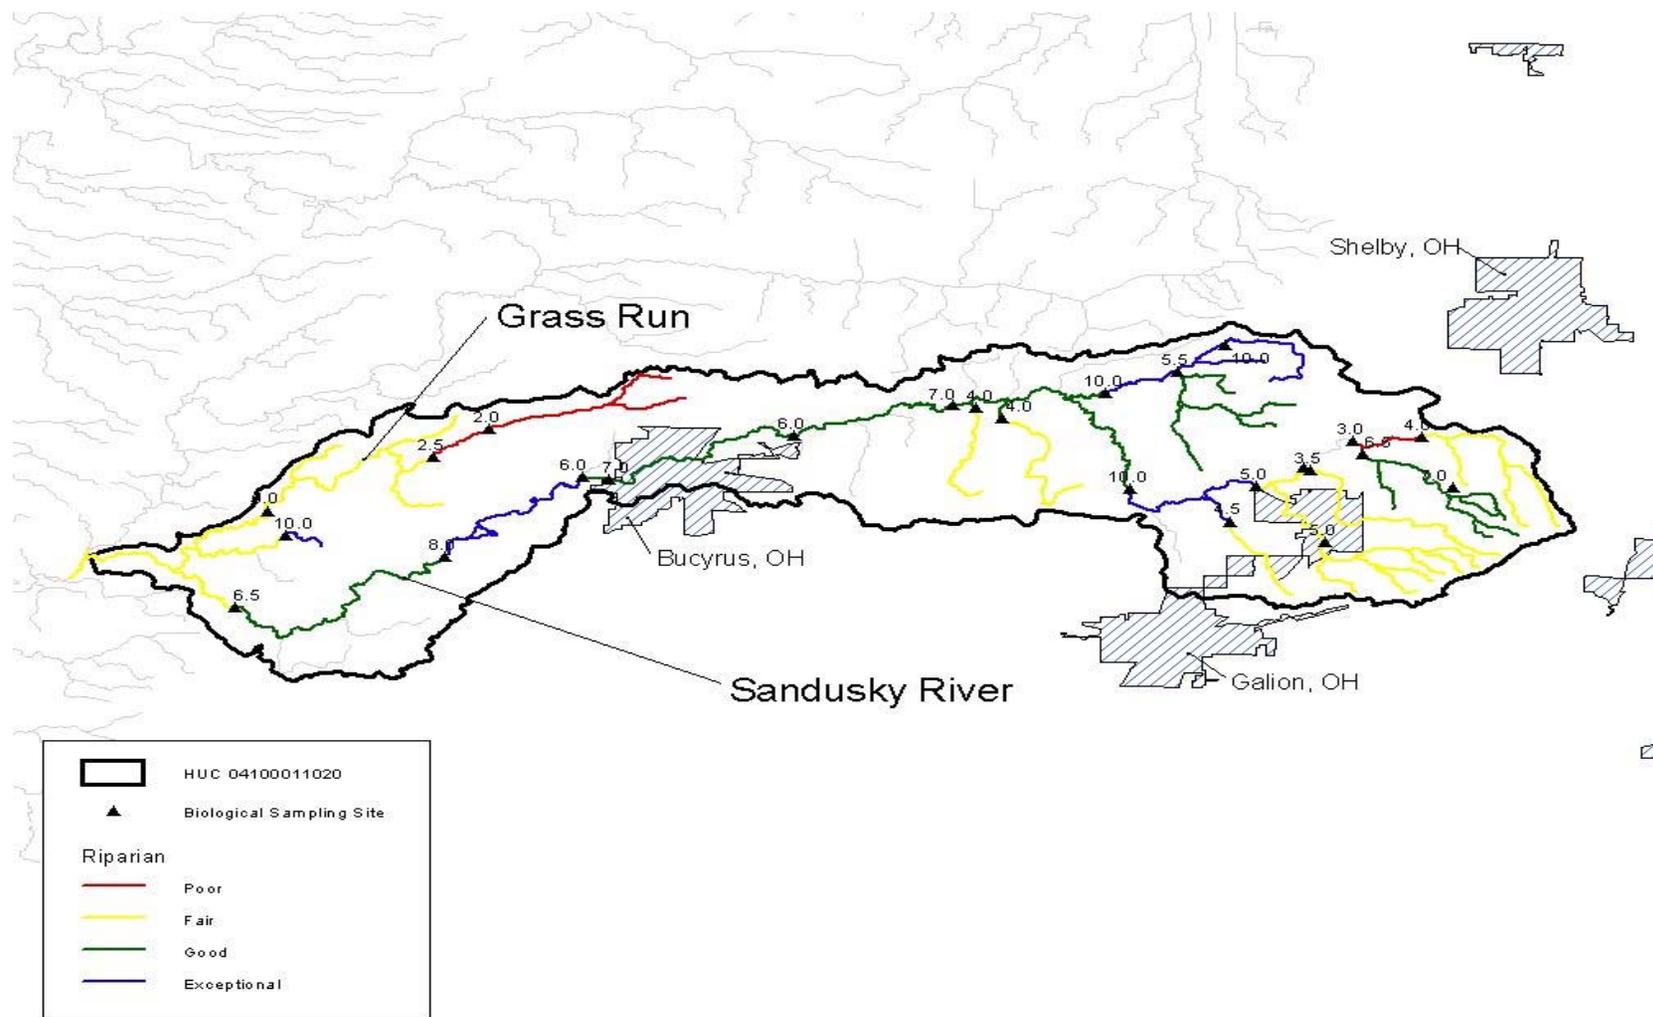
Figure 2: Riparian condition scores of the Bucyrus assessment unit (04100011-020)

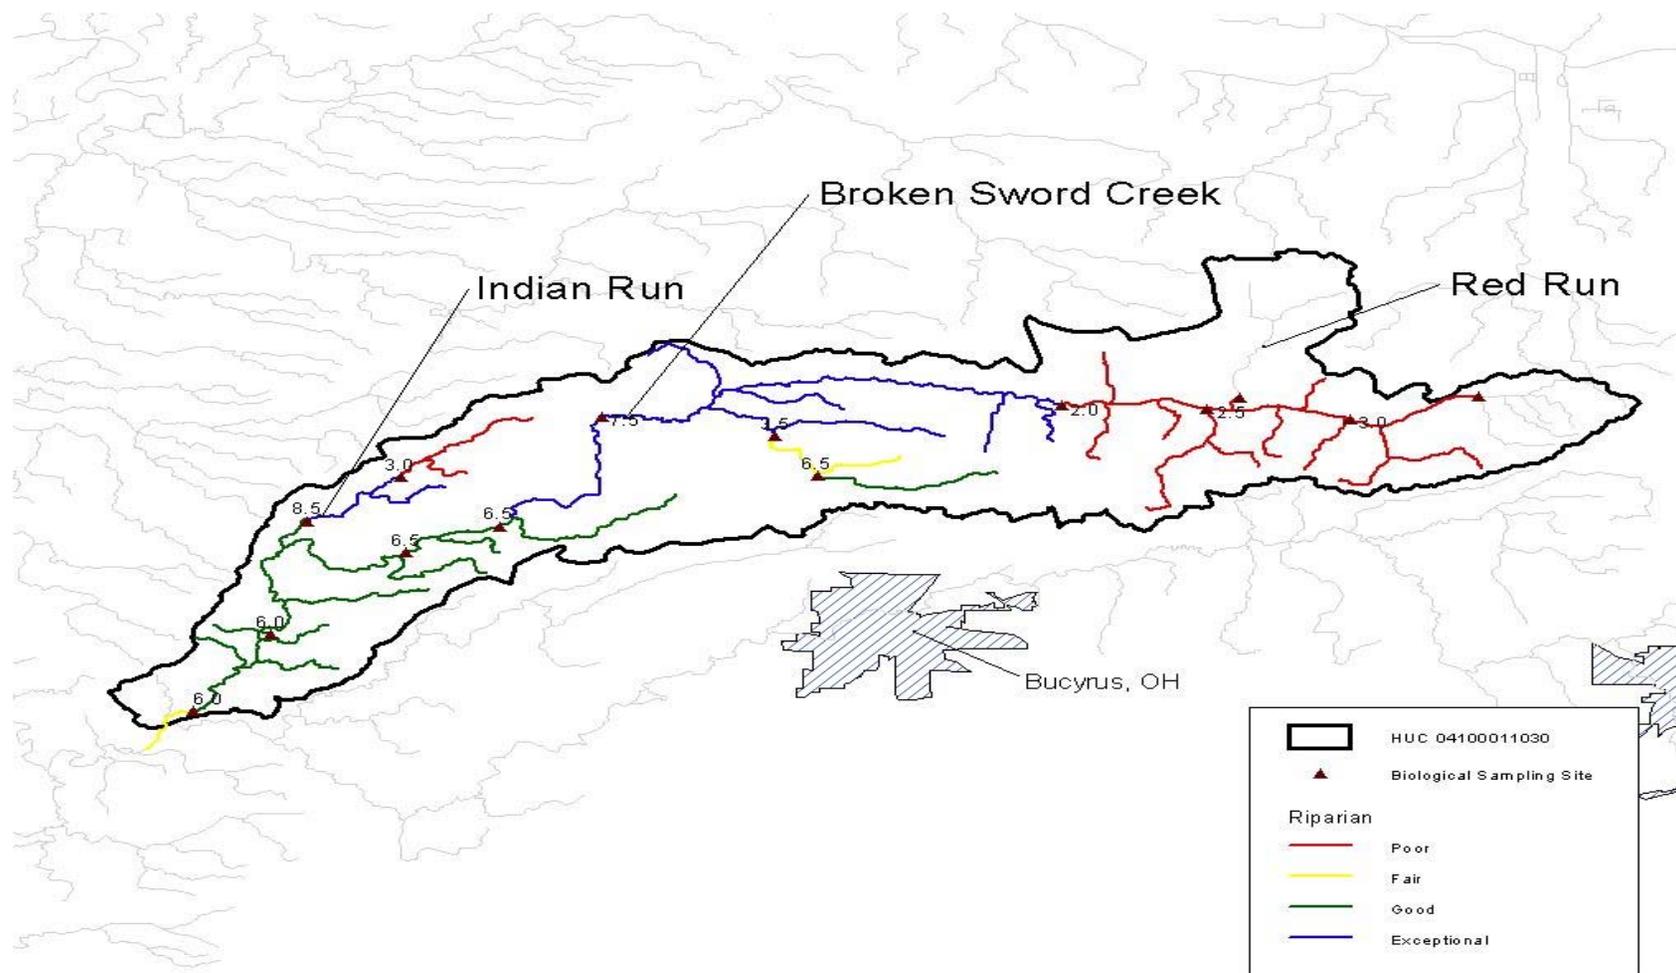
Figure 3: Riparian condition scores of the Broken Sword Creek assessment unit (04100011-030)

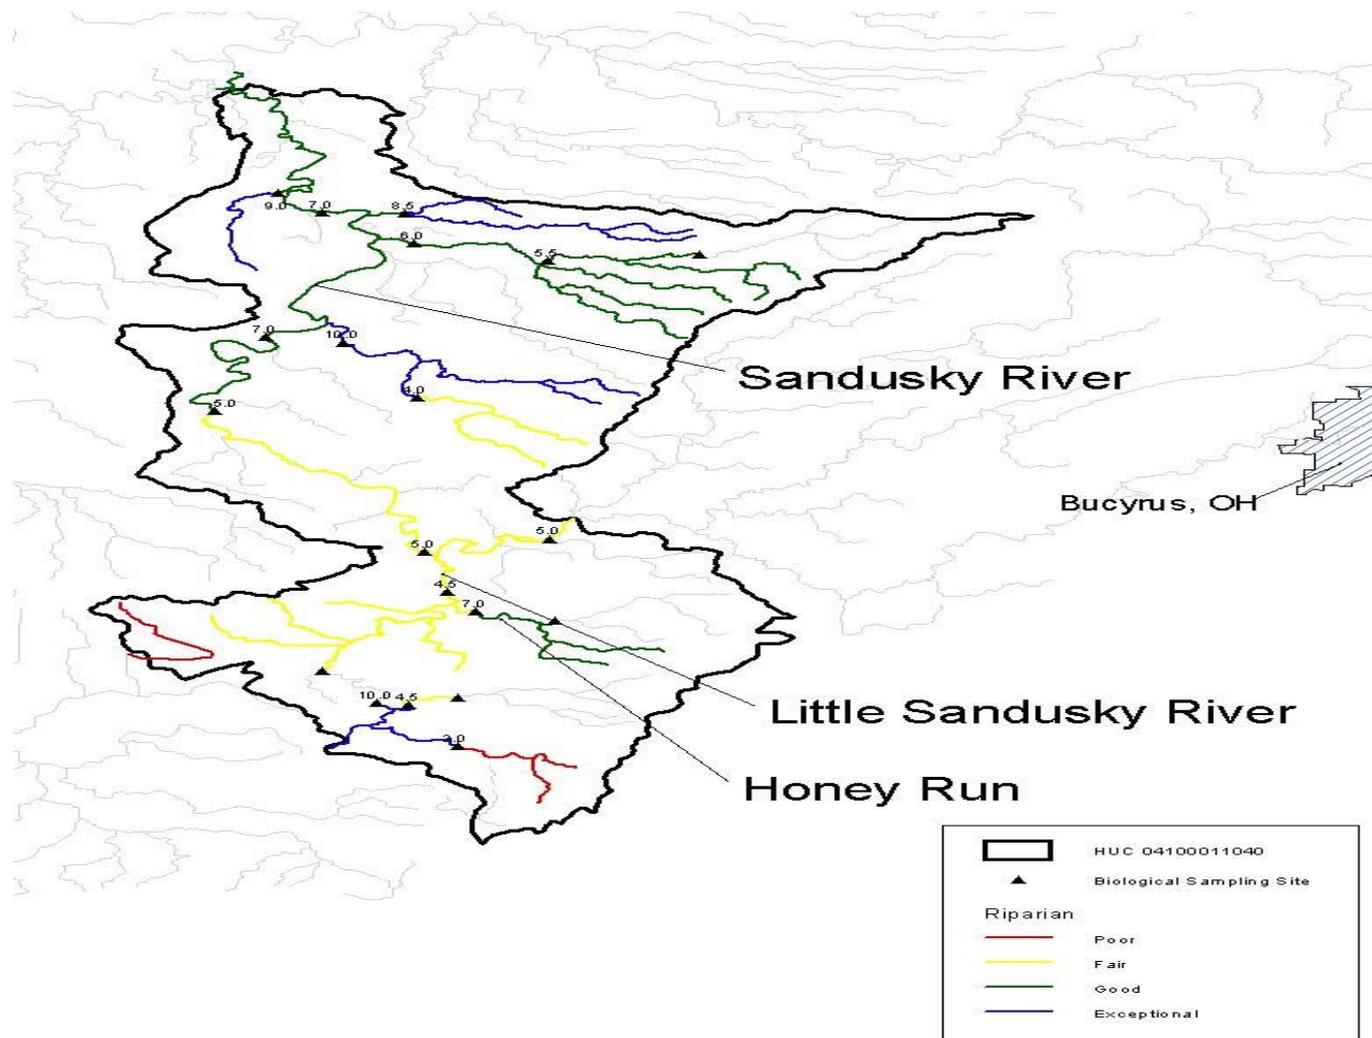
Figure 4: Riparian condition scores of the Upper Sandusky assessment unit (04100011-040)

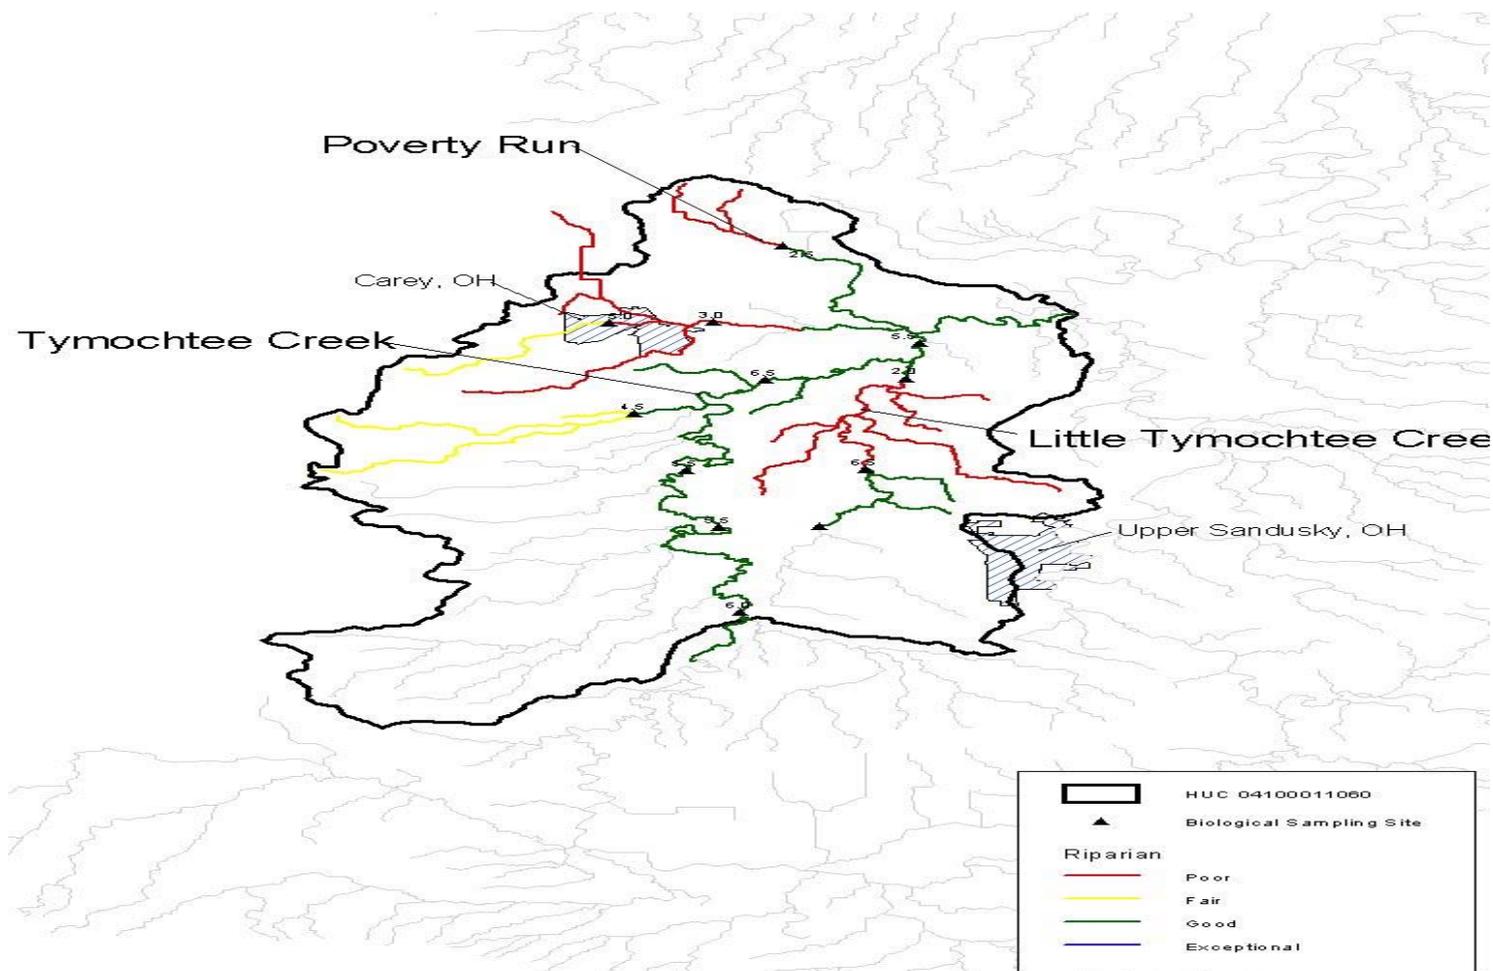
Figure 6: Riparian condition scores of the Lower Tymochtee Creek assessment unit (04100011-060)

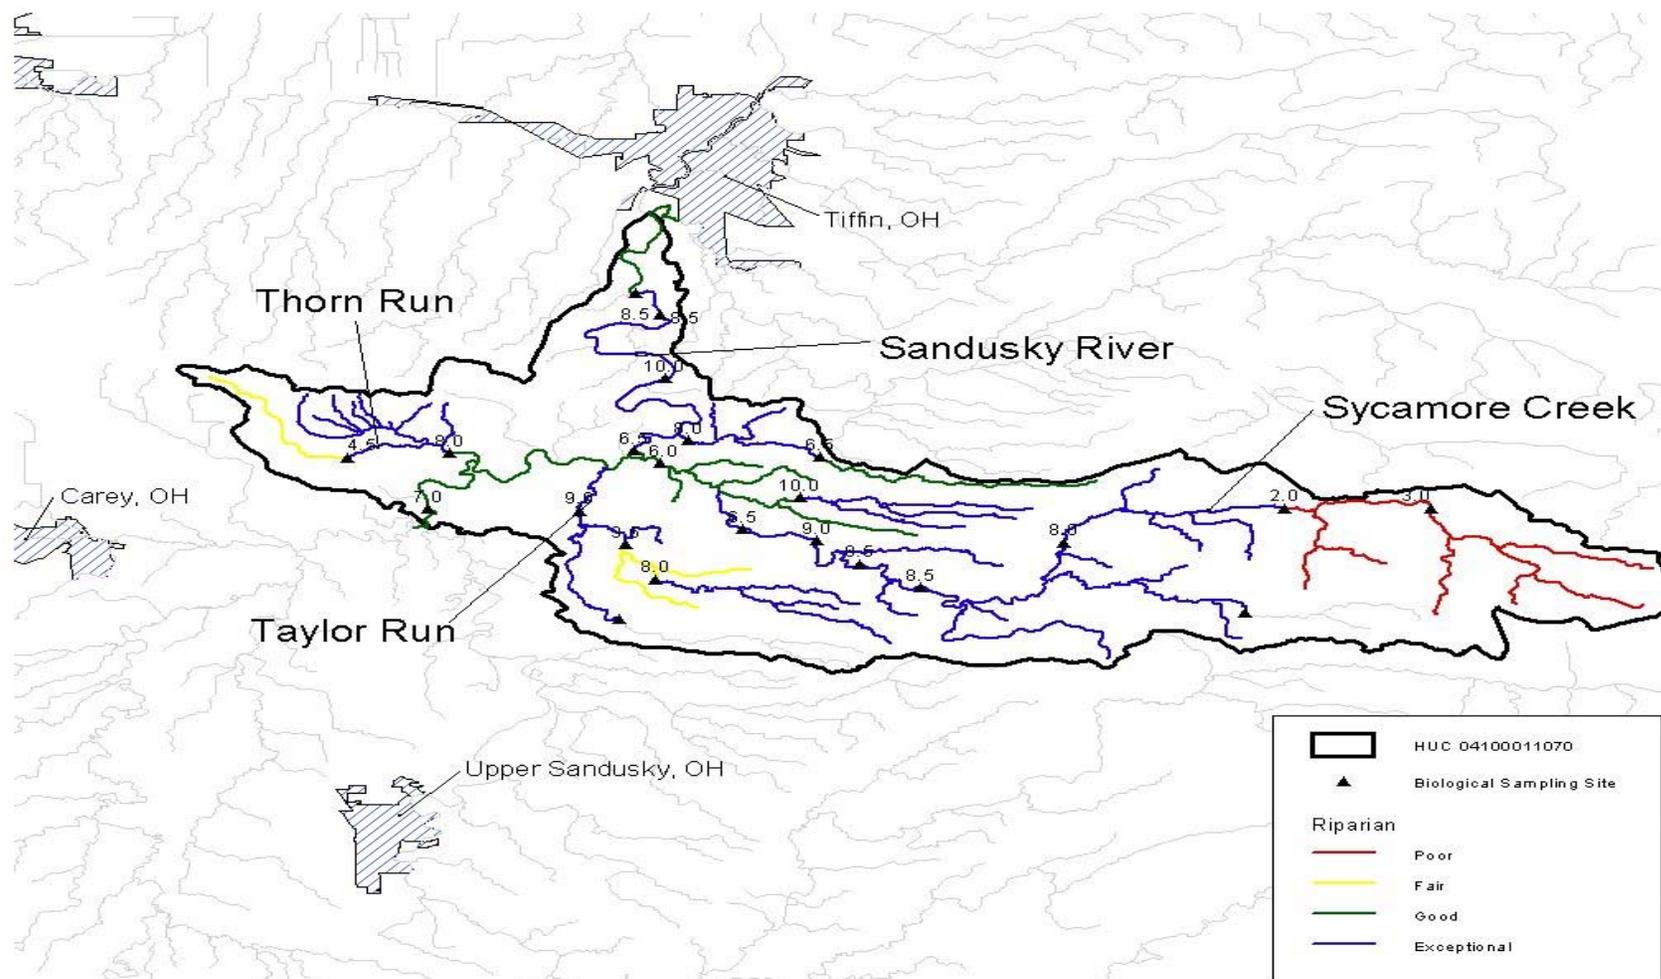
Figure 7: Riparian condition scores of the Mexico assessment unit (04100011-070)

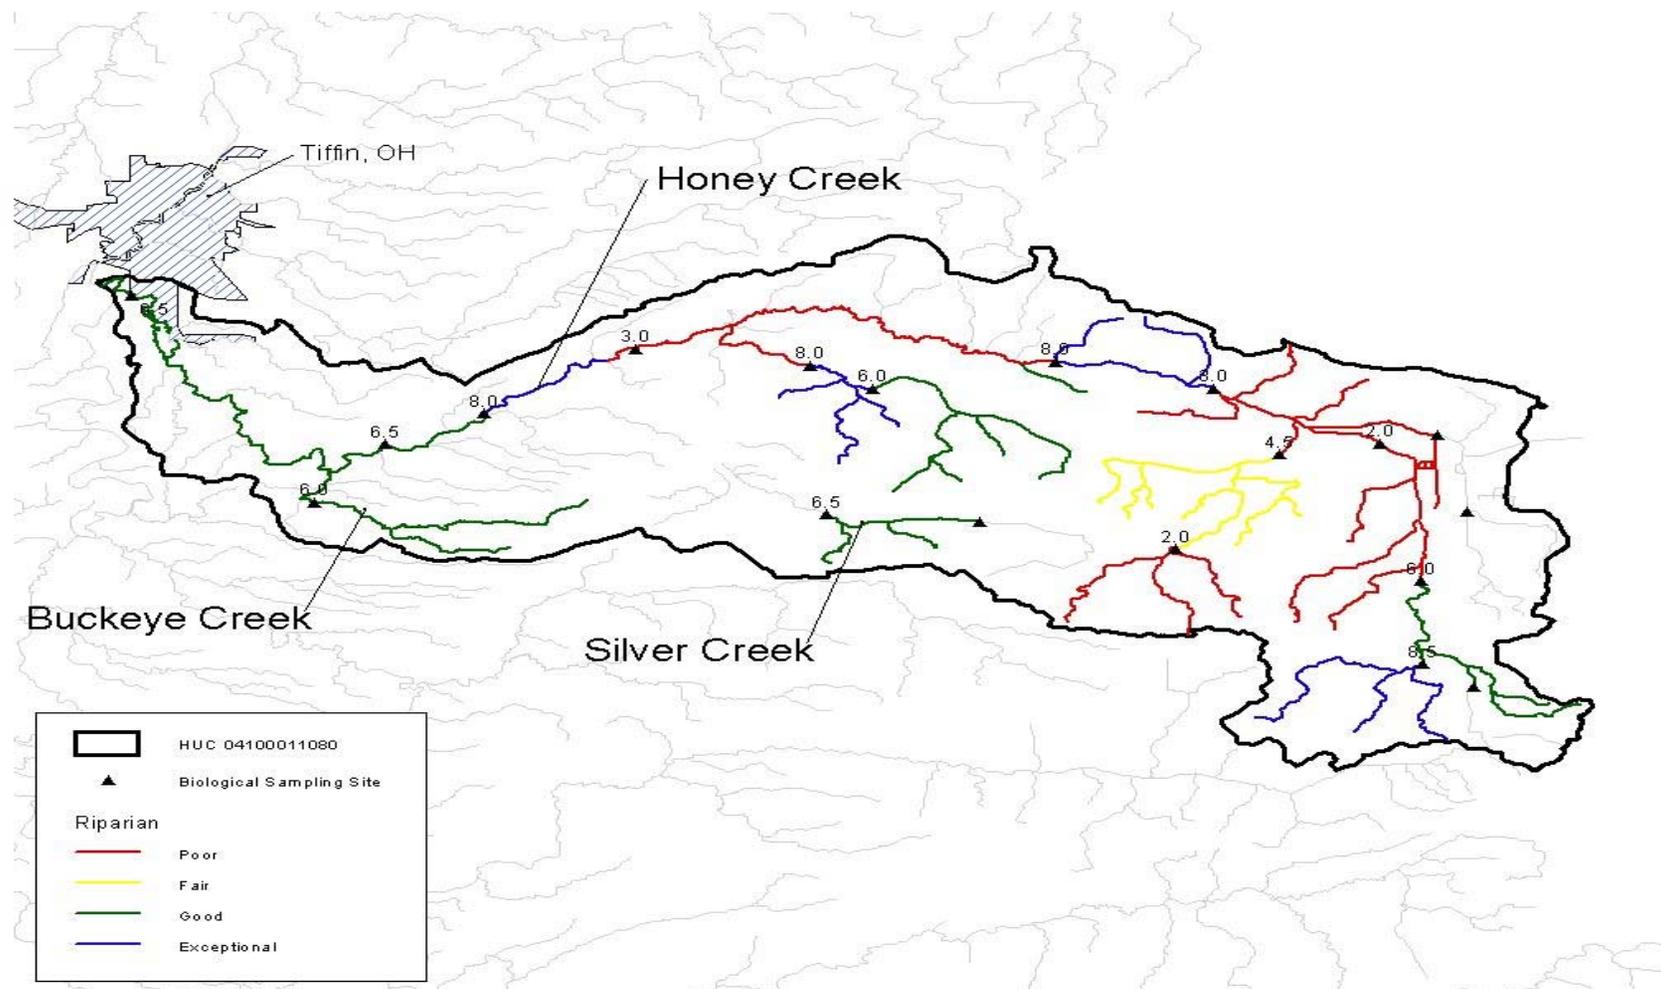
Figure 8: Riparian condition scores of the Honey Creek assessment unit (04100011-080)

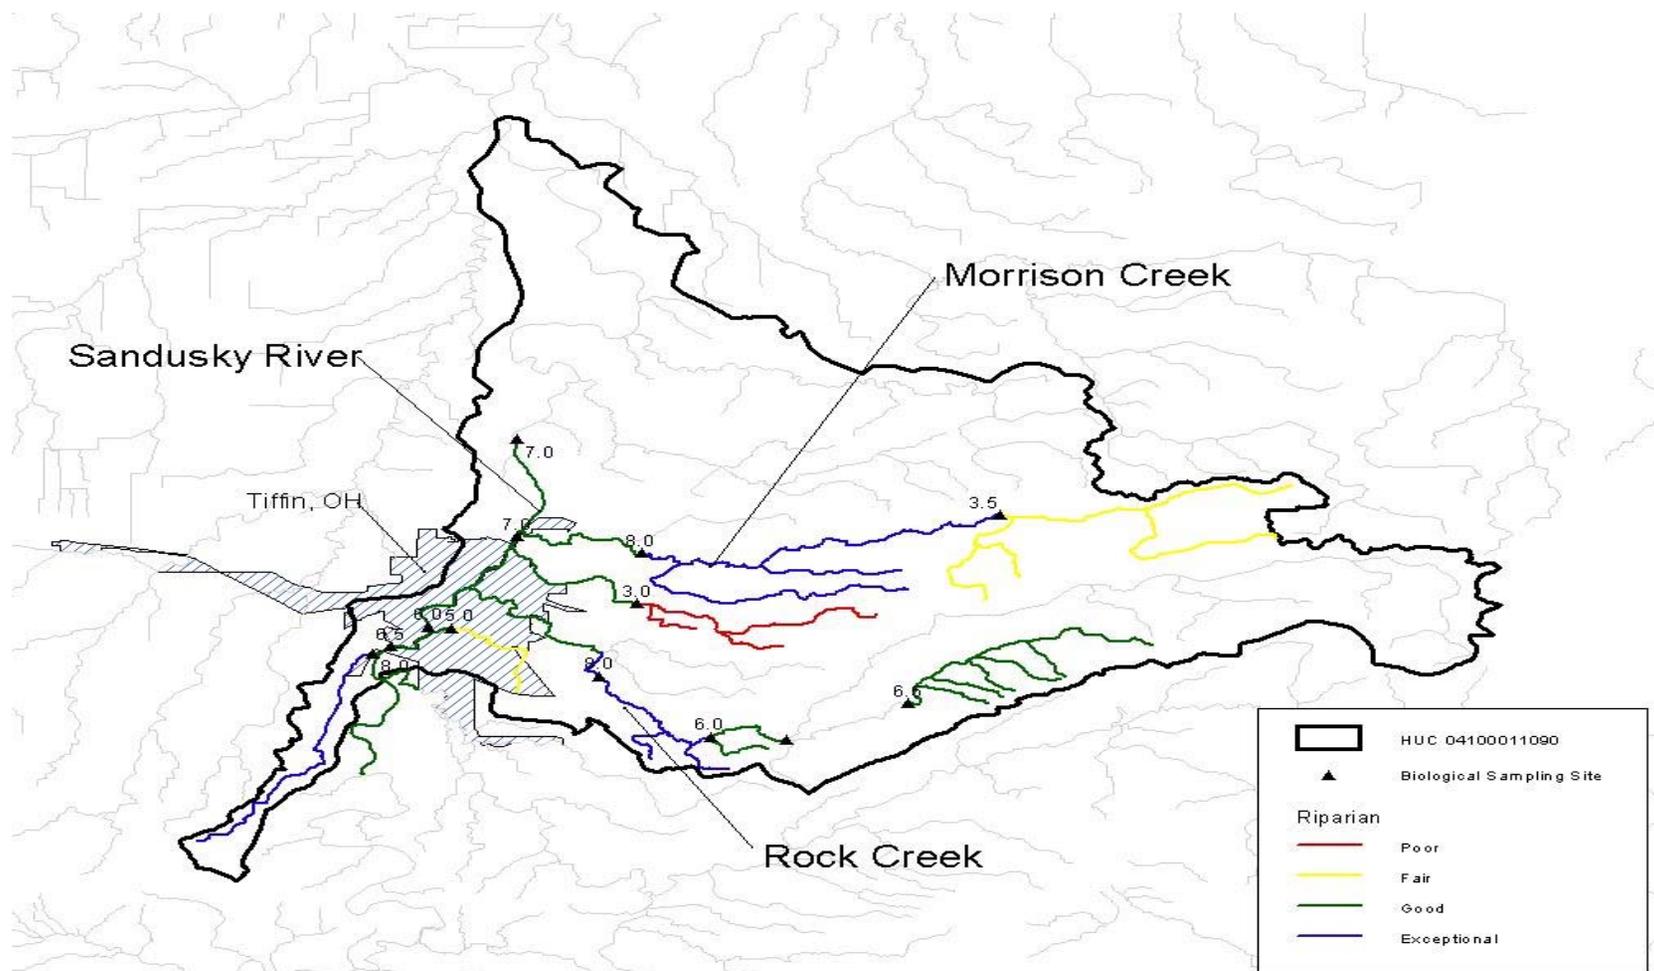
Figure 9: Riparian condition scores of the Tiffin assessment unit (04100011-090)
