Countywide Recycling & Disposal Facility, Remediation Unit

**Monthly Progress Report
Of
Operations, Monitoring & Maintenance Activities**

NOVEMBER 2009

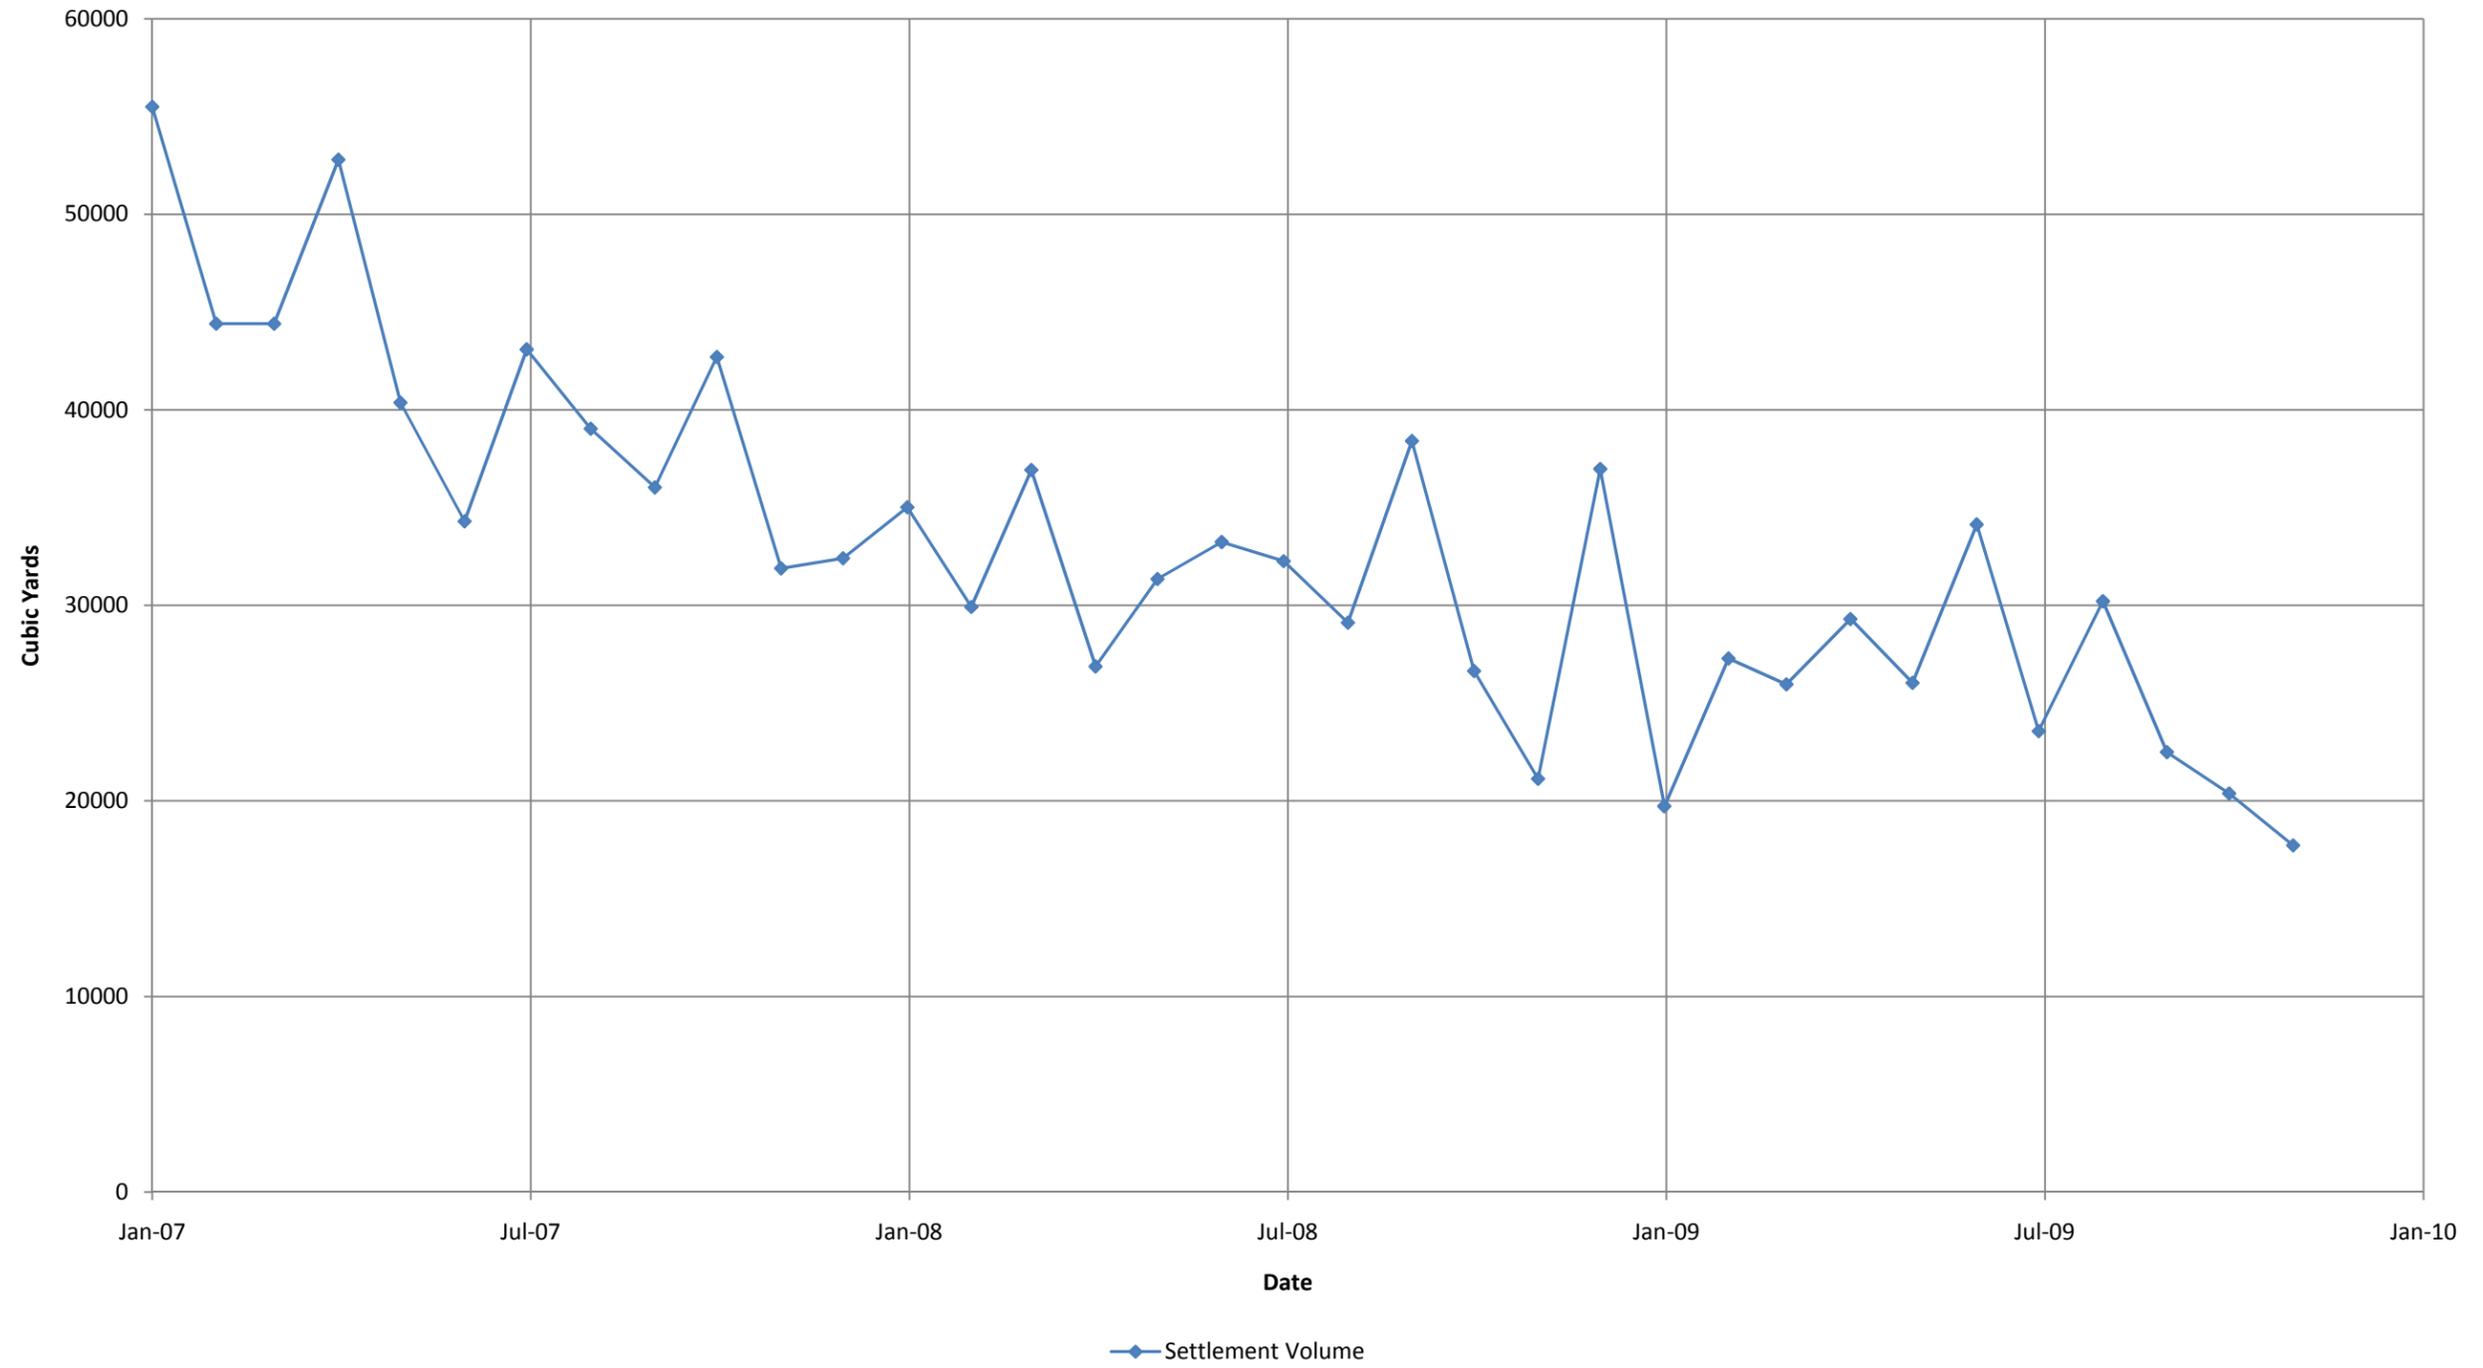
Graph 2 Settlement Volume

1. Information presented prior to October 2009 was compiled from data prepared and presented by SCS Engineers for Countywide Recycling and Disposal Facility.
2. Data presented on monthly basis.
3. Settlement volume reported prior to the 4th quarter of 2009 is for a limited area of the 88-acre reaction area.

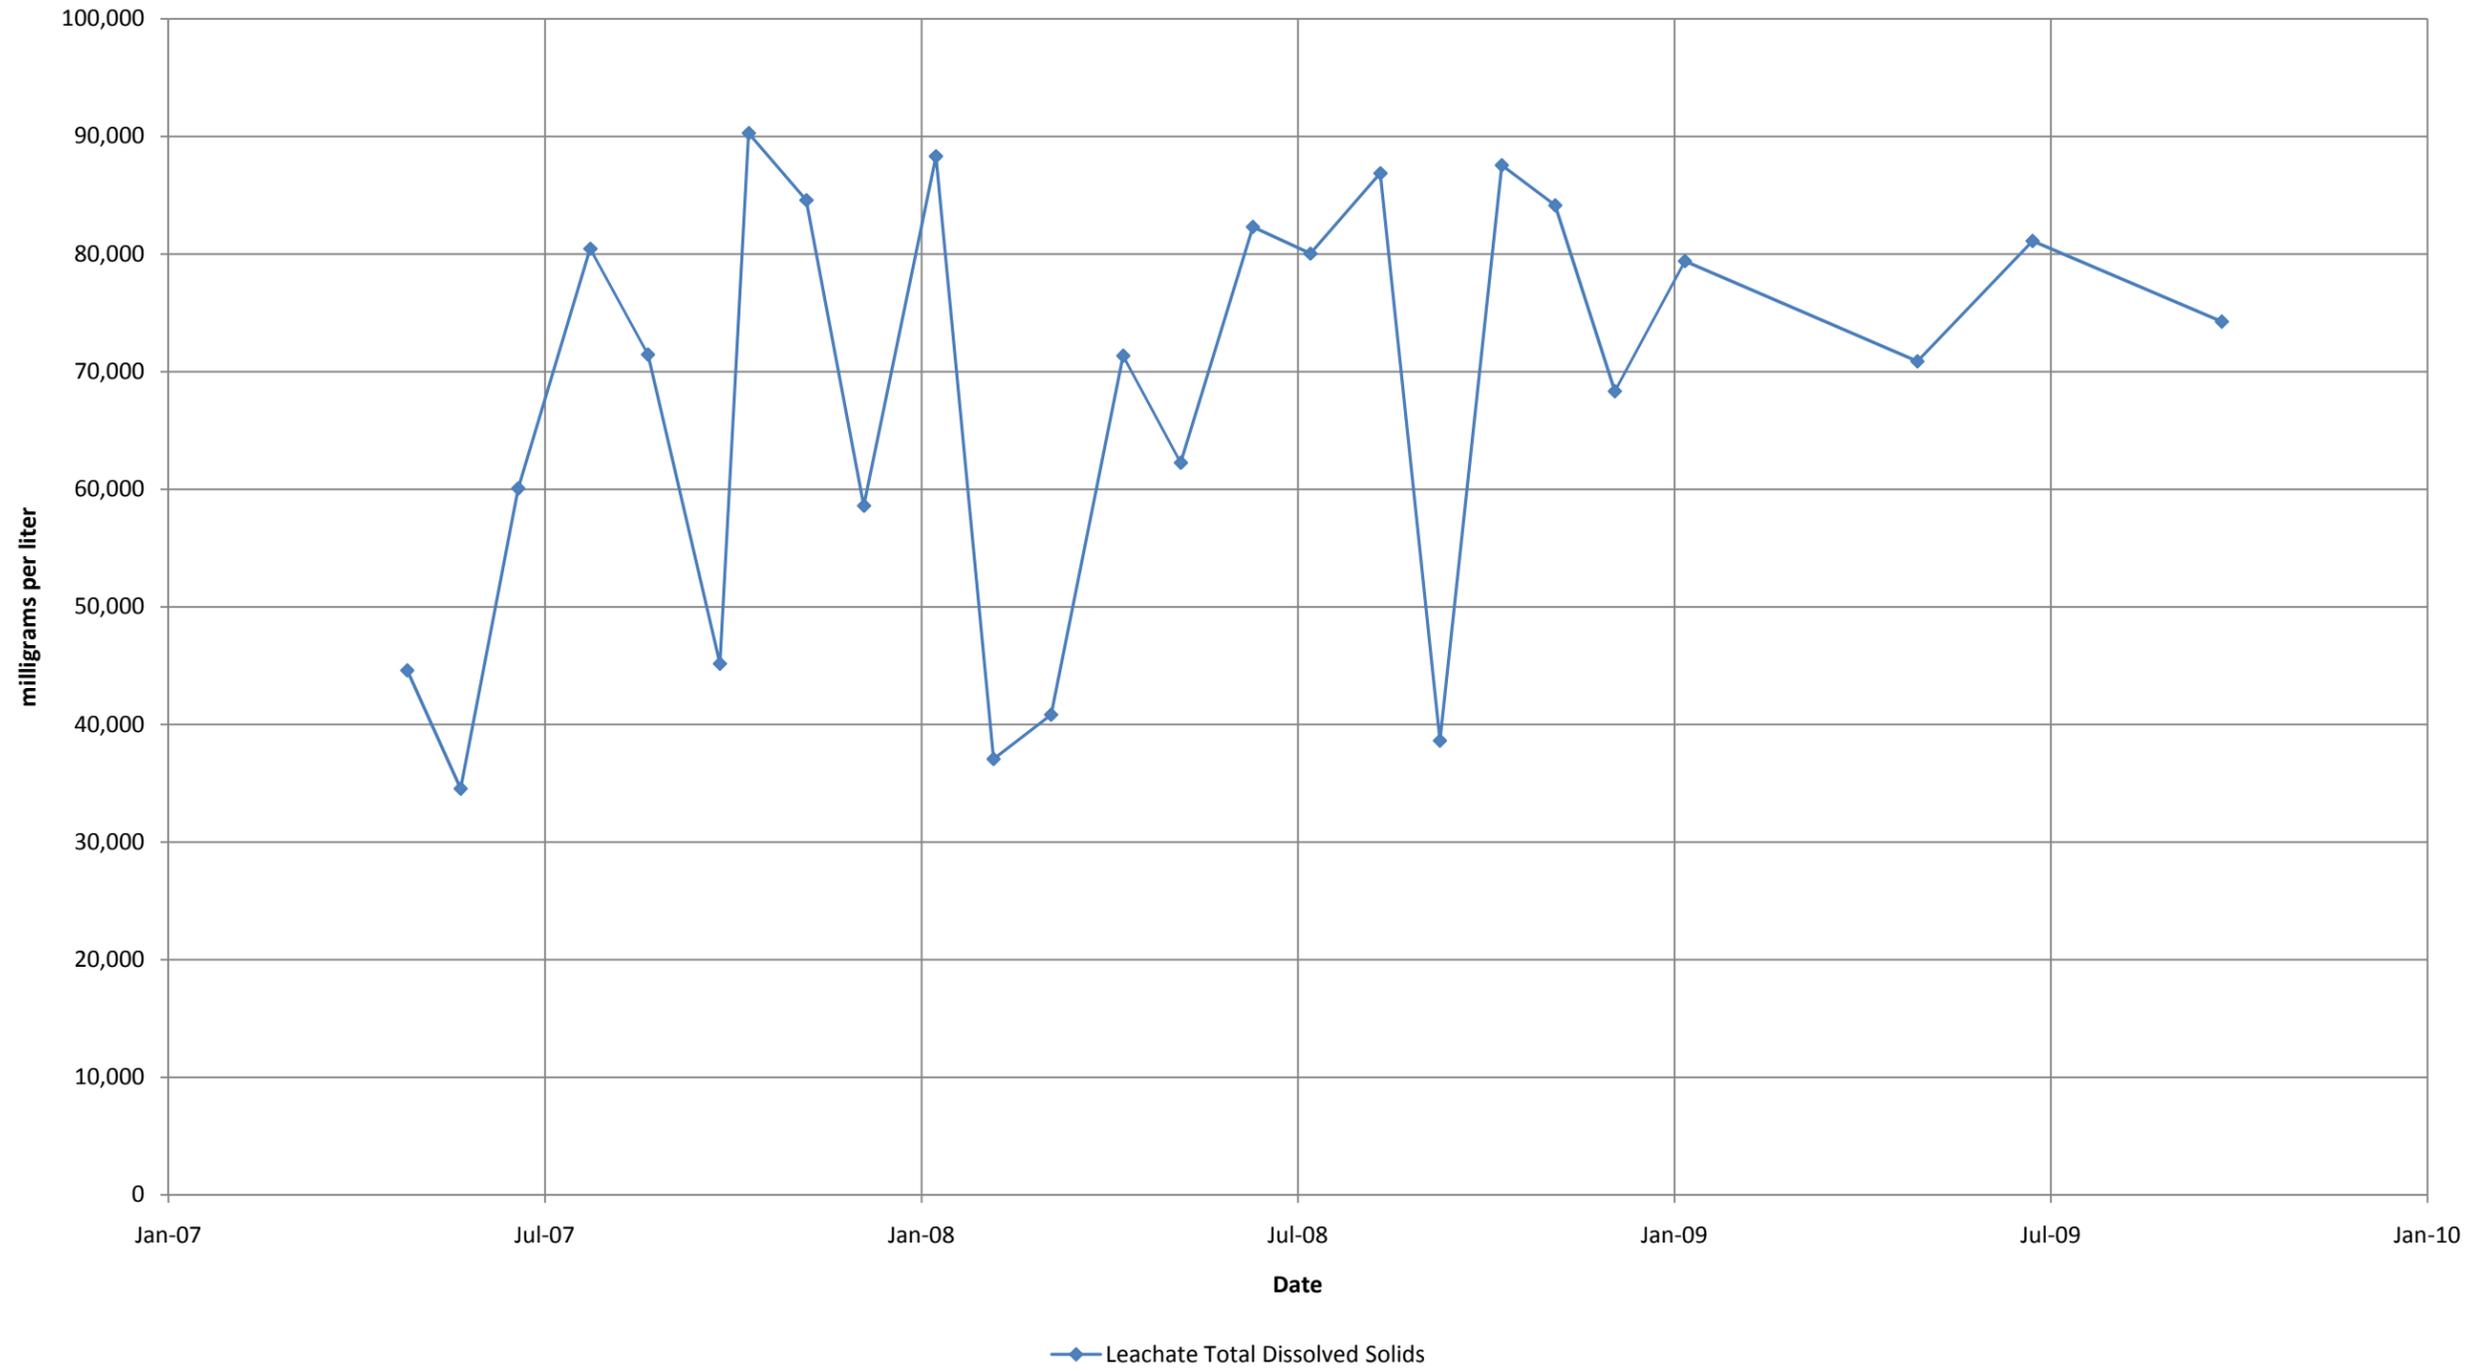
Graph 5 Leachate Total Dissolved Solids

1. Information presented prior to October 2009 was compiled from data prepared and presented by AECOM for Countywide Recycling and Disposal Facility.
2. Data shown prior to October 2009 are flow-weighted averages of data from the East, North and South leachate collection tanks.
3. Data shown prior to October 2009 comprises data from the leachate collection system only, and excludes certain leachate toe drains, sumps and gas collection wells.
4. No Data Collected in November 2009.

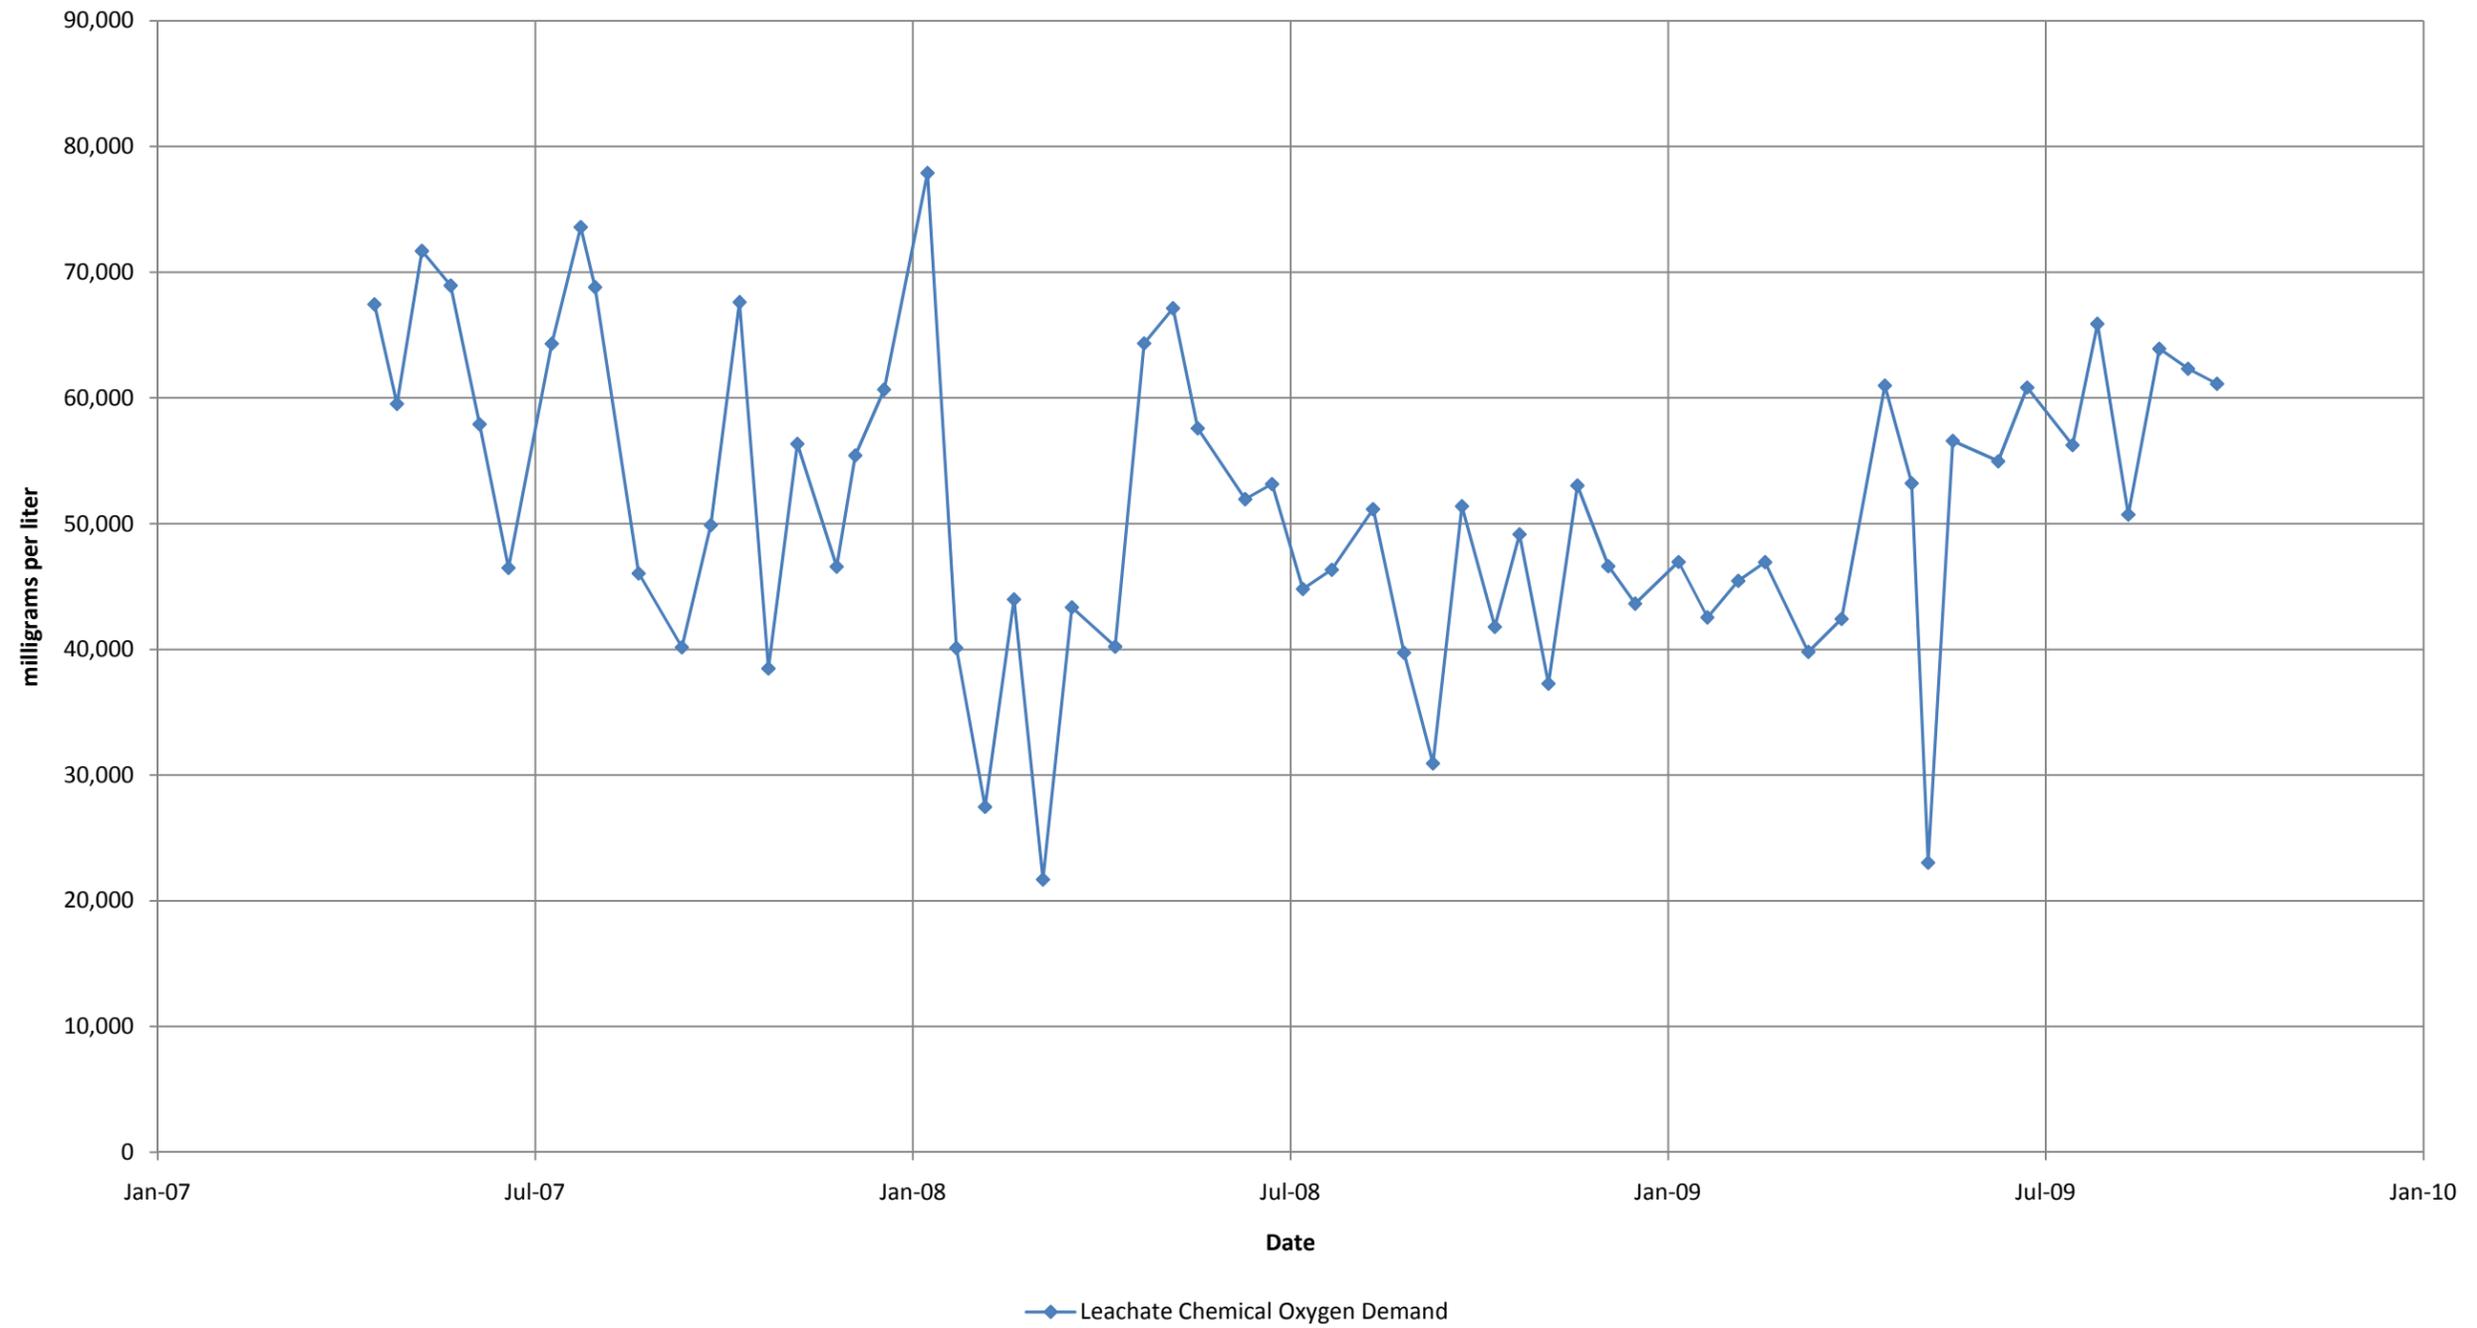
Graph 6 Leachate Chemical Oxygen Demand

1. Information presented prior to October 2009 was compiled from data prepared and presented by AECOM for Countywide Recycling and Disposal Facility.
2. Data shown prior to October 2009 are flow-weighted averages of data from the East, North and South leachate collection tanks.
3. Data shown prior to October 2009 comprises data from the leachate collection system only, and excludes certain leachate toe drains, sumps and gas collection wells.
4. No Data Collected in November 2009.

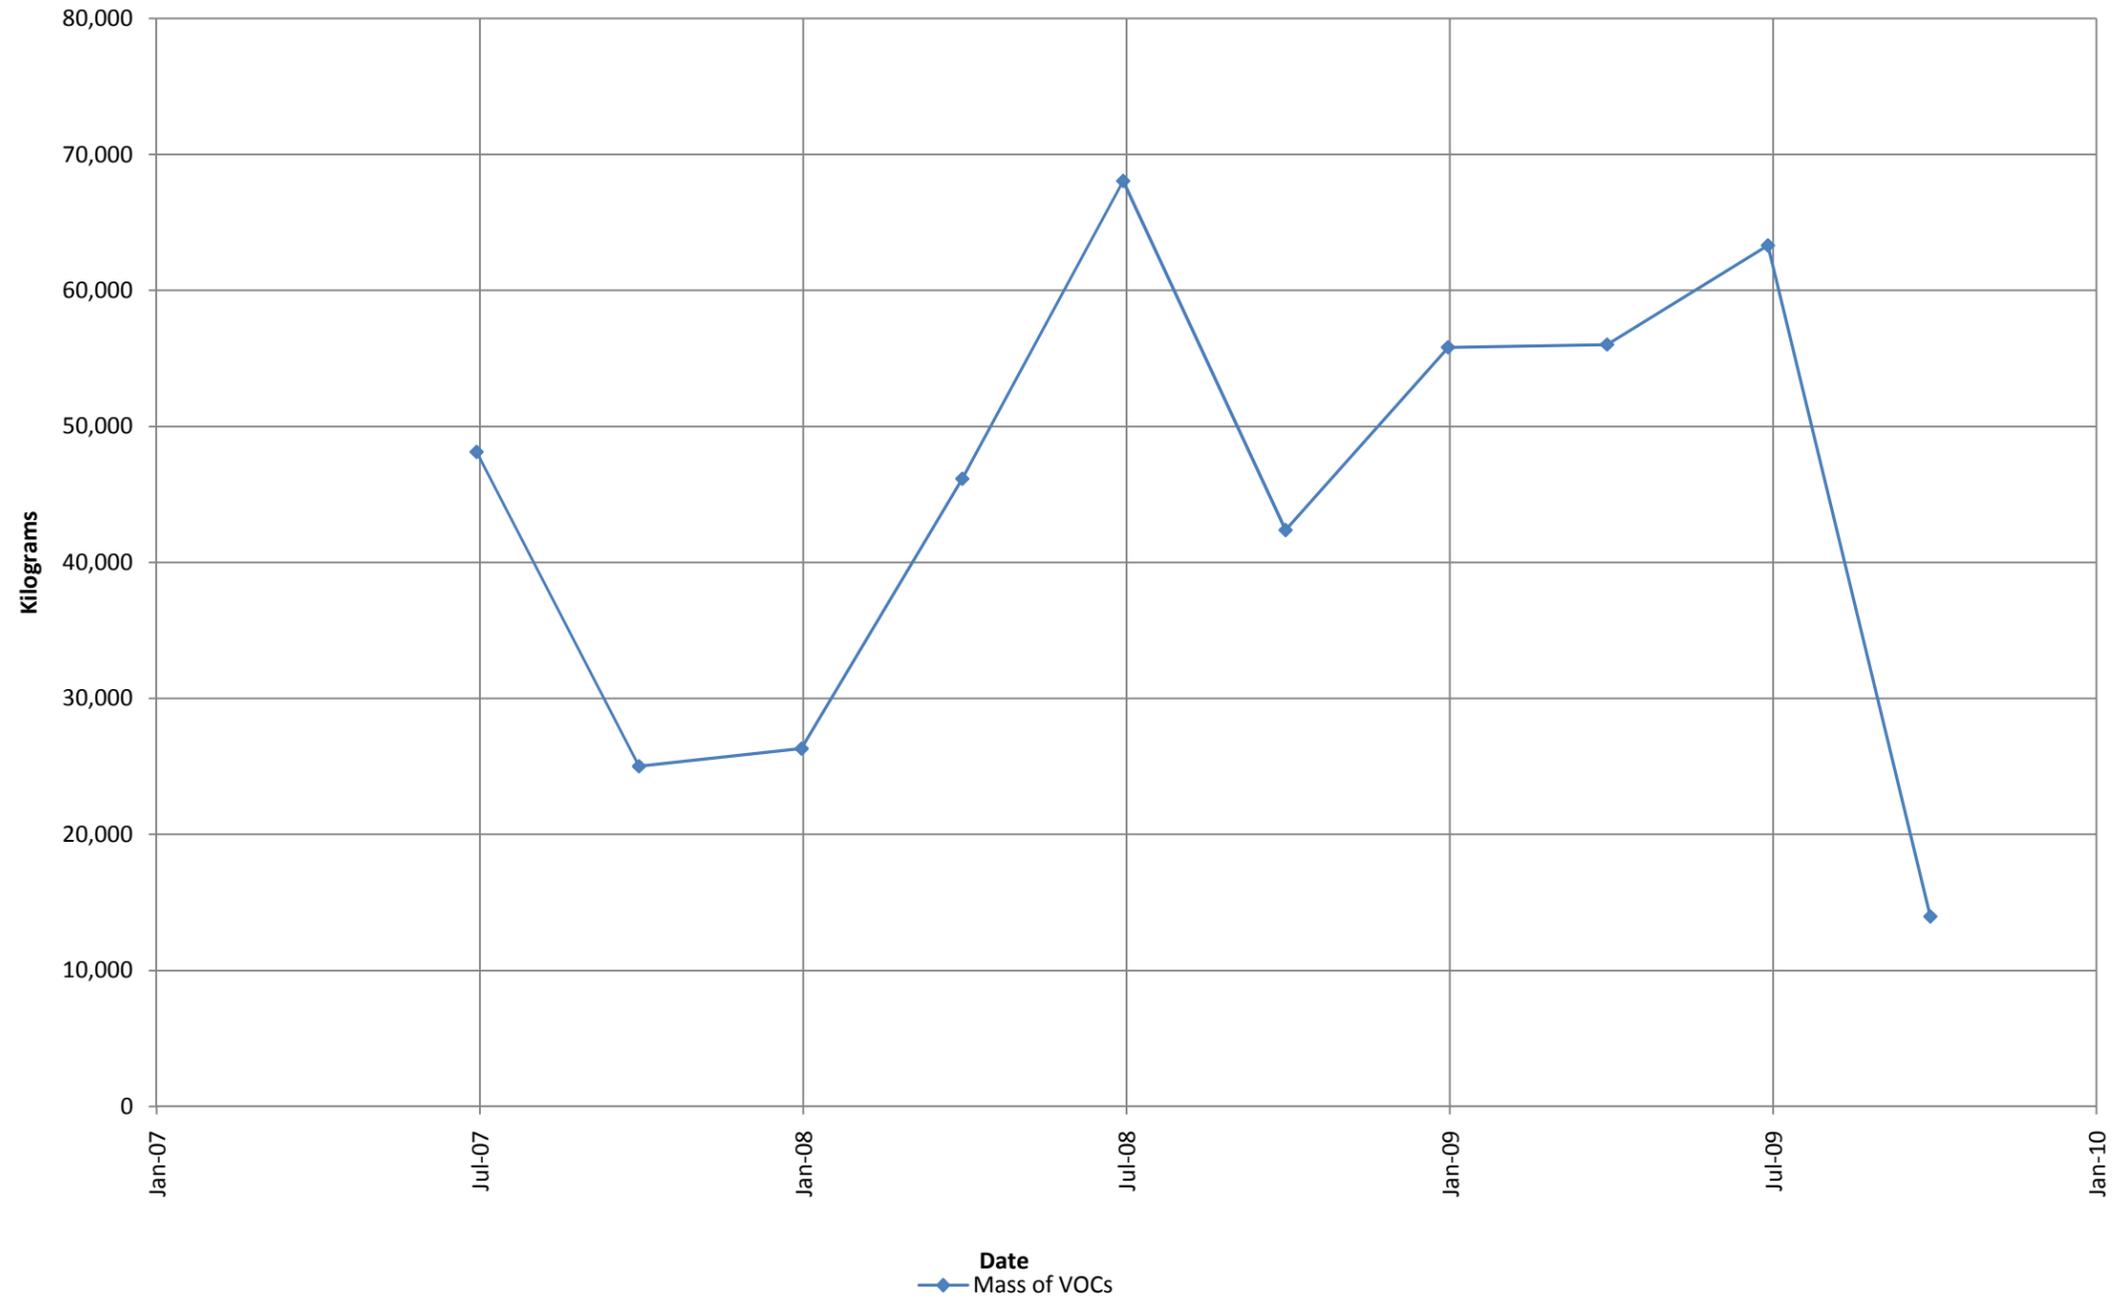
Graph 7 Total Mass of VOCs

1. Information presented prior to October 2009 was compiled from data prepared and presented by SCS Engineers for Countywide Recycling and Disposal Facility.
2. Data presentation frequency is quarterly.
3. Flare 4 was not sampled for air quality beginning in September 2009.
4. Beginning in fourth quarter 2009, mass based on data collected only from Flares 7 and 10.
5. Fourth quarter total mass based on flow through the end of November 2009. Fourth quarter total mass will be updated at the end of December 2009 to account for December flow data.

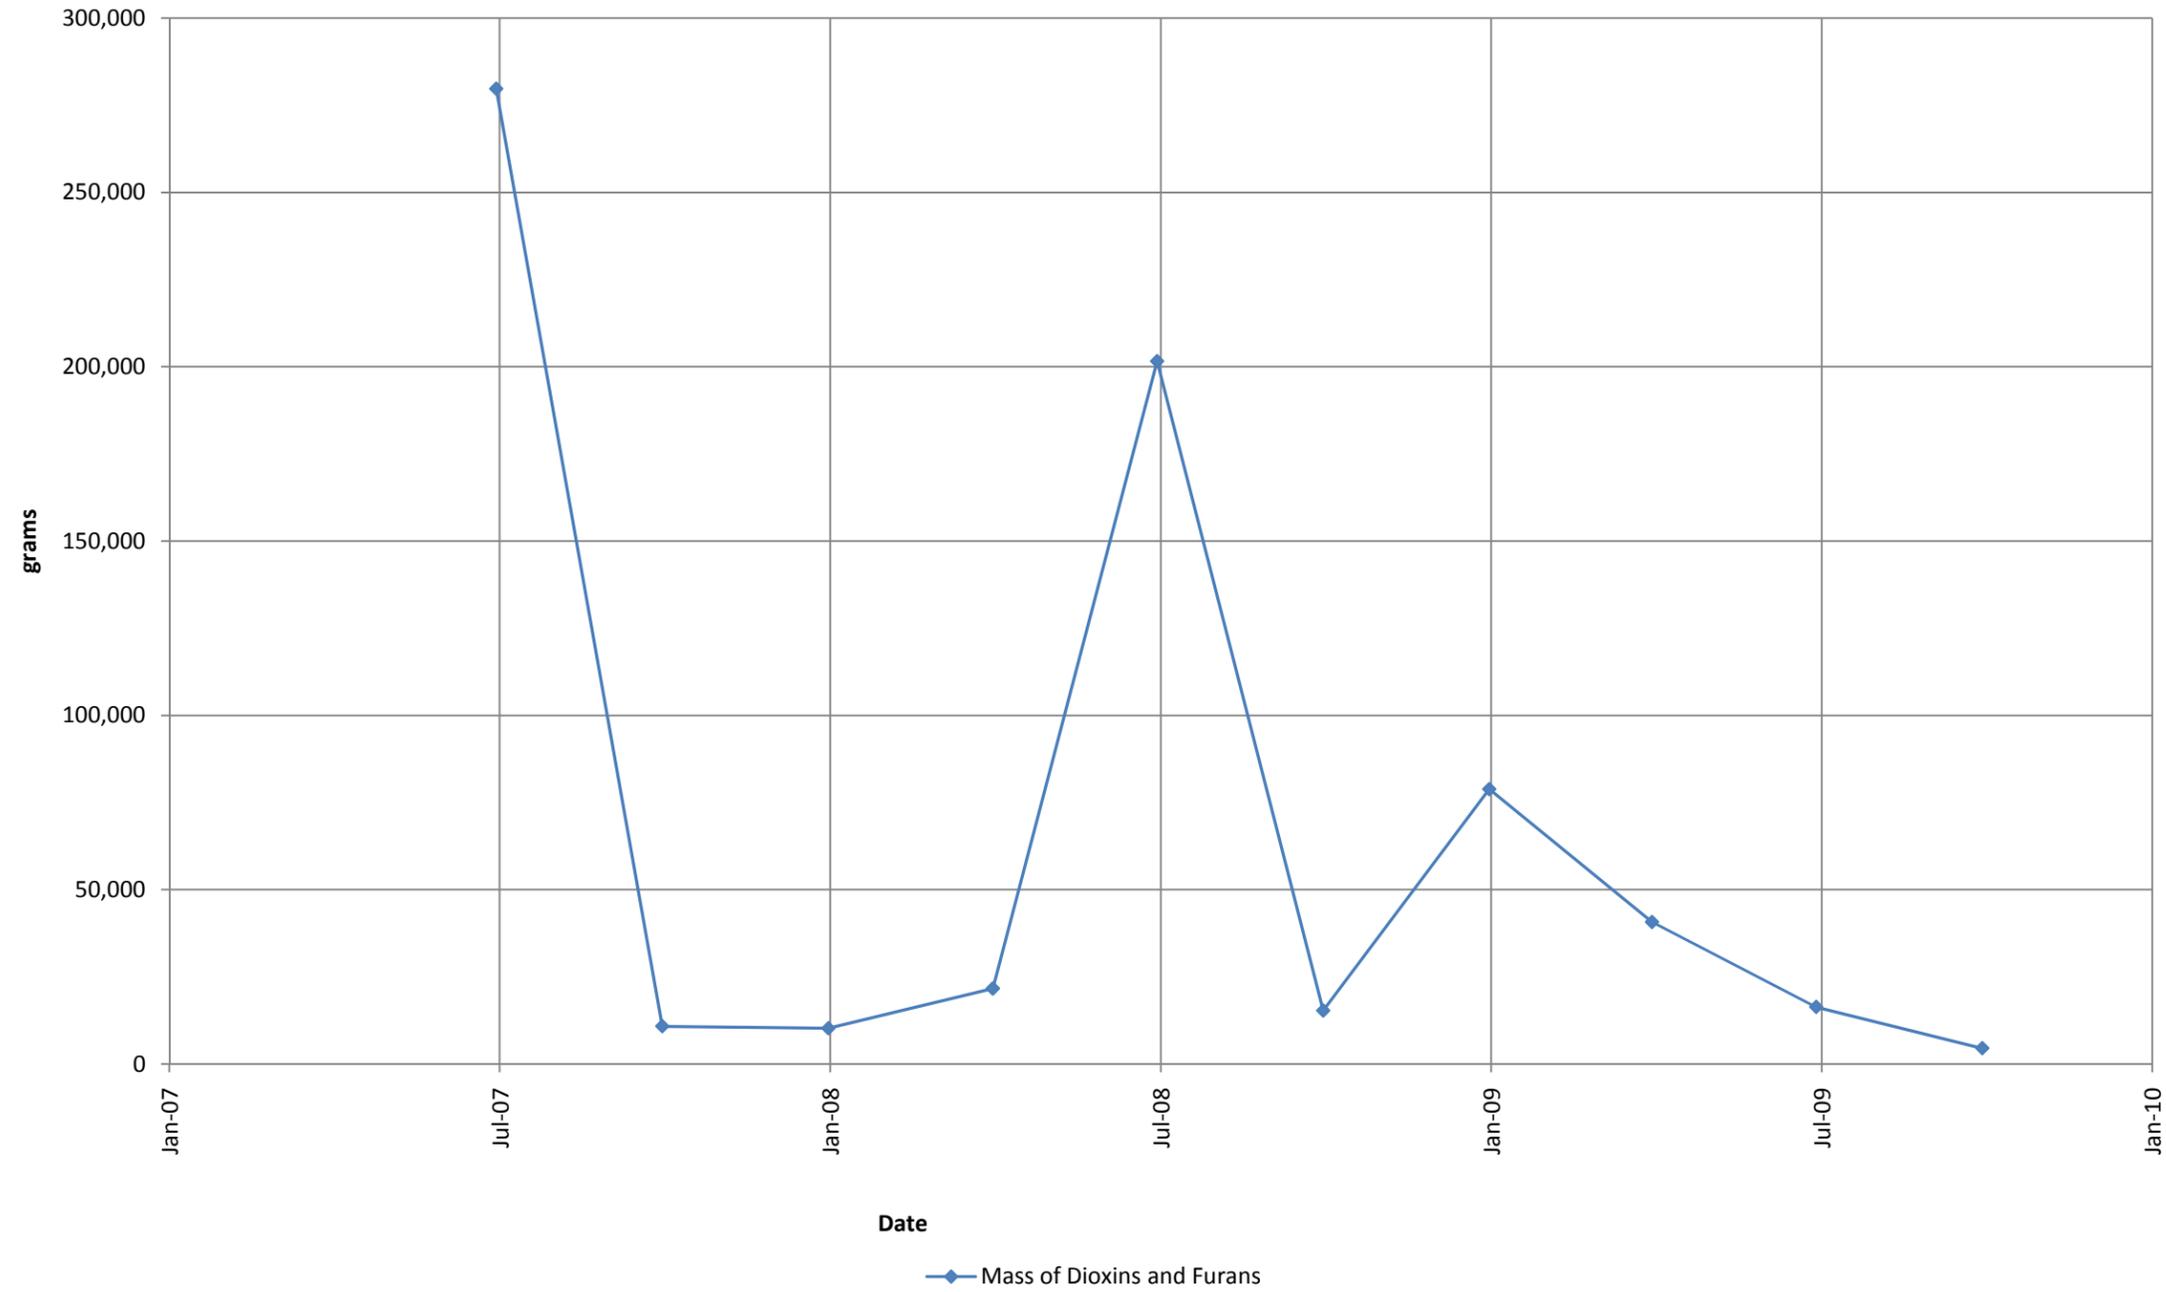
Graph 8 Total Mass of Dioxins and Furans

1. Information presented prior to October 2009 was compiled from data prepared and presented by SCS Engineers for Countywide Recycling and Disposal Facility.
2. Data presentation frequency is quarterly.
3. Flare 4 was not sampled for air quality beginning in September 2009.
4. Beginning in fourth quarter 2009, mass based on data collected only from Flares 7 and 10.
5. Fourth quarter total mass based on flow through the end of November 2009. Fourth quarter total mass will be updated at the end of December 2009 to account for December flow data.

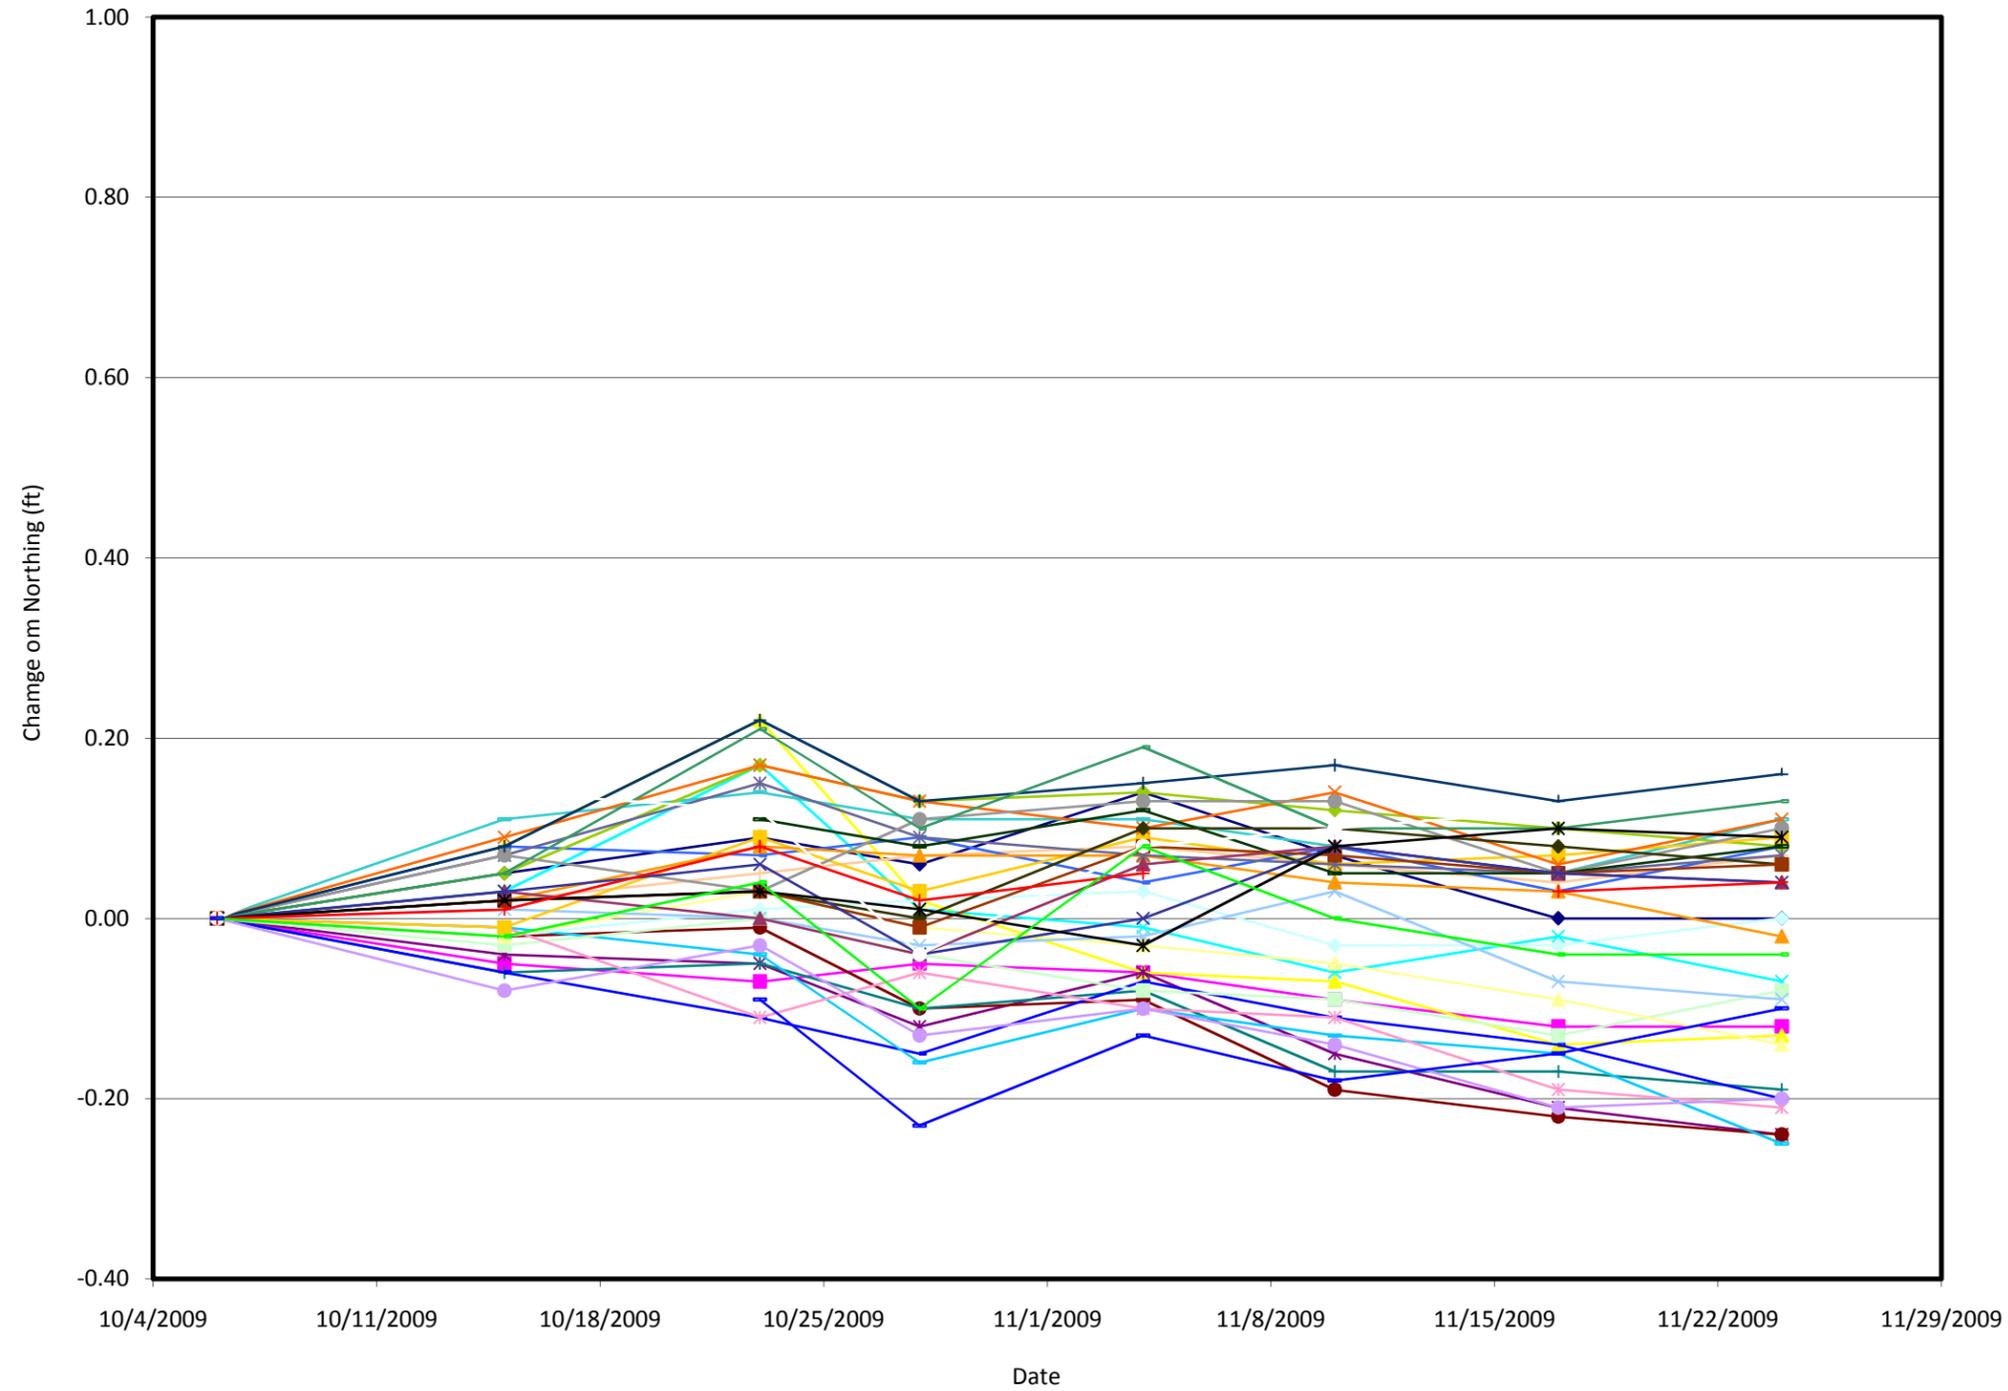
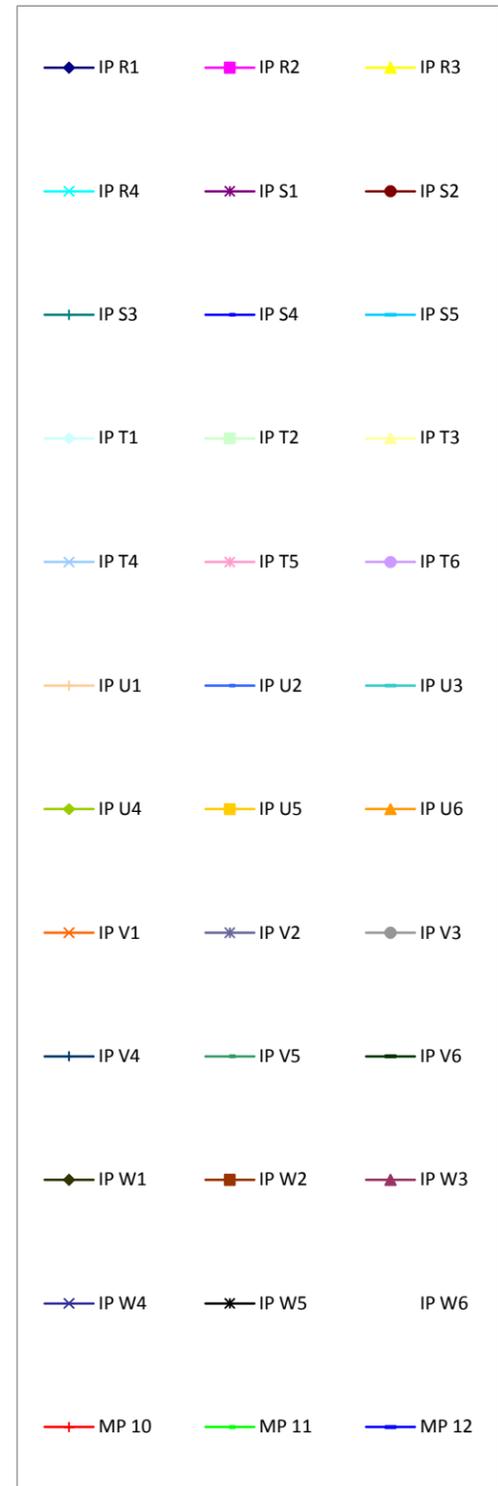
Graph 11 - South Slope Pin Movement
Northing Change

- No pins or toe monitoring points exceeded the trigger rates of 0.05ft per day of horizontal movement
- No signs of heave are present, although minor upward vertical movement was recorded at individual locations
- The minor vertical movements are all less than 0.02 ft and diminished with time, suggesting they represent limitations in survey rather than any trend.
- No signs of instability are indicated.

1. Data compiled by PJ Carey Associates, PC.
2. Survey provided by DEI beginning on October 5, 2009.
