Countywide Recycling & Disposal Facility, Remediation Unit

**Monthly Progress Report
Of
Operations, Monitoring & Maintenance Activities**

NOVEMBER 2009

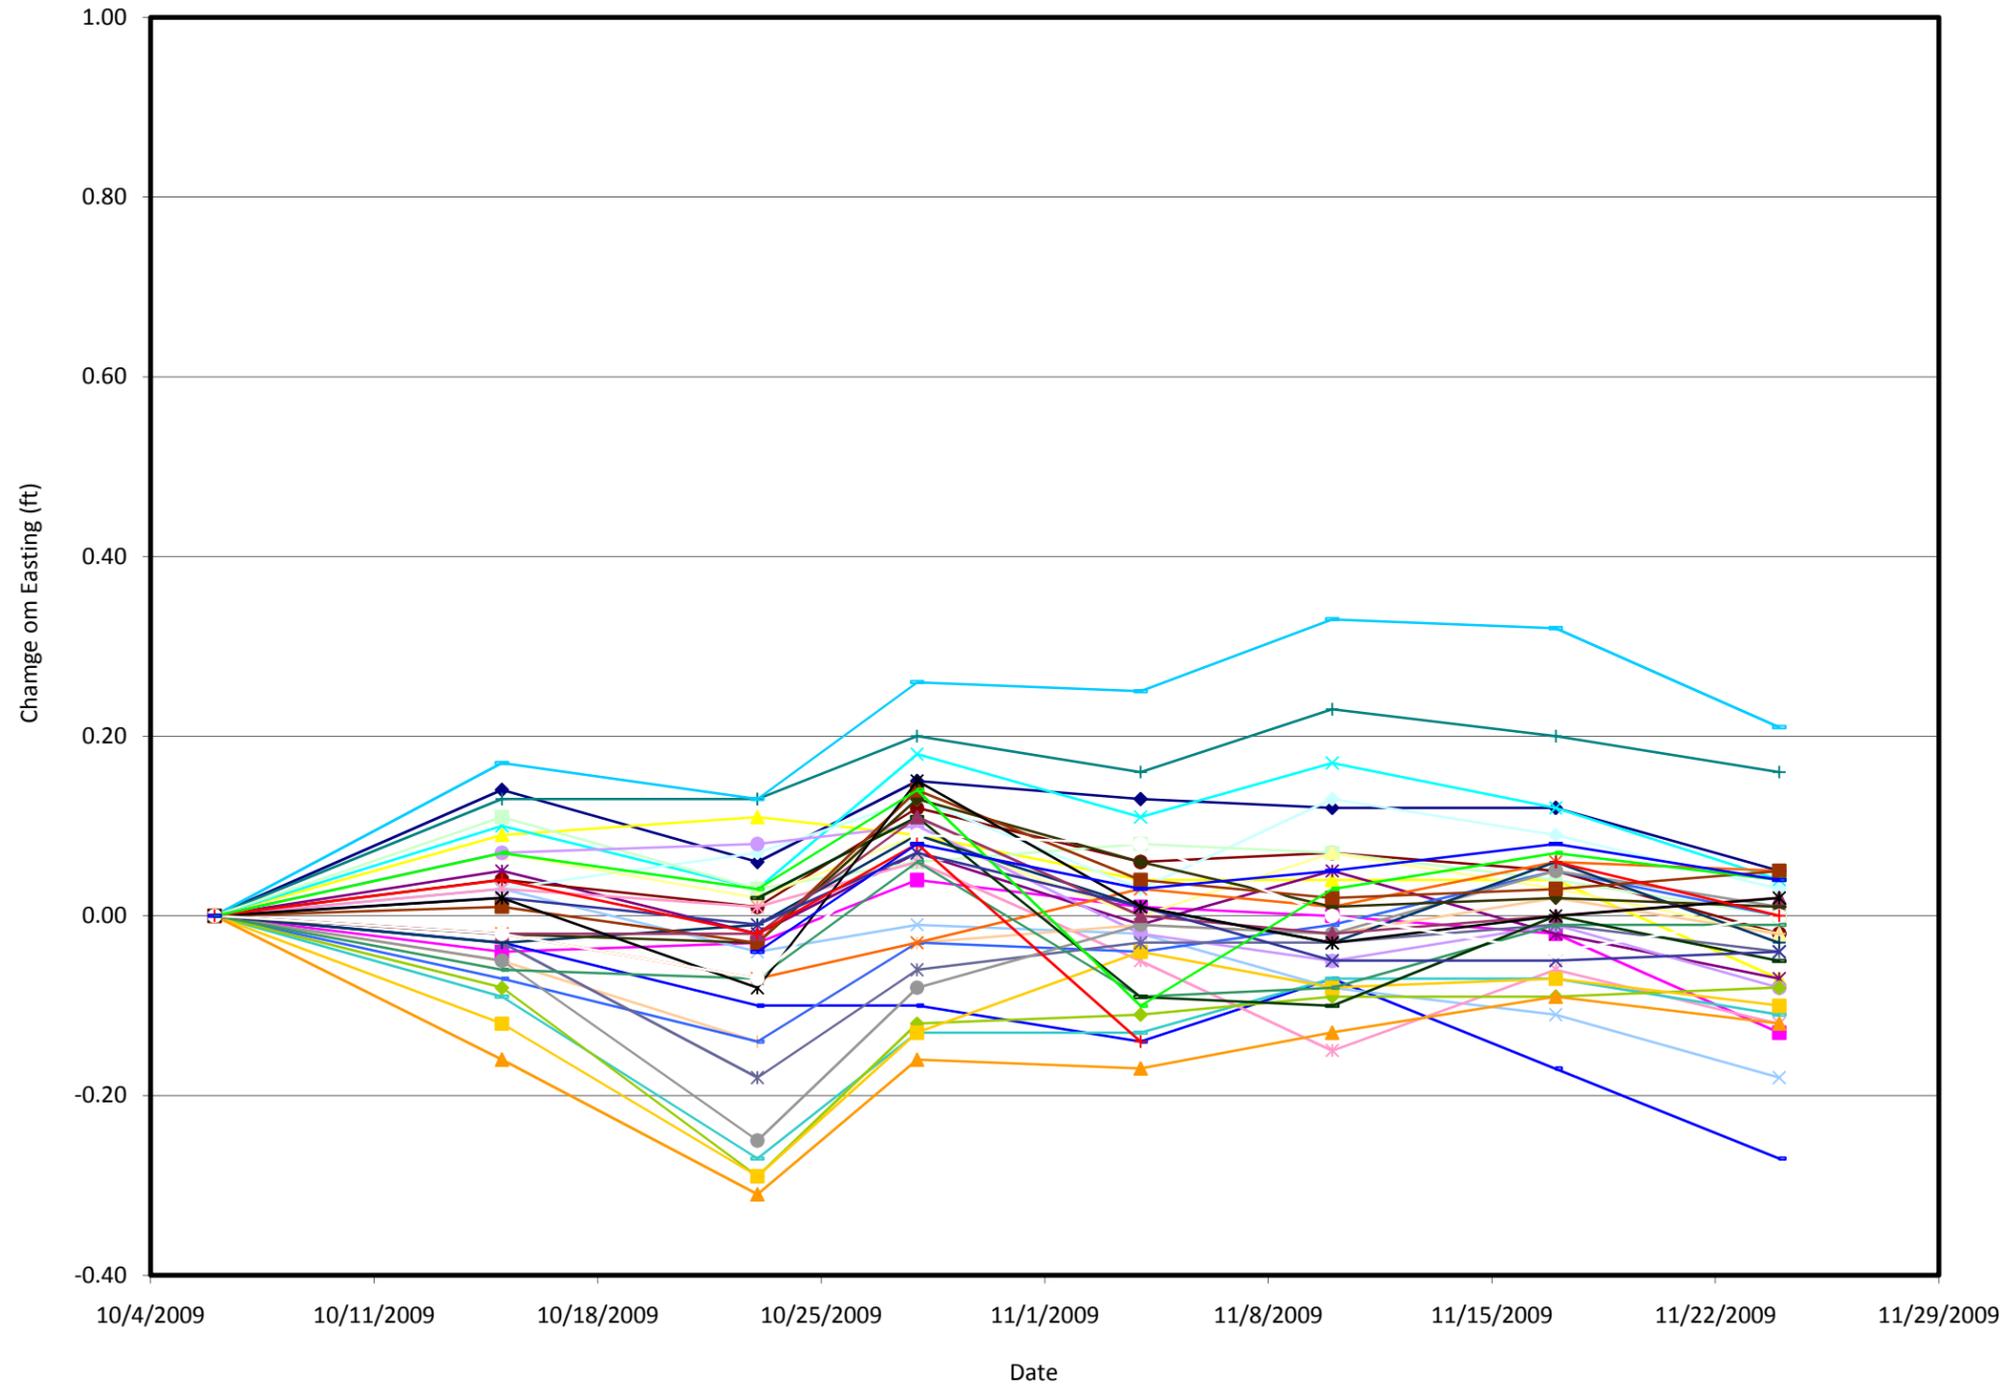
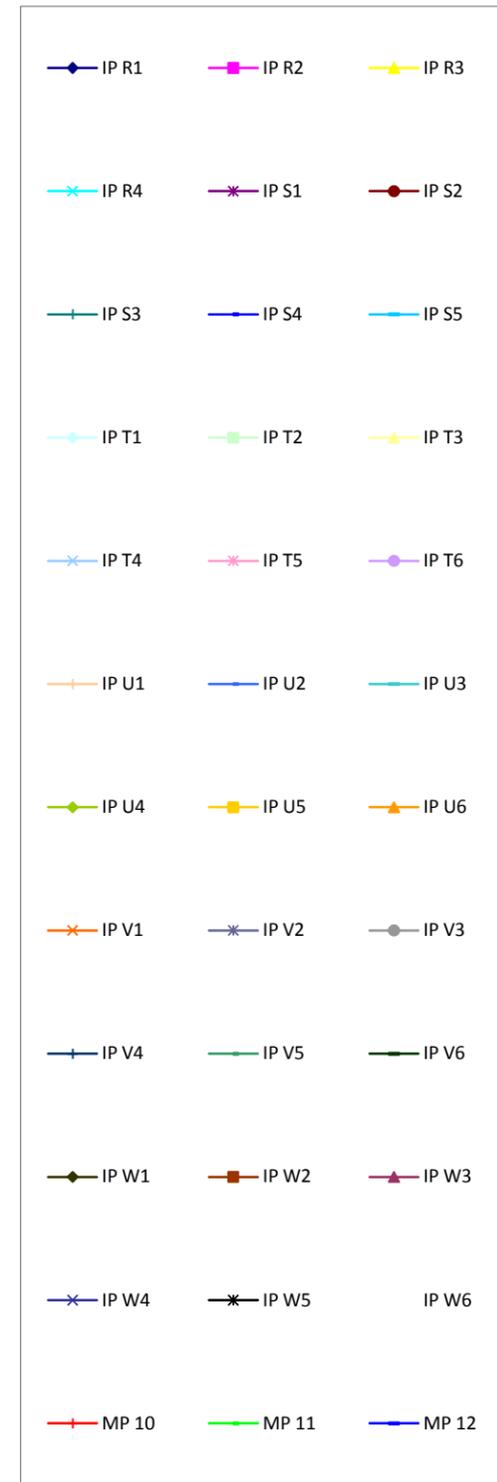
Graph 12 - South Slope Pin Movement Easting Change

- No pins or toe monitoring points exceeded the trigger rates of 0.05ft per day of horizontal movement
- No signs of heave are present, although minor upward vertical movement was recorded at individual locations
- The minor vertical movements are all less than 0.02 ft and diminished with time, suggesting they represent limitations in survey rather than any trend.
- No signs of instability are indicated.

1. Data compiled by PJ Carey Associates, PC.
2. Survey provided by DEI beginning on October 5, 2009.

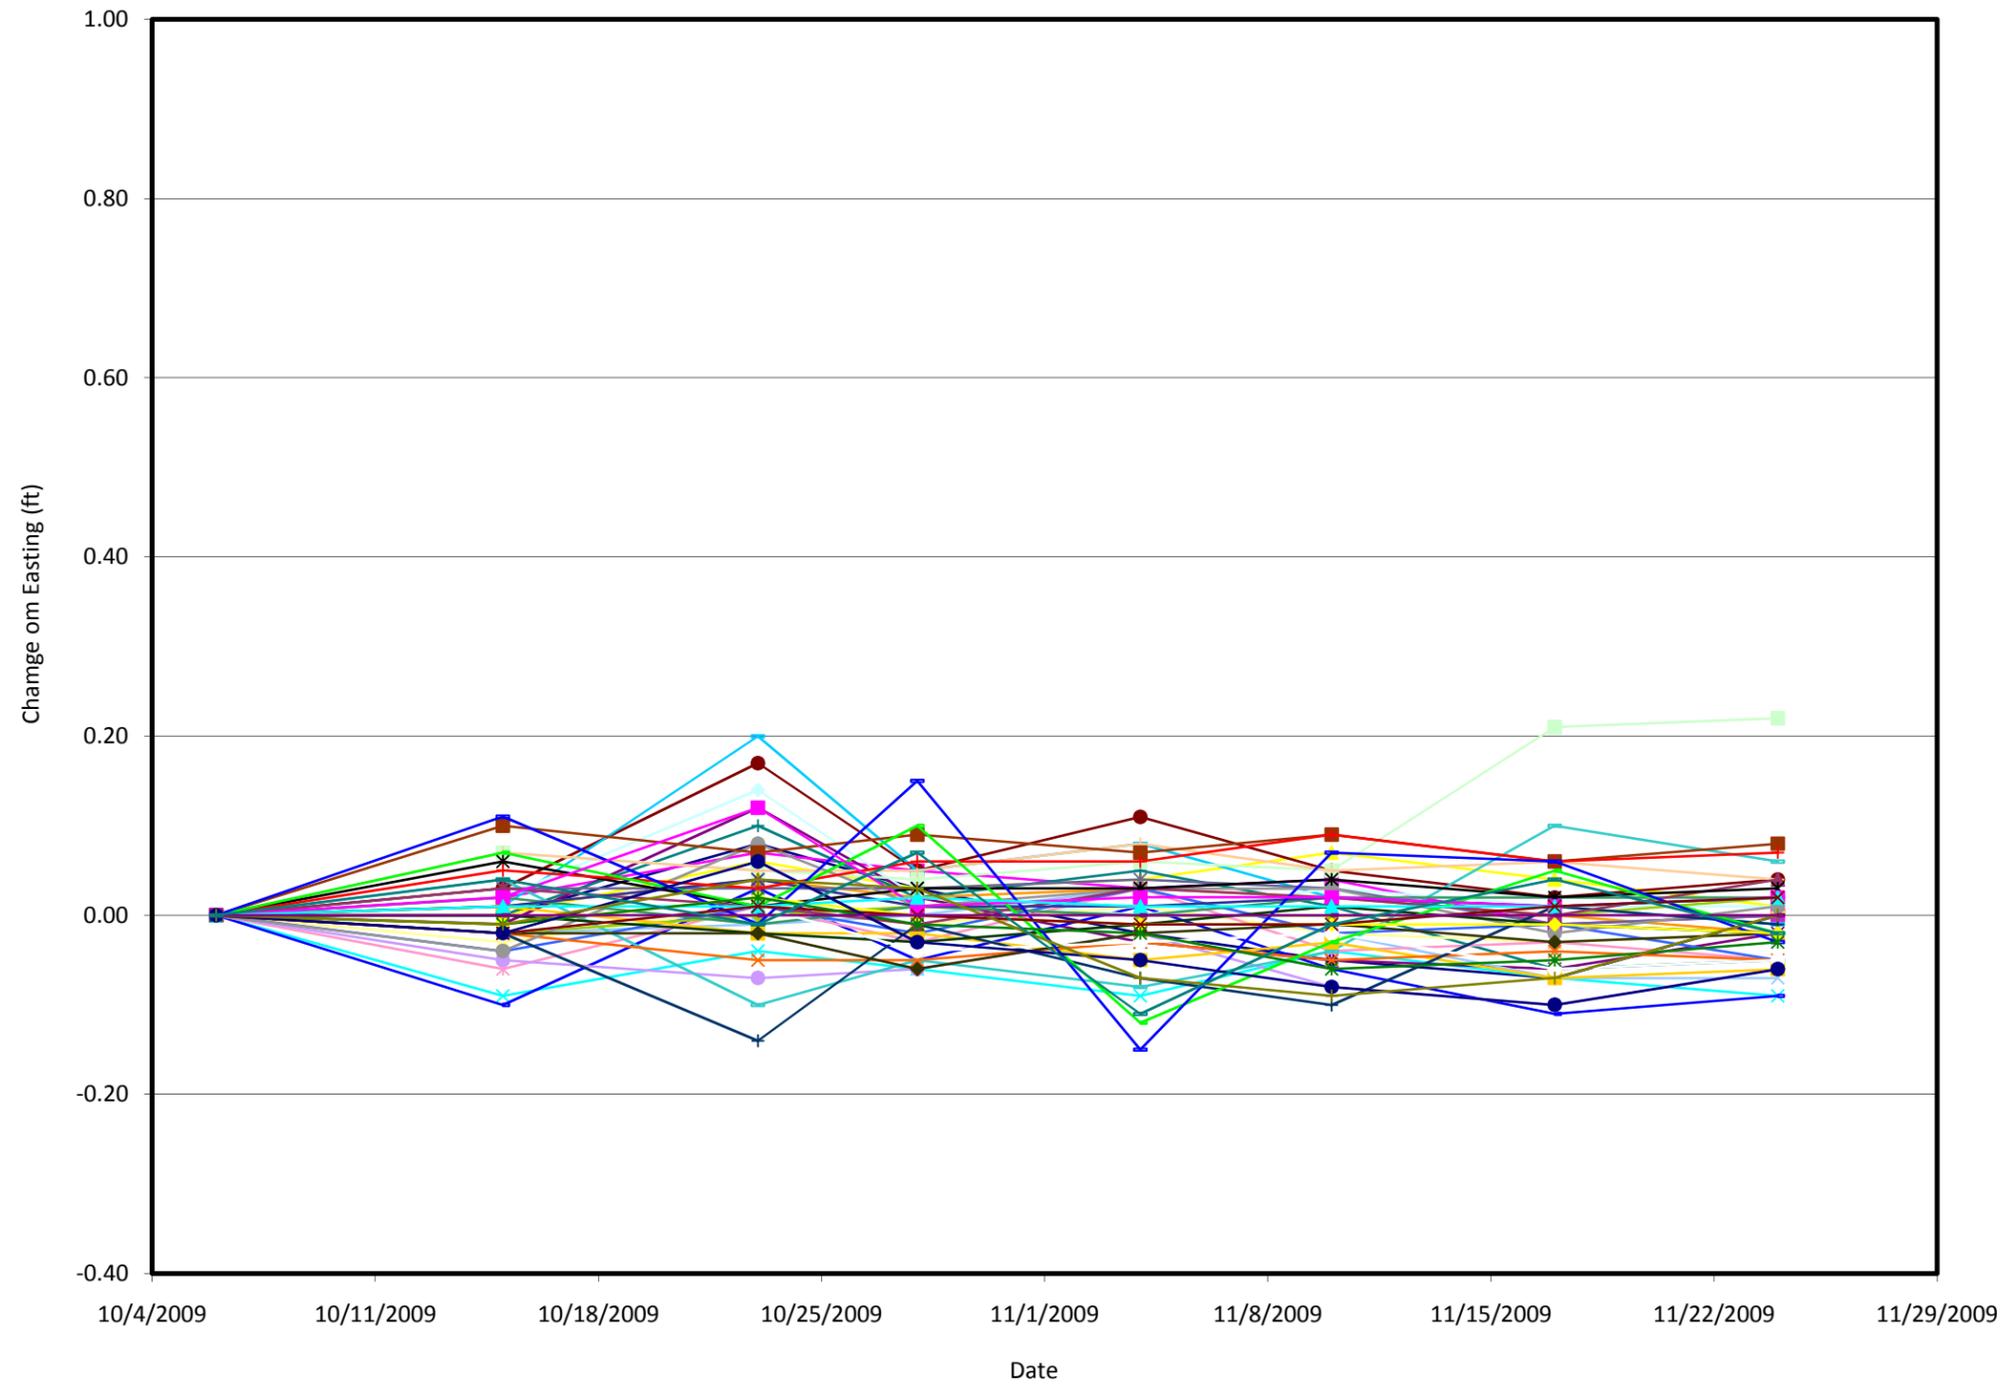
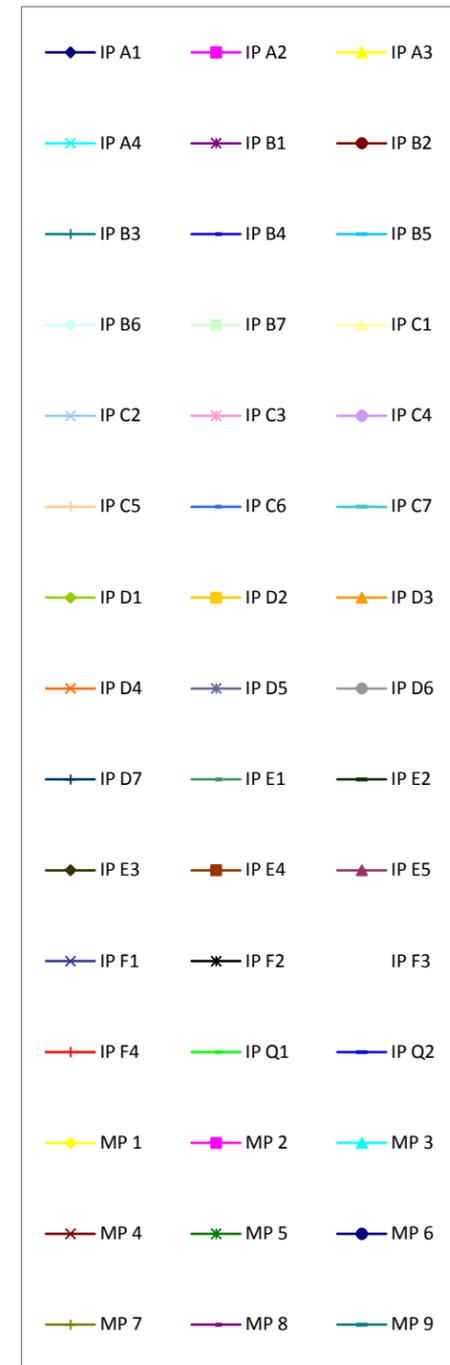
Graph 15 - West Slope Pin Movement
Easting Change

1. Data compiled by PJ Carey Associates, PC.
2. Survey provided by DEI beginning on October 5, 2009.

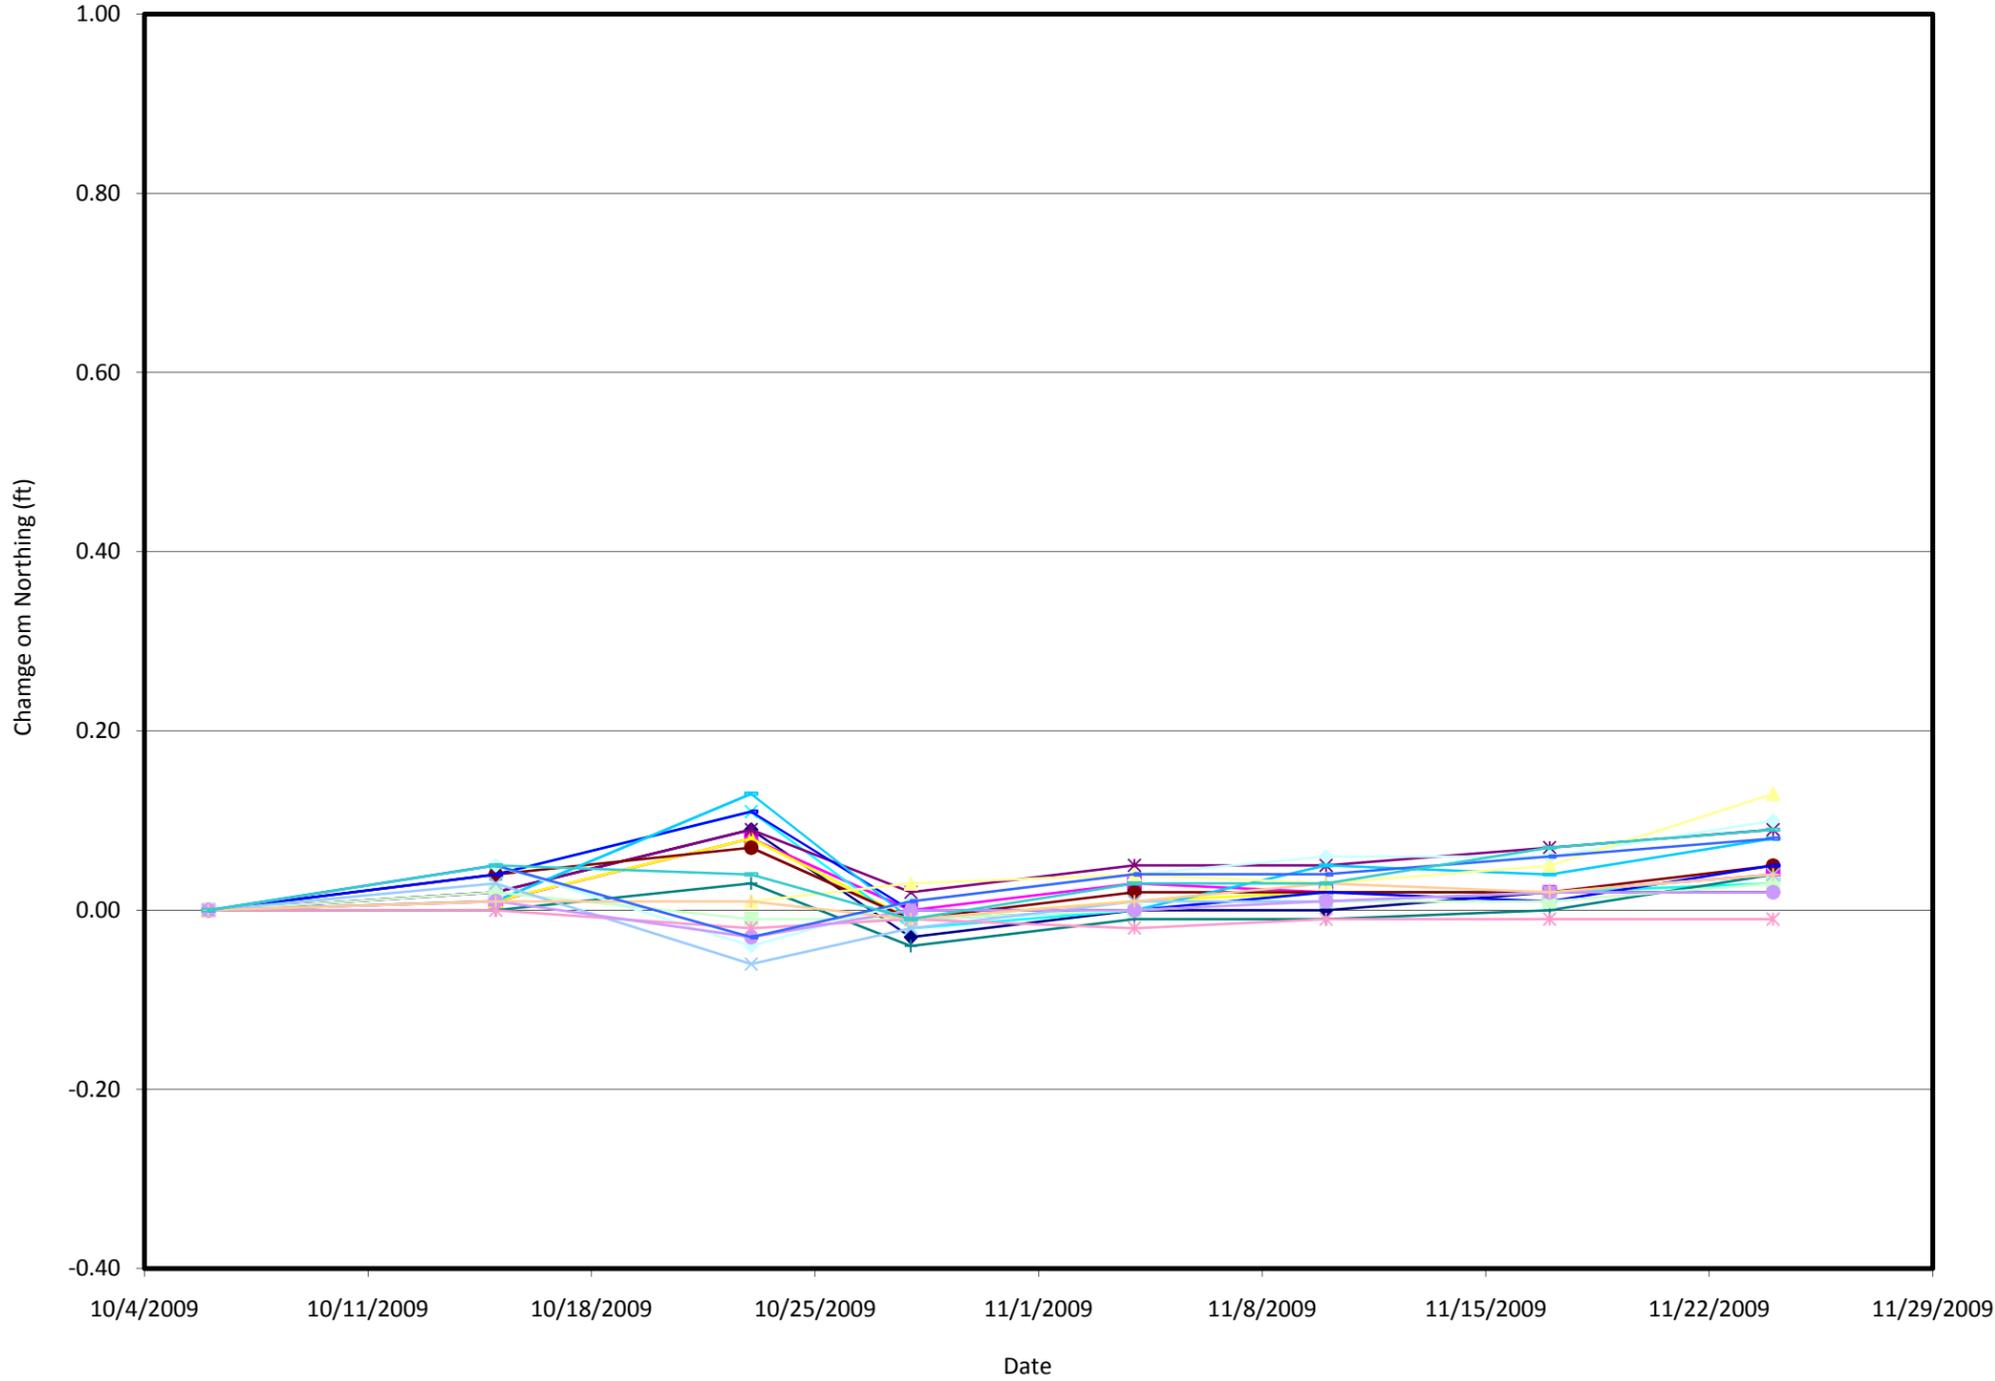
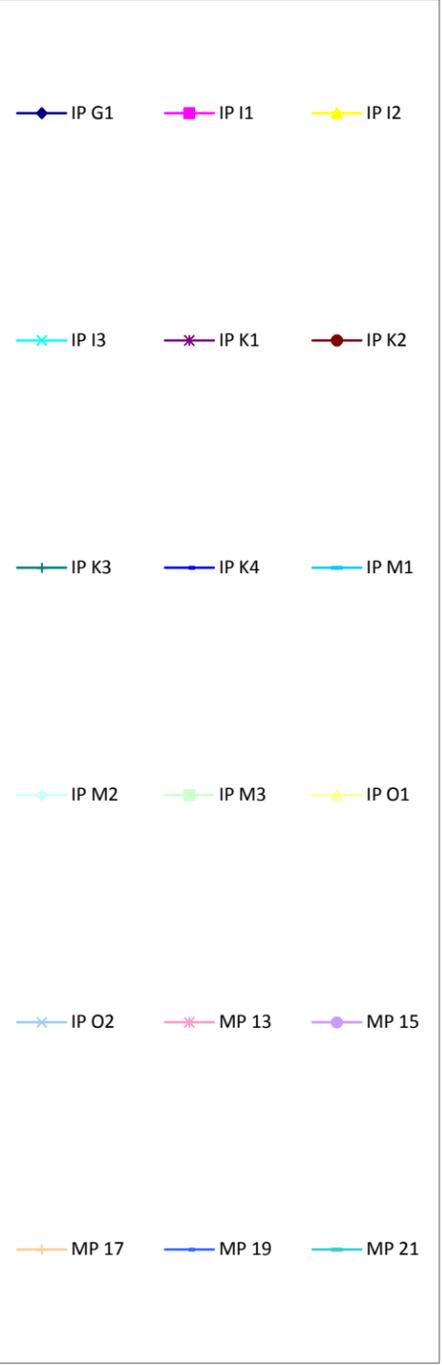
Graph 17 - North Slope Pin Movement
Northing Change

1. Data compiled by PJ Carey Associates, PC.
2. Survey provided by DEI beginning on October 5, 2009.

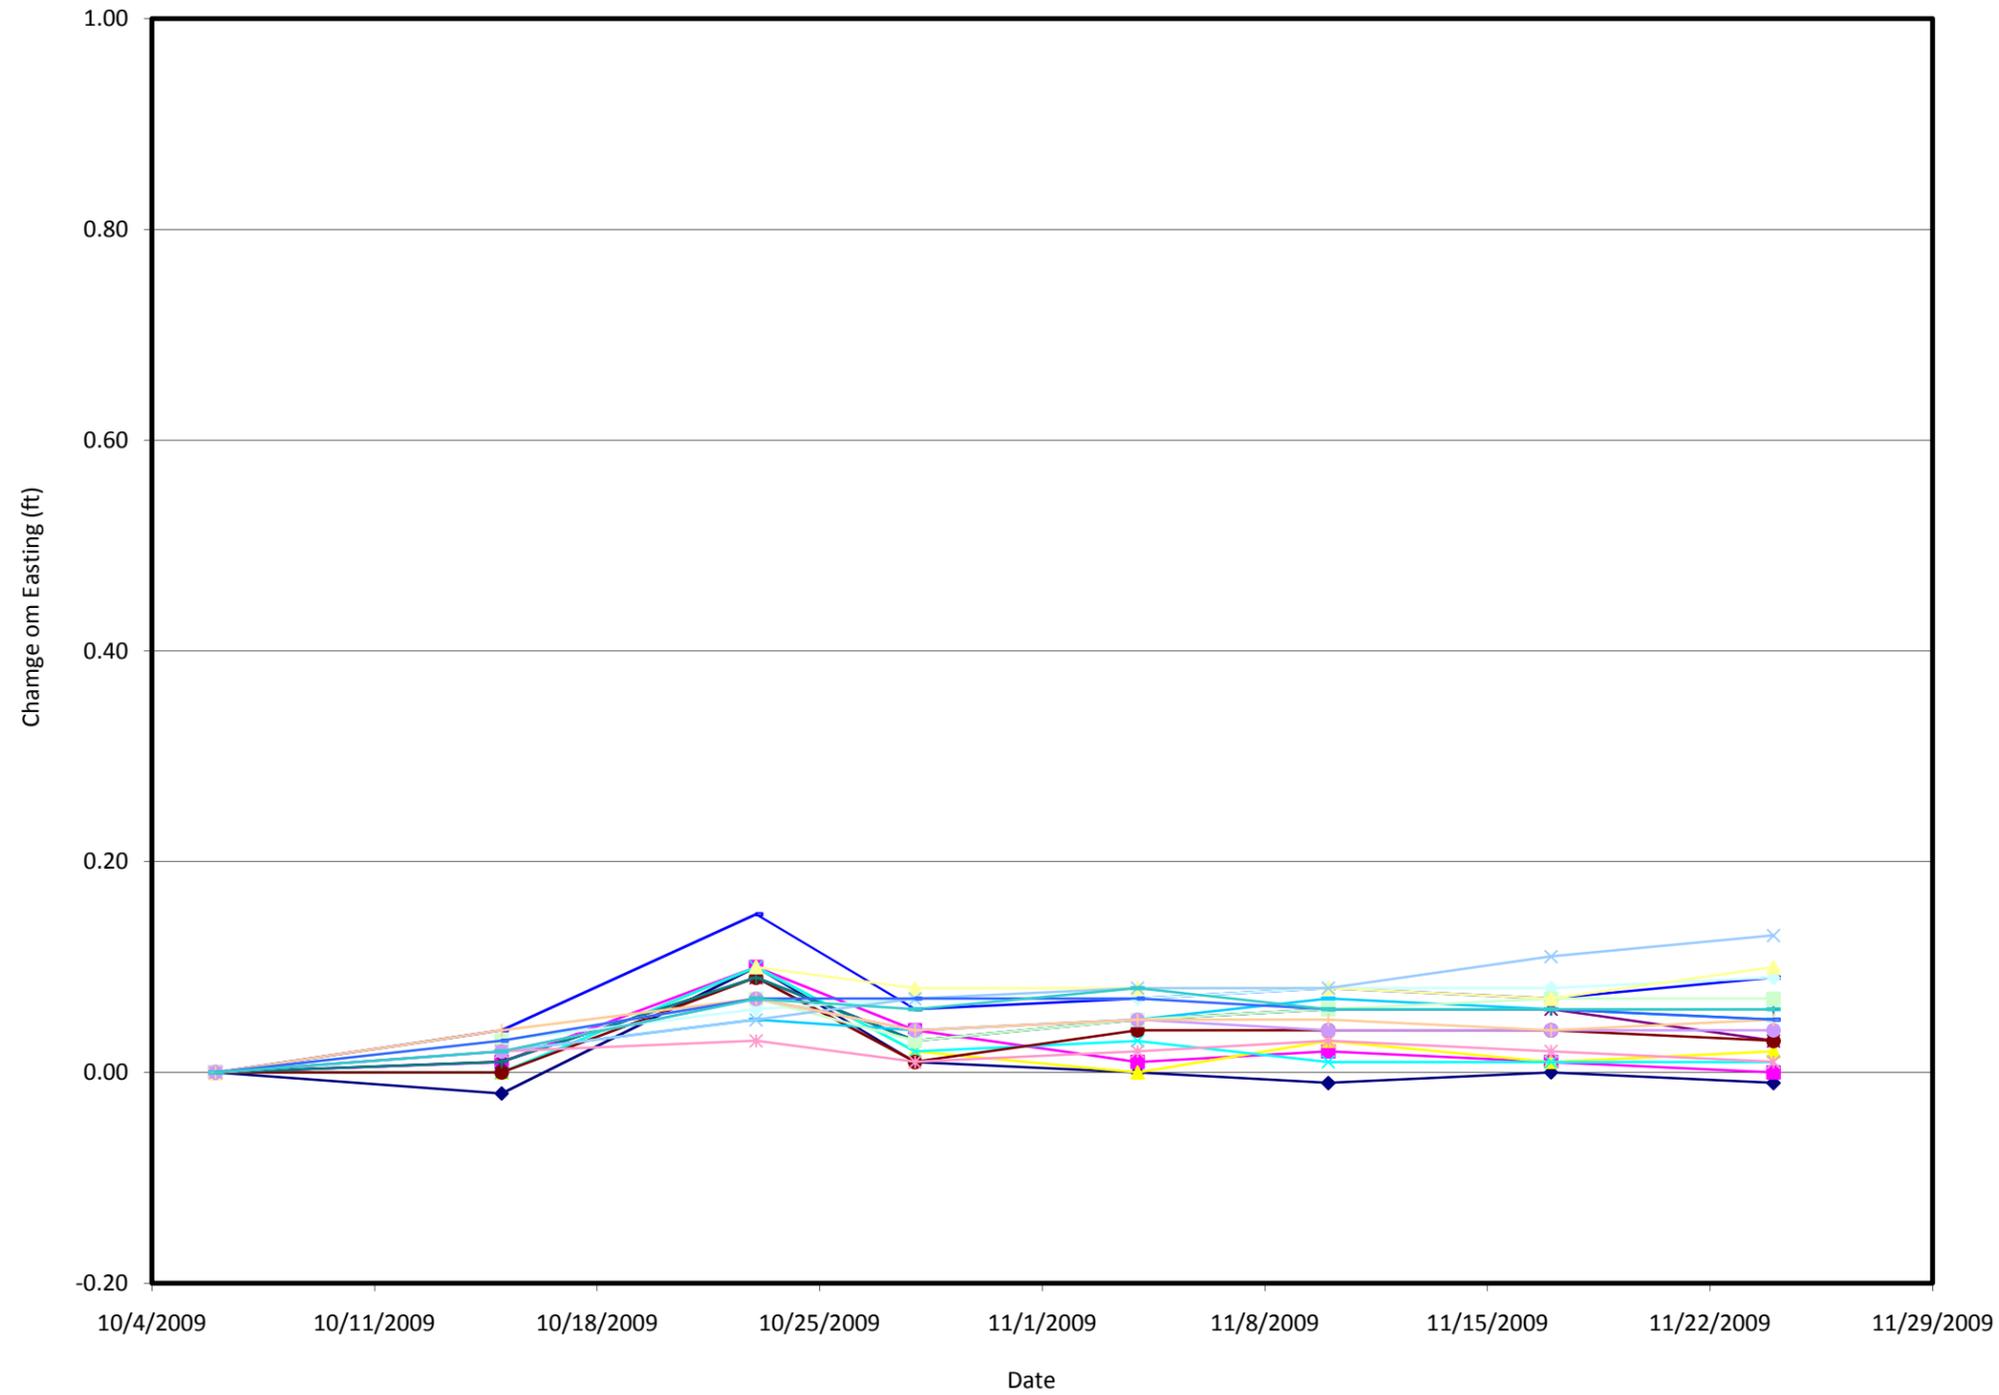
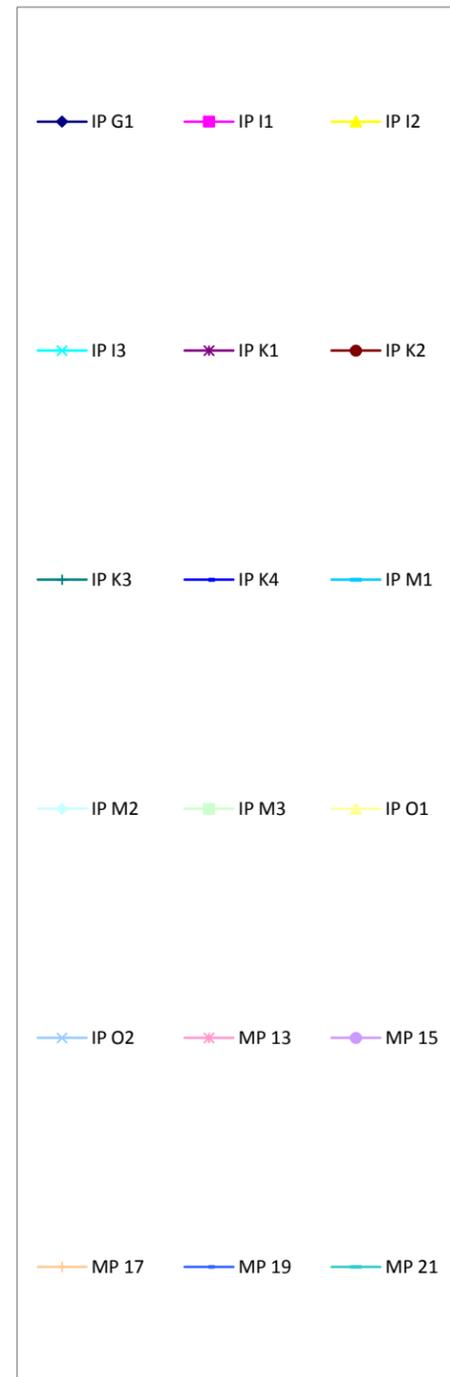
Graph 18 - North Slope Pin Movement Easting Change

1. Data compiled by PJ Carey Associates, PC.
 2. Survey provided by DEI beginning on October 5, 2009.

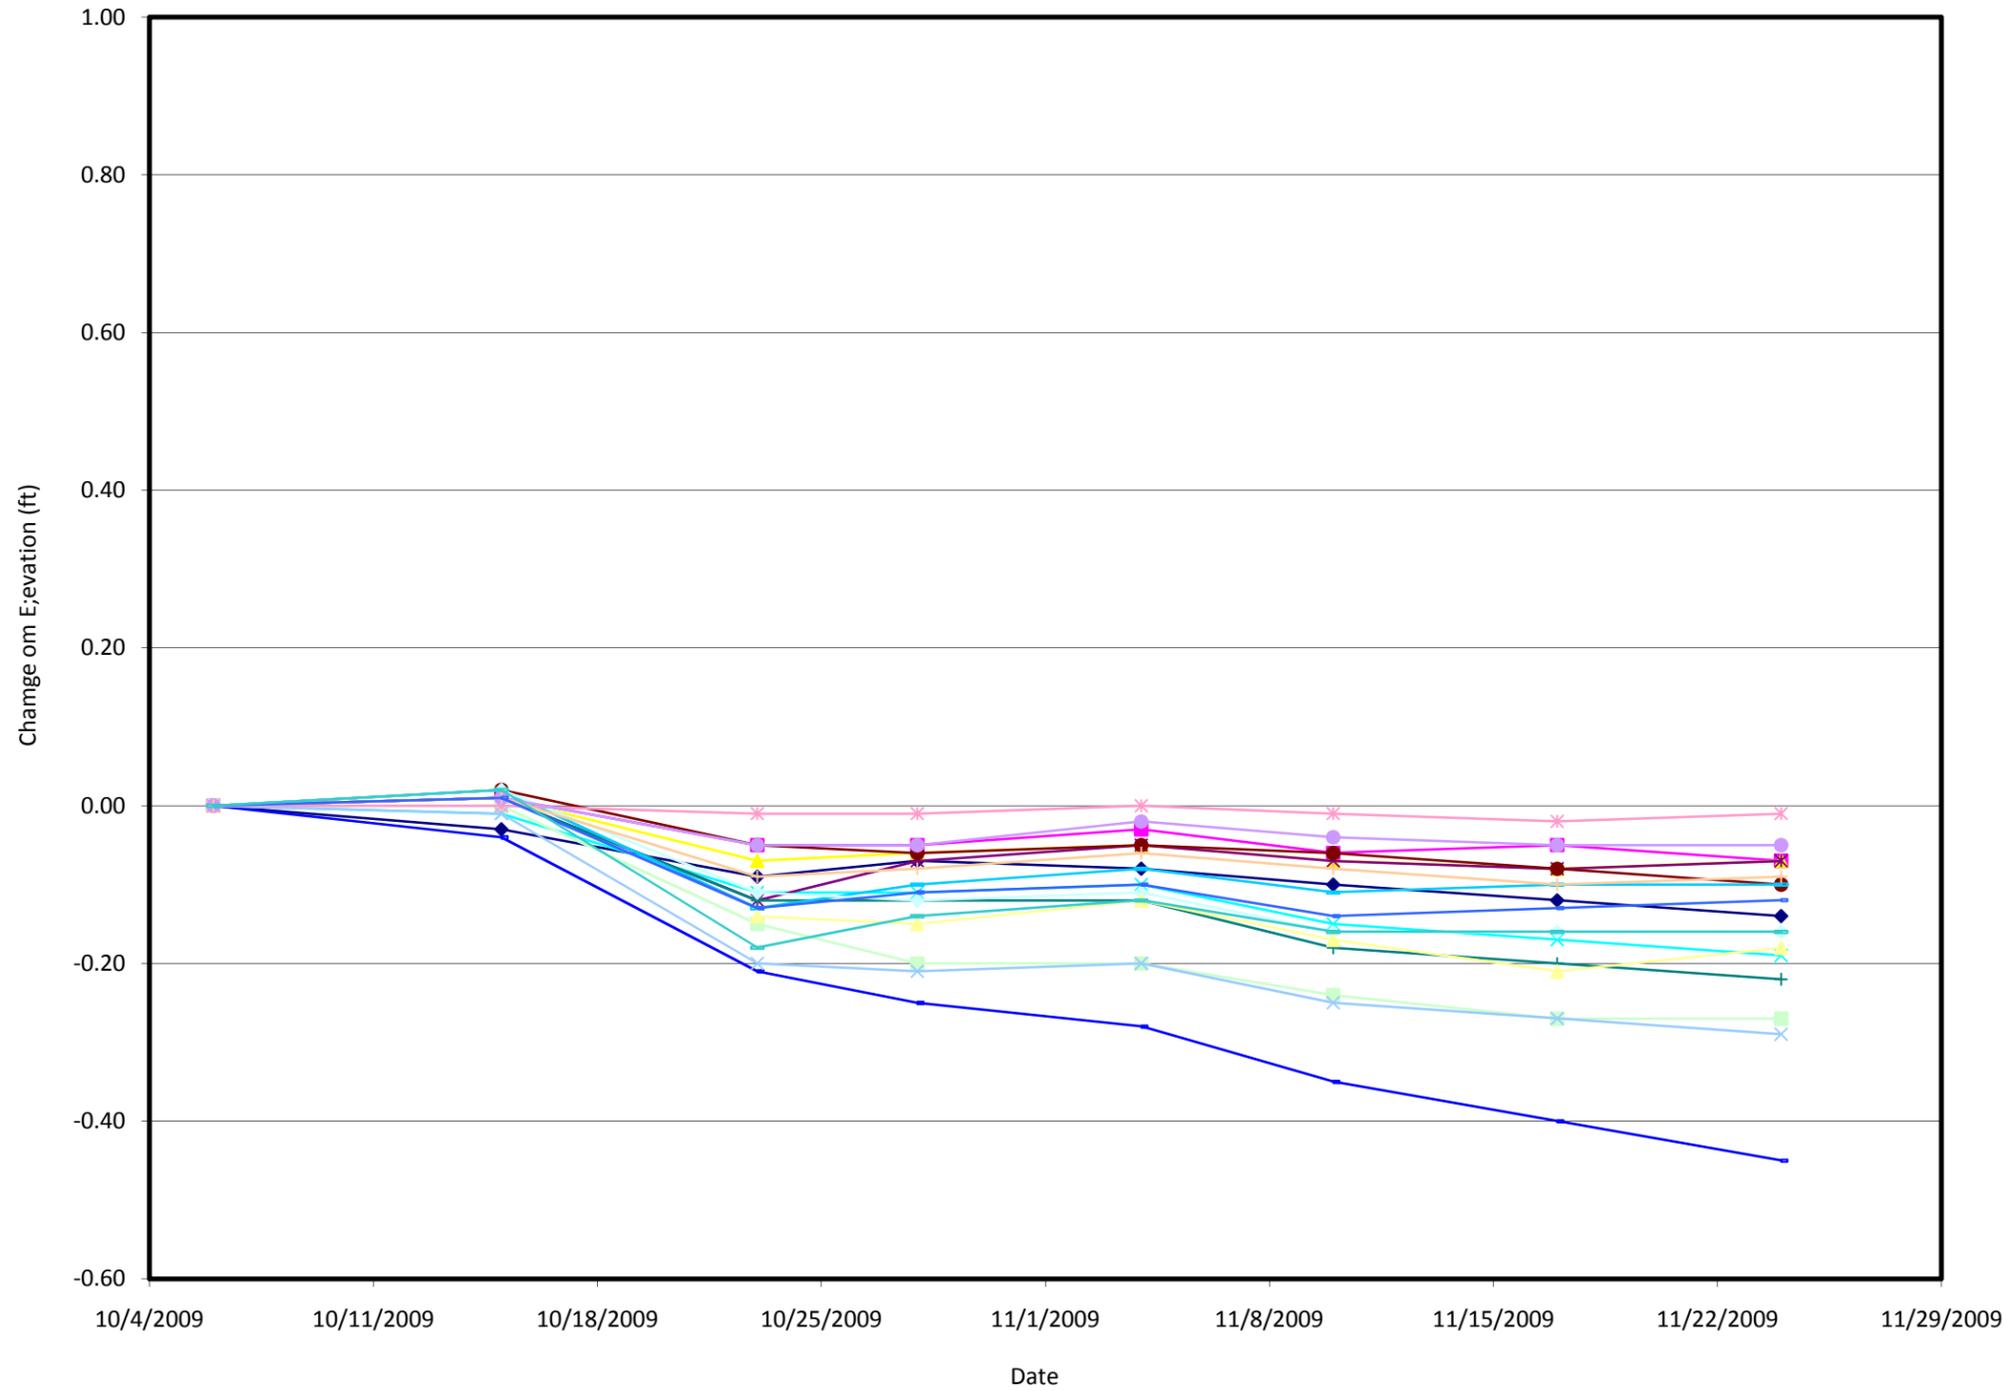
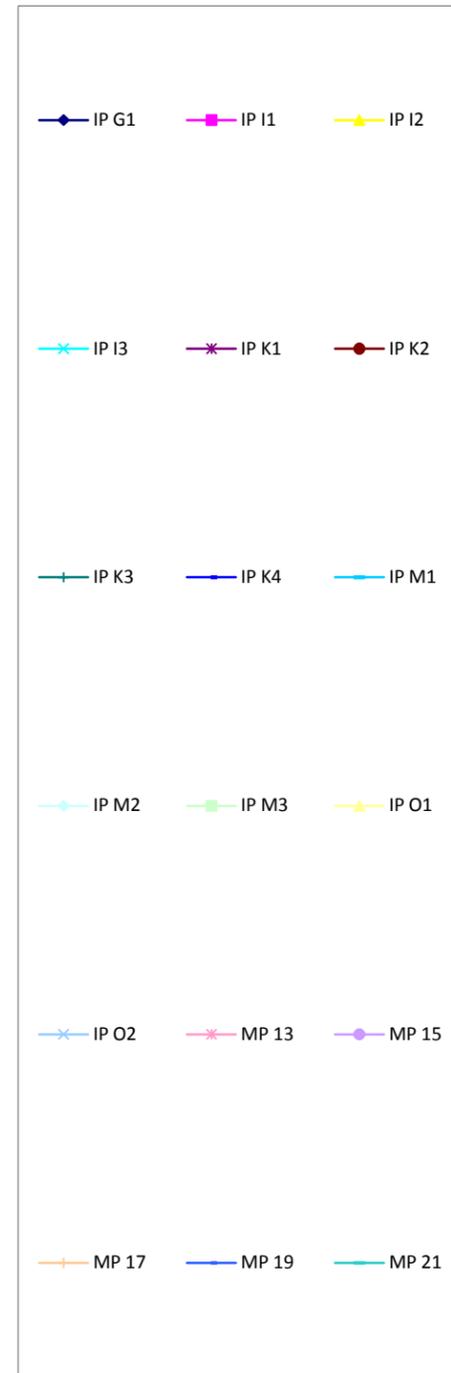
Graph 19 - North Slope Pin Movement Elevation Change

1. Data compiled by PJ Carey Associates, PC.
 2. Survey provided by DEI beginning on October 5, 2009.

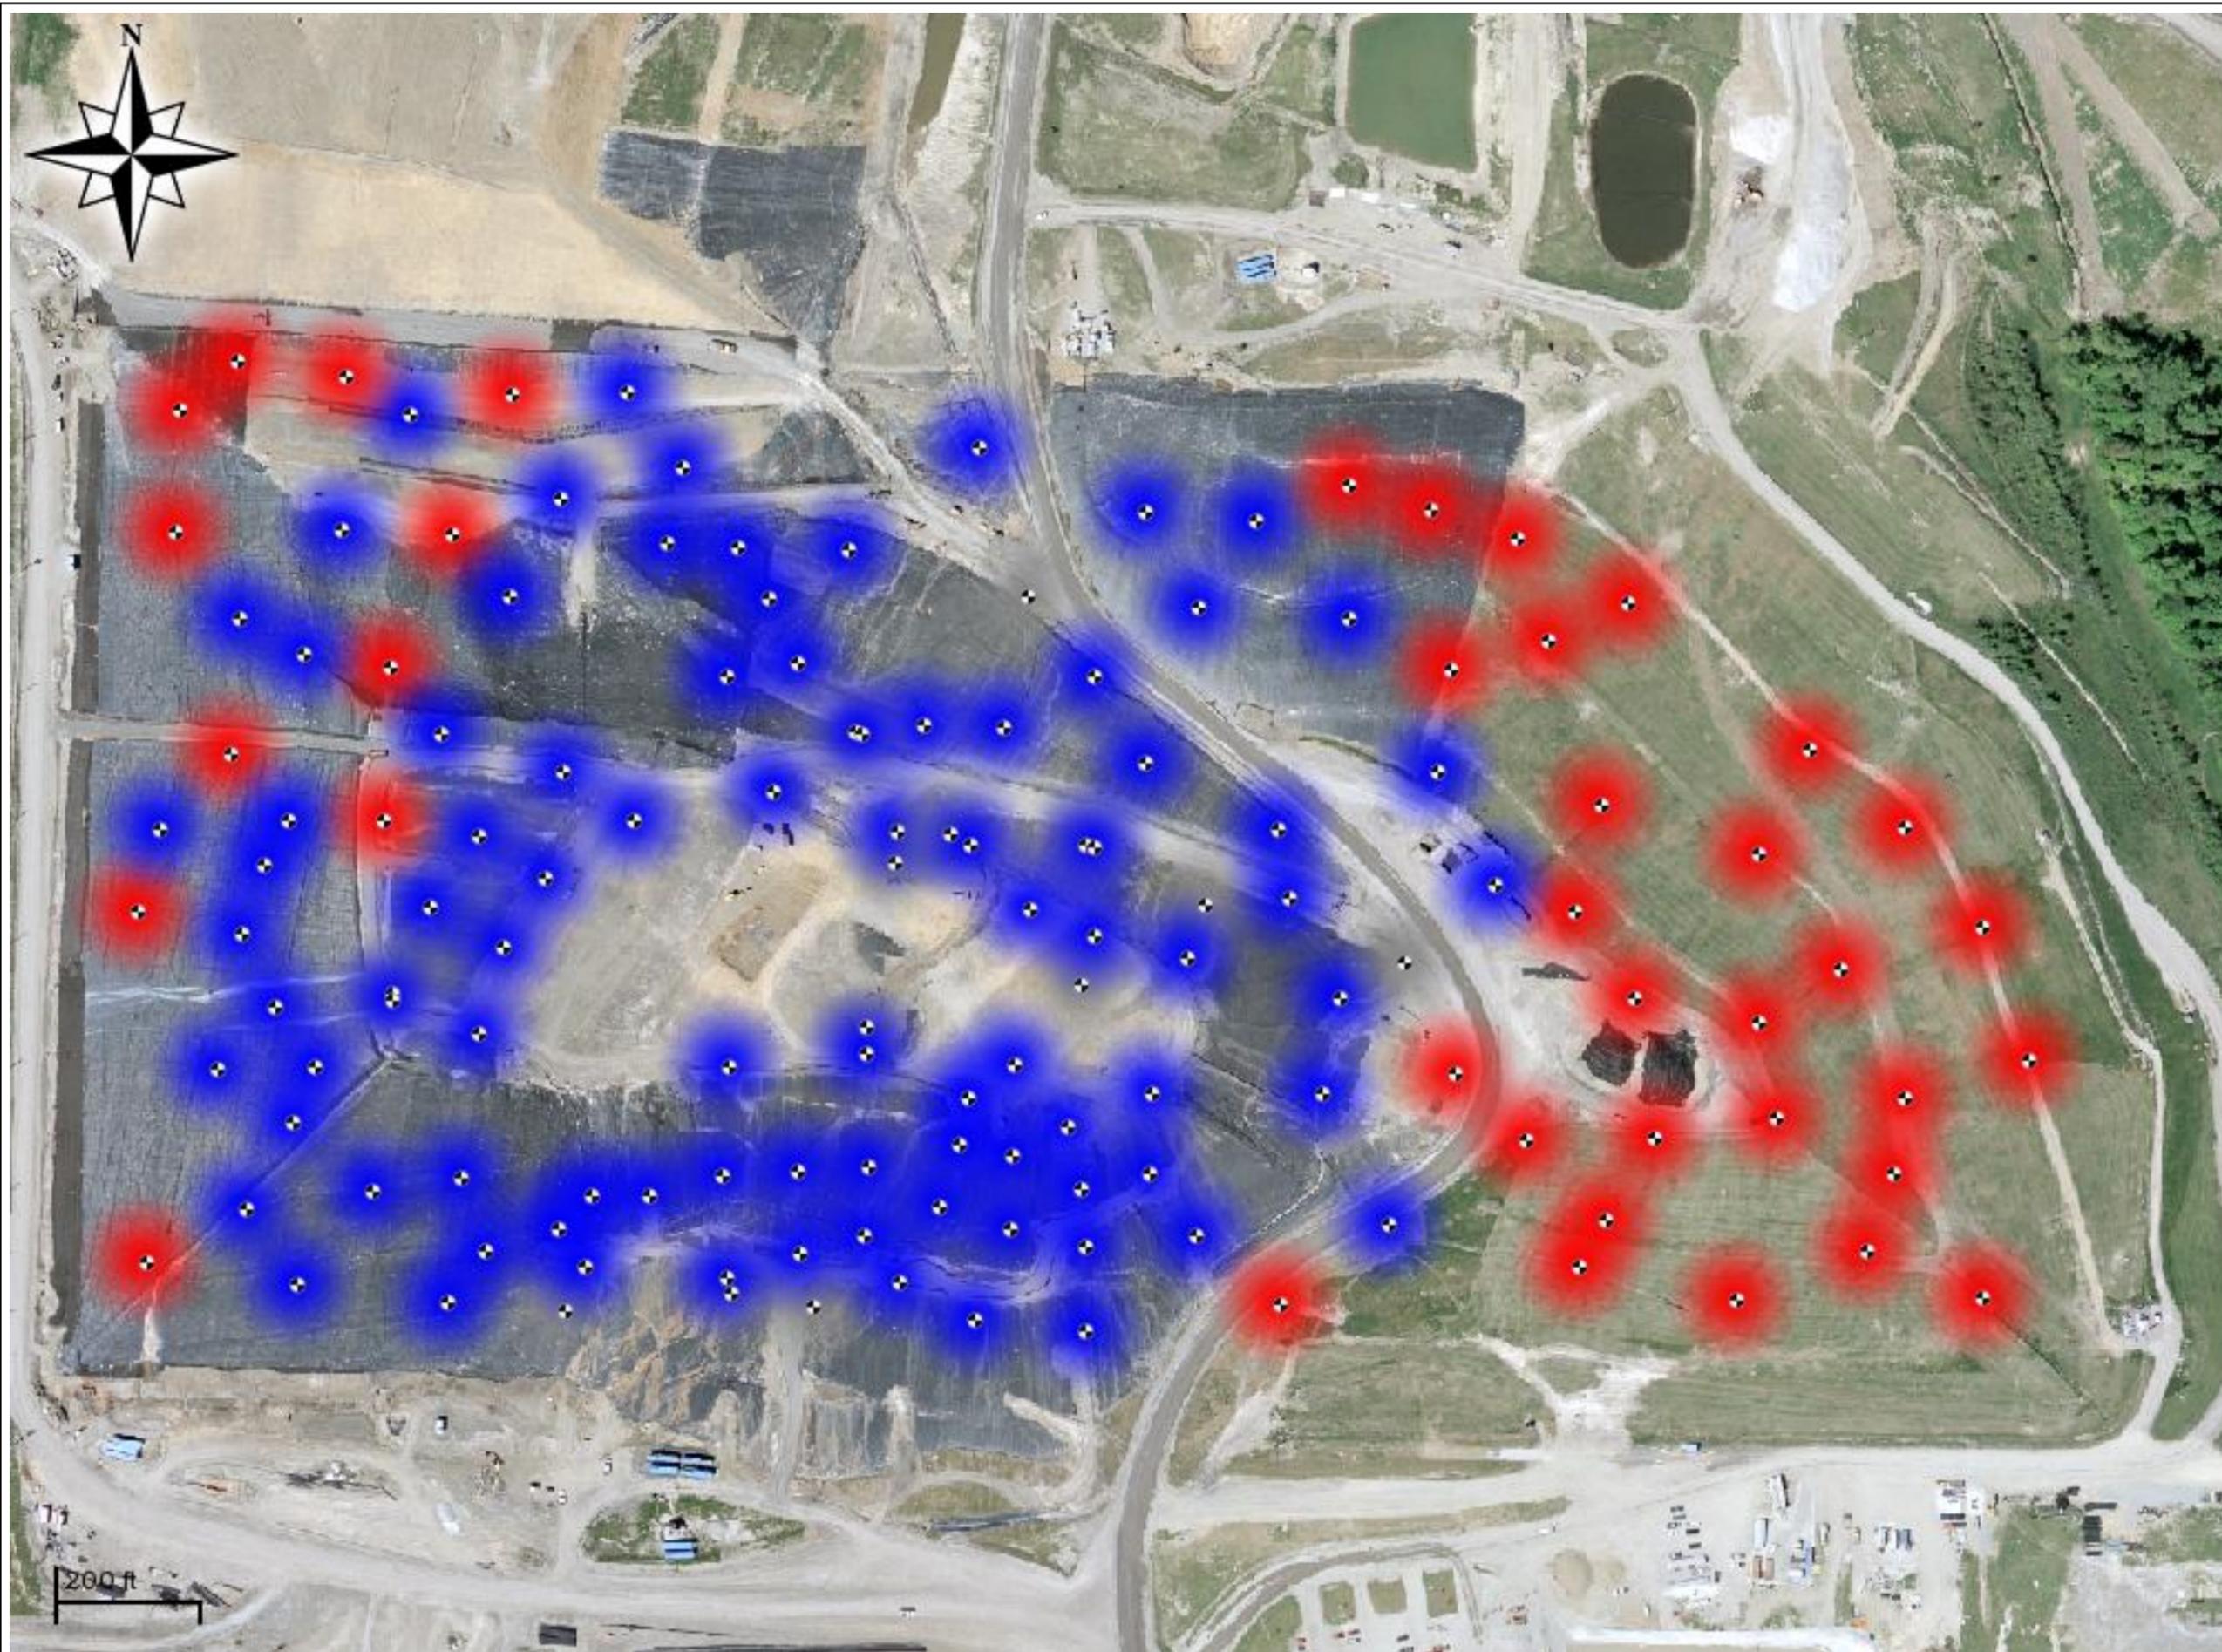
Figure 1
Average Methane to Carbon Dioxide Ratio
 Countywide Recycling and Disposal Facility
 3619 Gracemont St. S.W.
 East Sparta, Ohio

A radius influence of 100 feet is assumed at each device.
