Countywide Recycling & Disposal Facility, Remediation Unit

**Monthly Progress Report
Of
Operations, Monitoring & Maintenance Activities**

NOVEMBER 2009

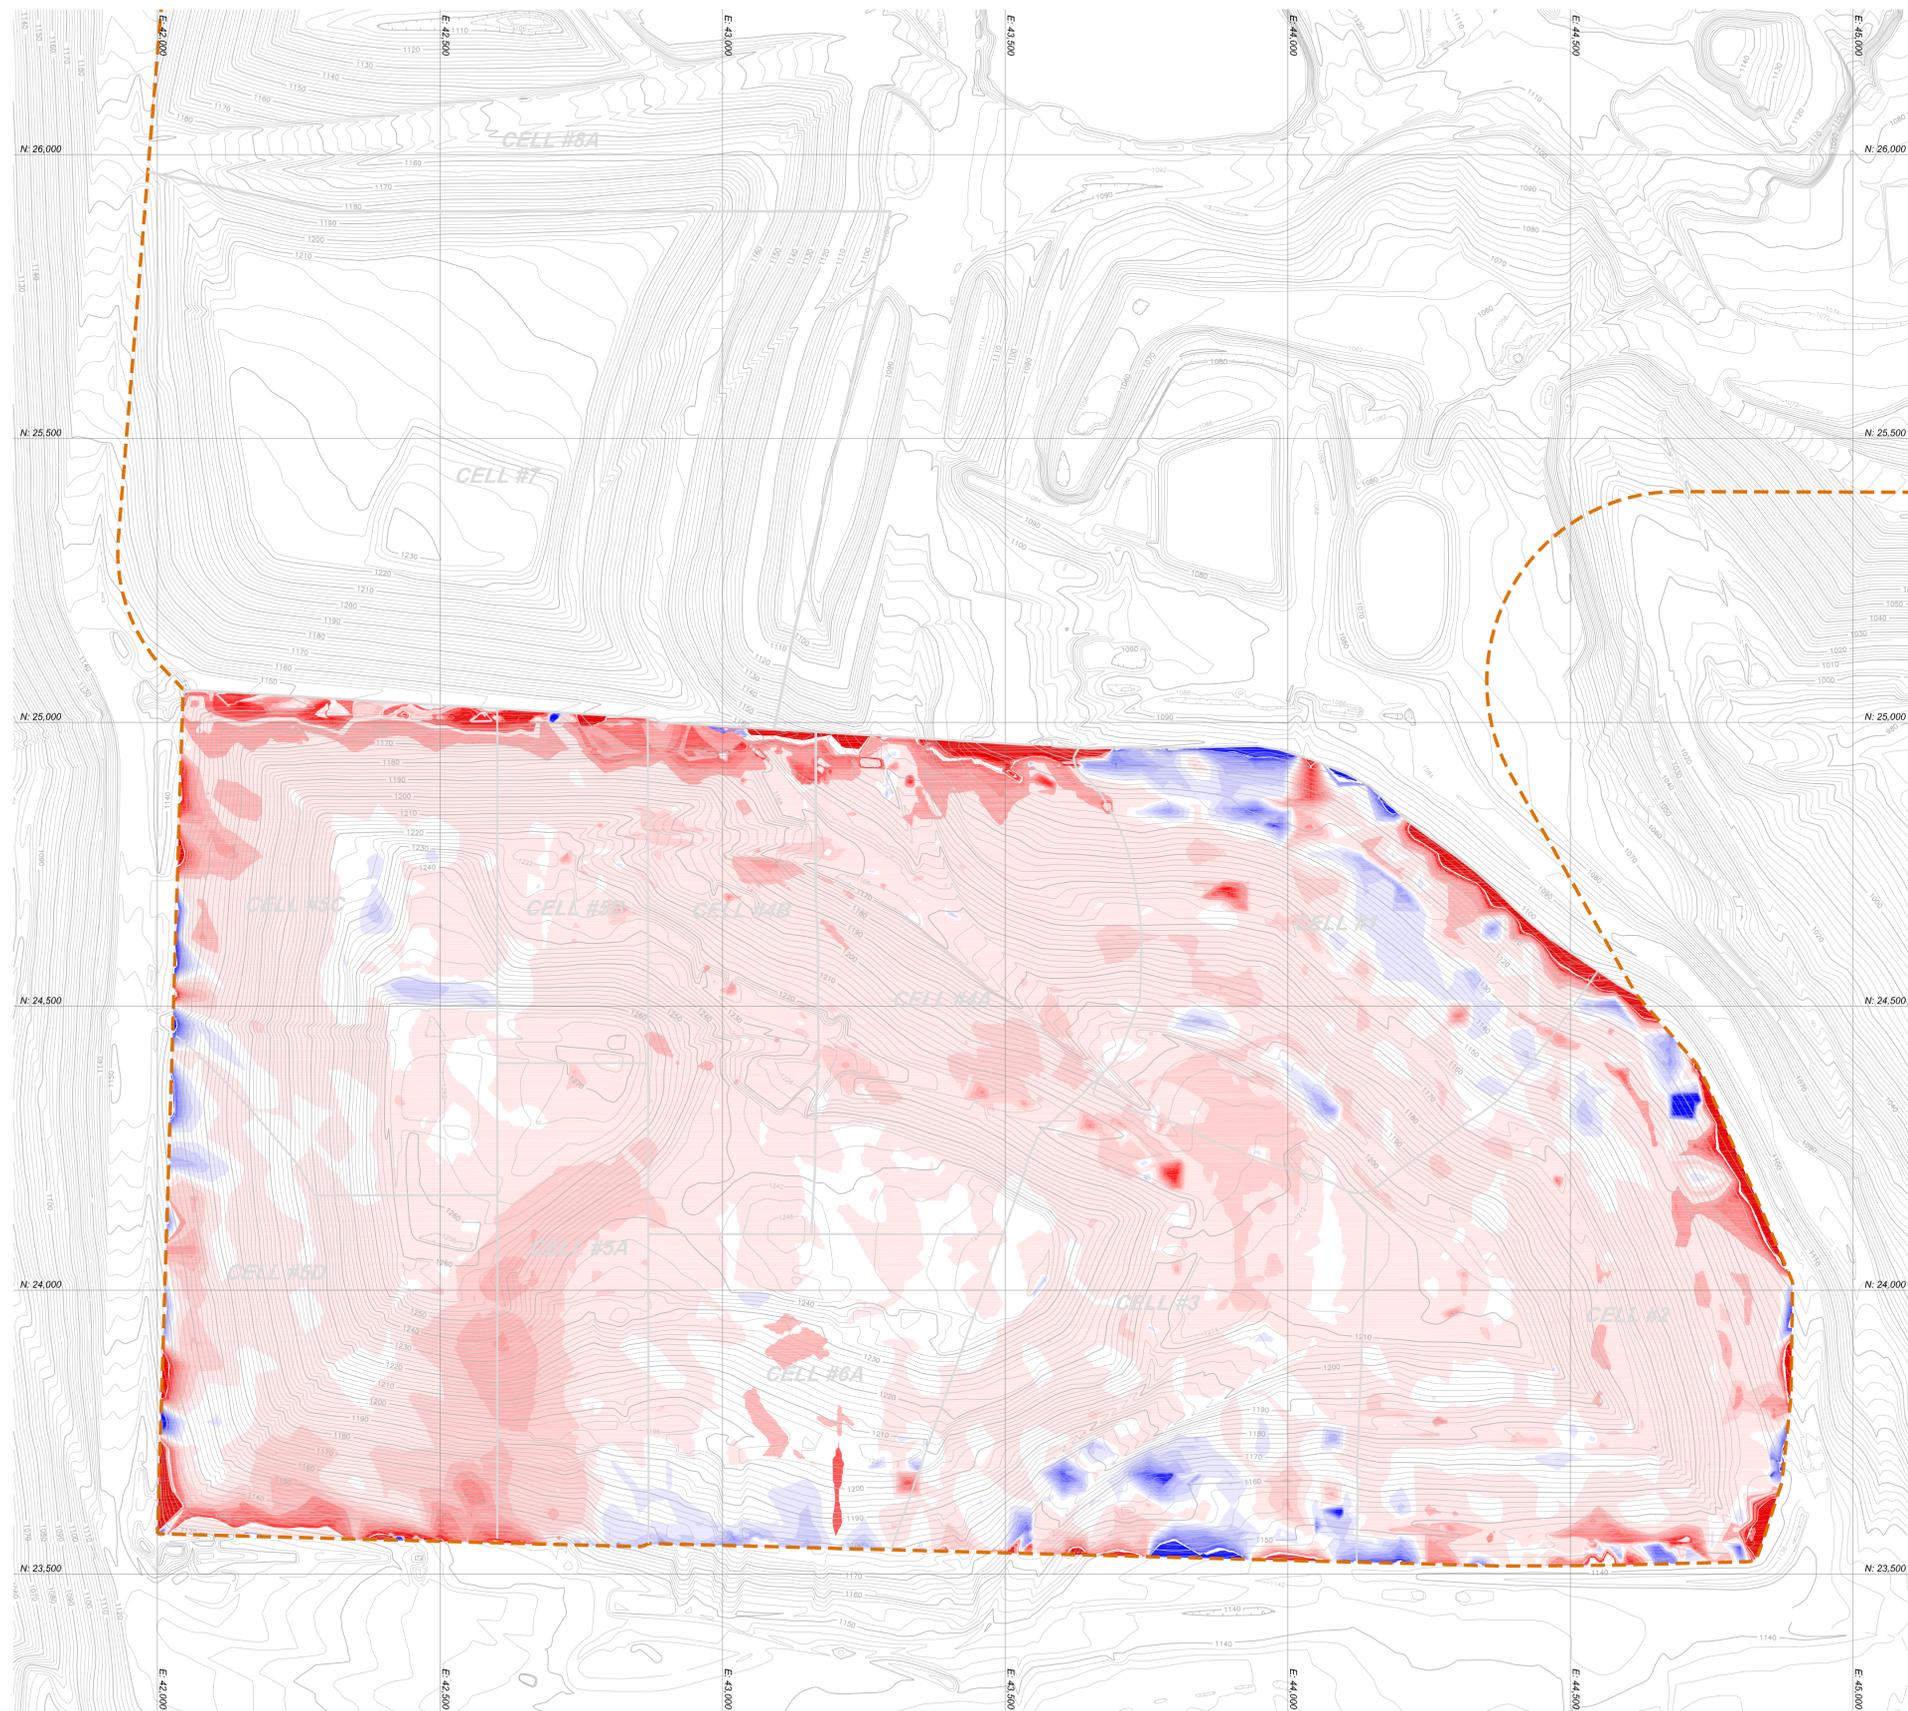
COUNTYWIDE RDF		PROJECT: 88 Ac. REMEDIATION UNIT	
SCALE: 1" = 150', CTR=2'	REVISIONS	SHEET TITLE: INCREMENTAL SETTLEMENT MAP (NOVEMBER 2009)	
SURVEYED:		FILE ID: Settlement Survey 11-09	FIGURE 2
DRAWN: BWS 12/09/09		<p>Diversified Engineering Inc. COUNTYWIDE ENGINEERS & SURVEYORS 225 FAR AVENUE, N.E. NEW PHILADELPHIA, OH 44663 Phone: (330) 364-3031 Fax: (330) 364-4633 Email: cwrdf@eng.com</p>	
CHECKED: CCV 12/09/09			
REVISED DATE:

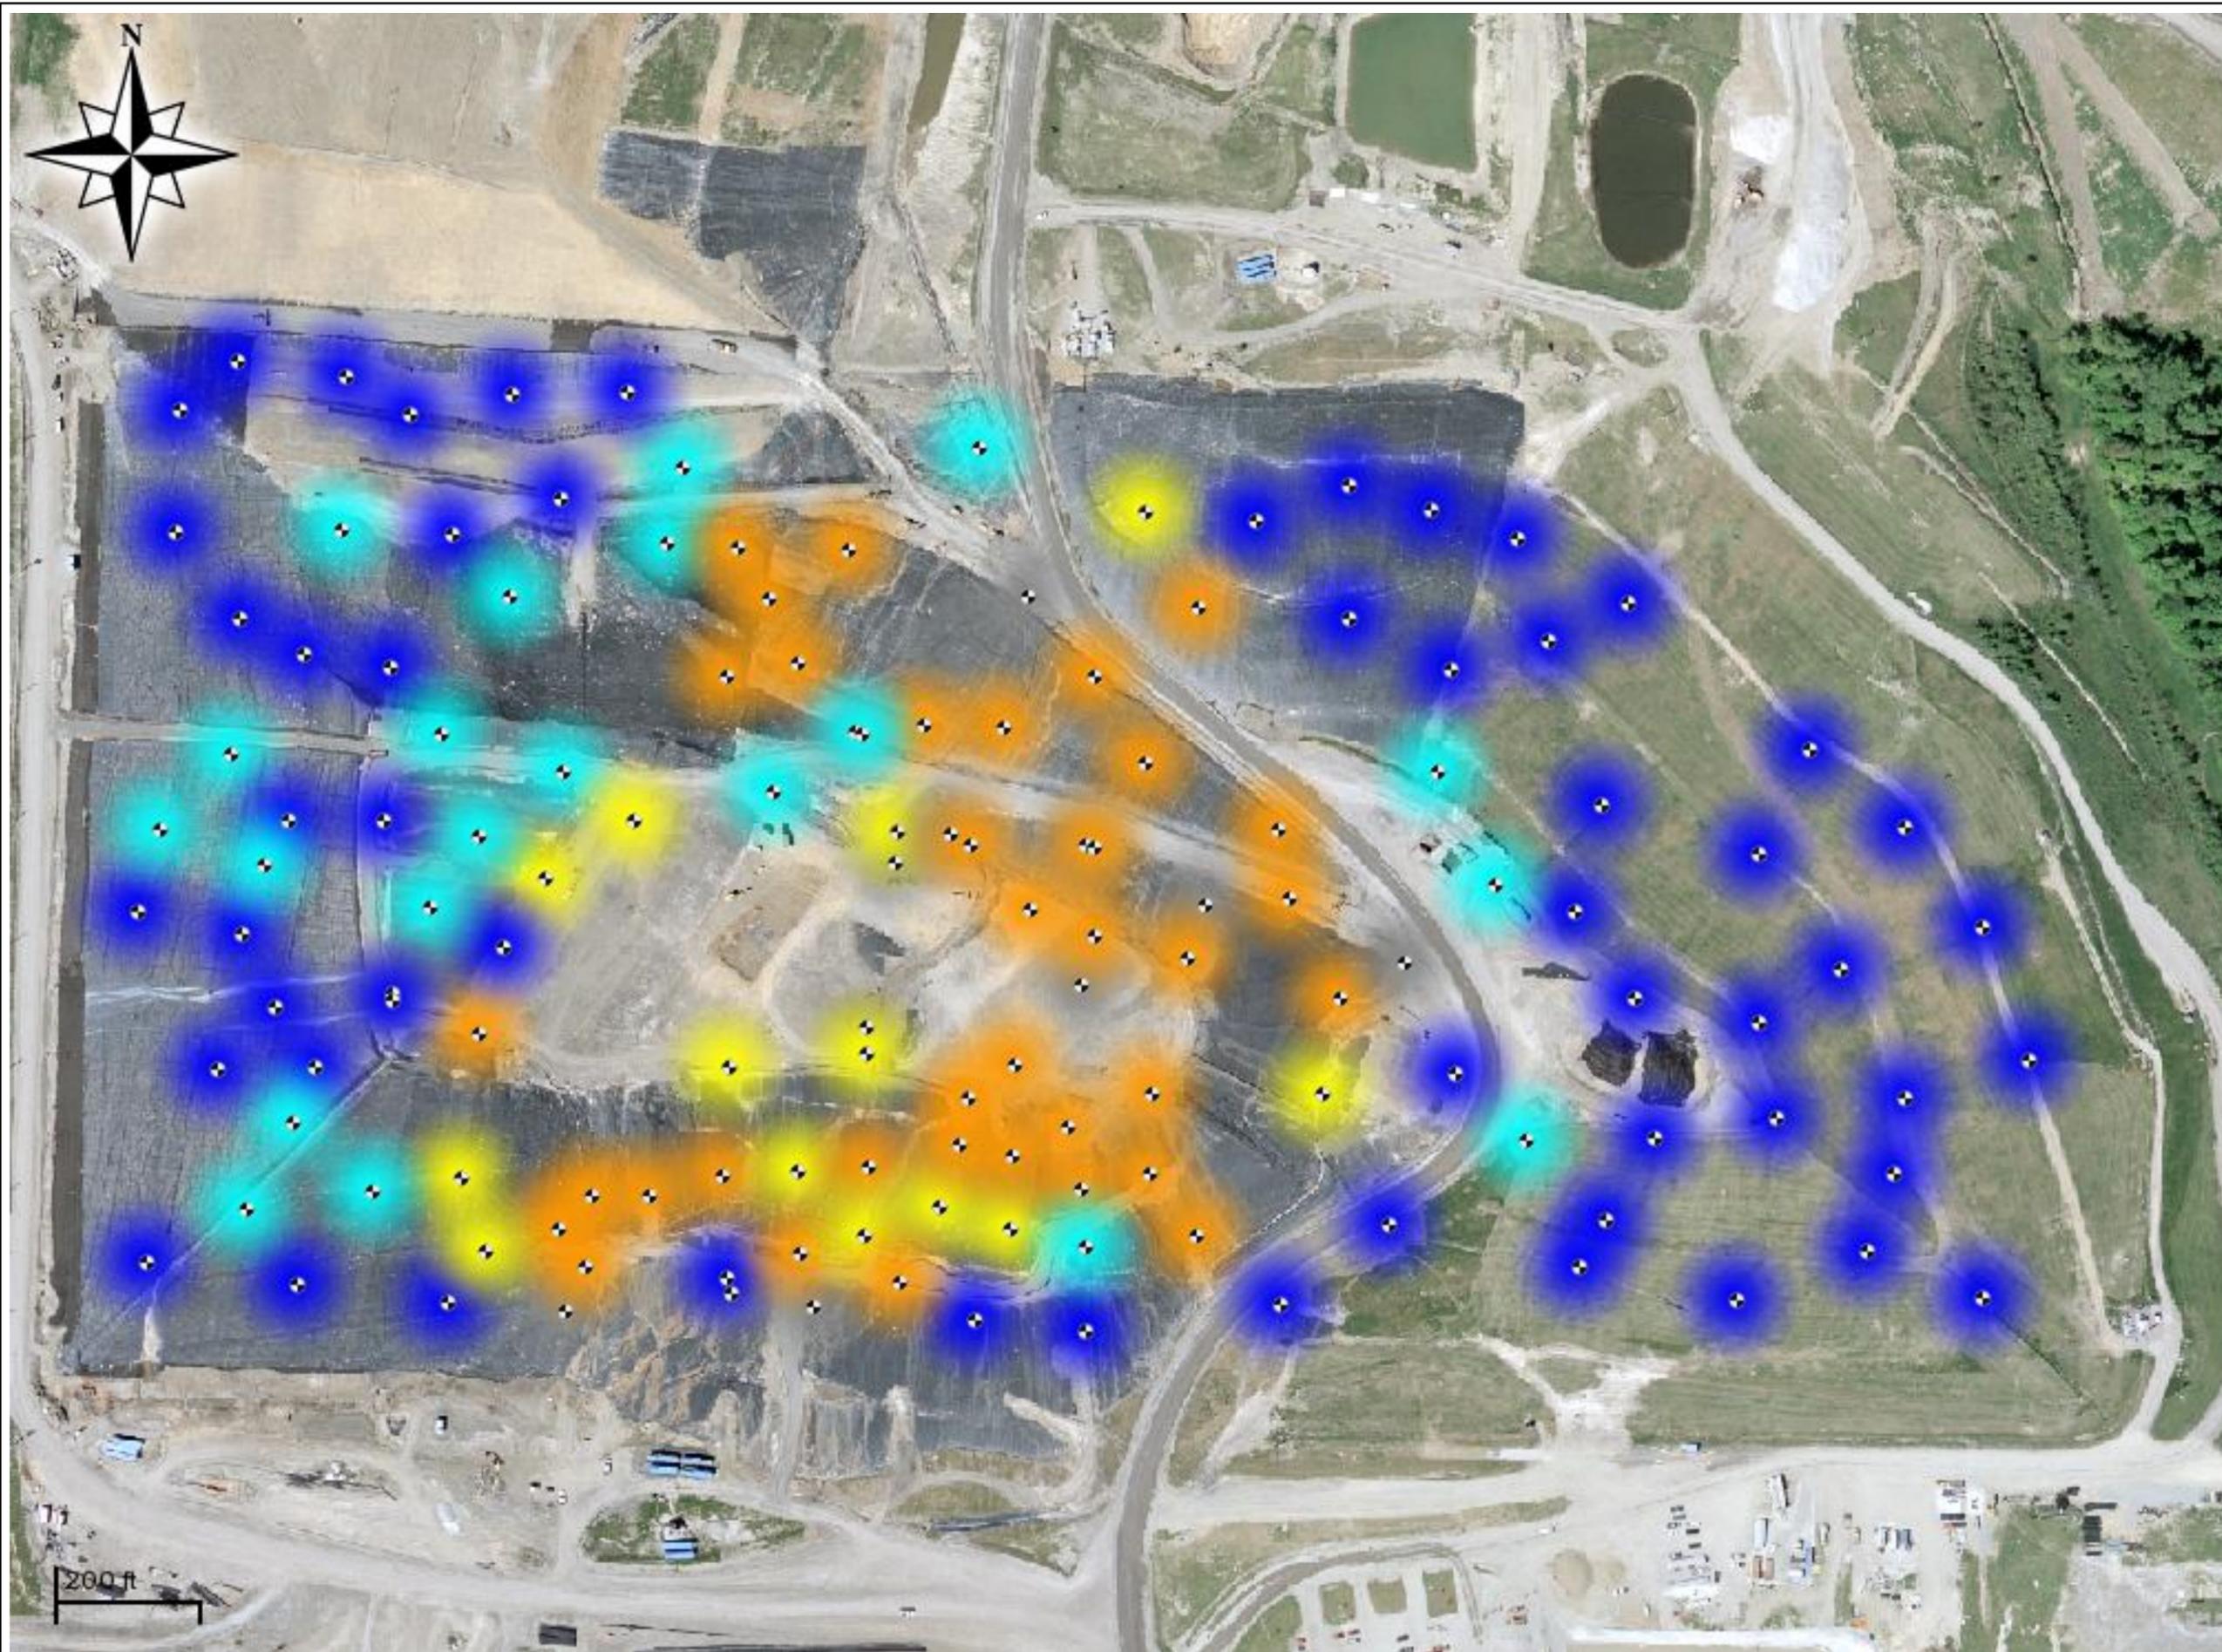
Figure 3
Average Wellhead
Temperature
 Countywide Recycling
 and Disposal Facility
 3619 Gracemont St. S.W.
 East Sparta, Ohio

A radius influence of 100 feet
 is assumed at each device.

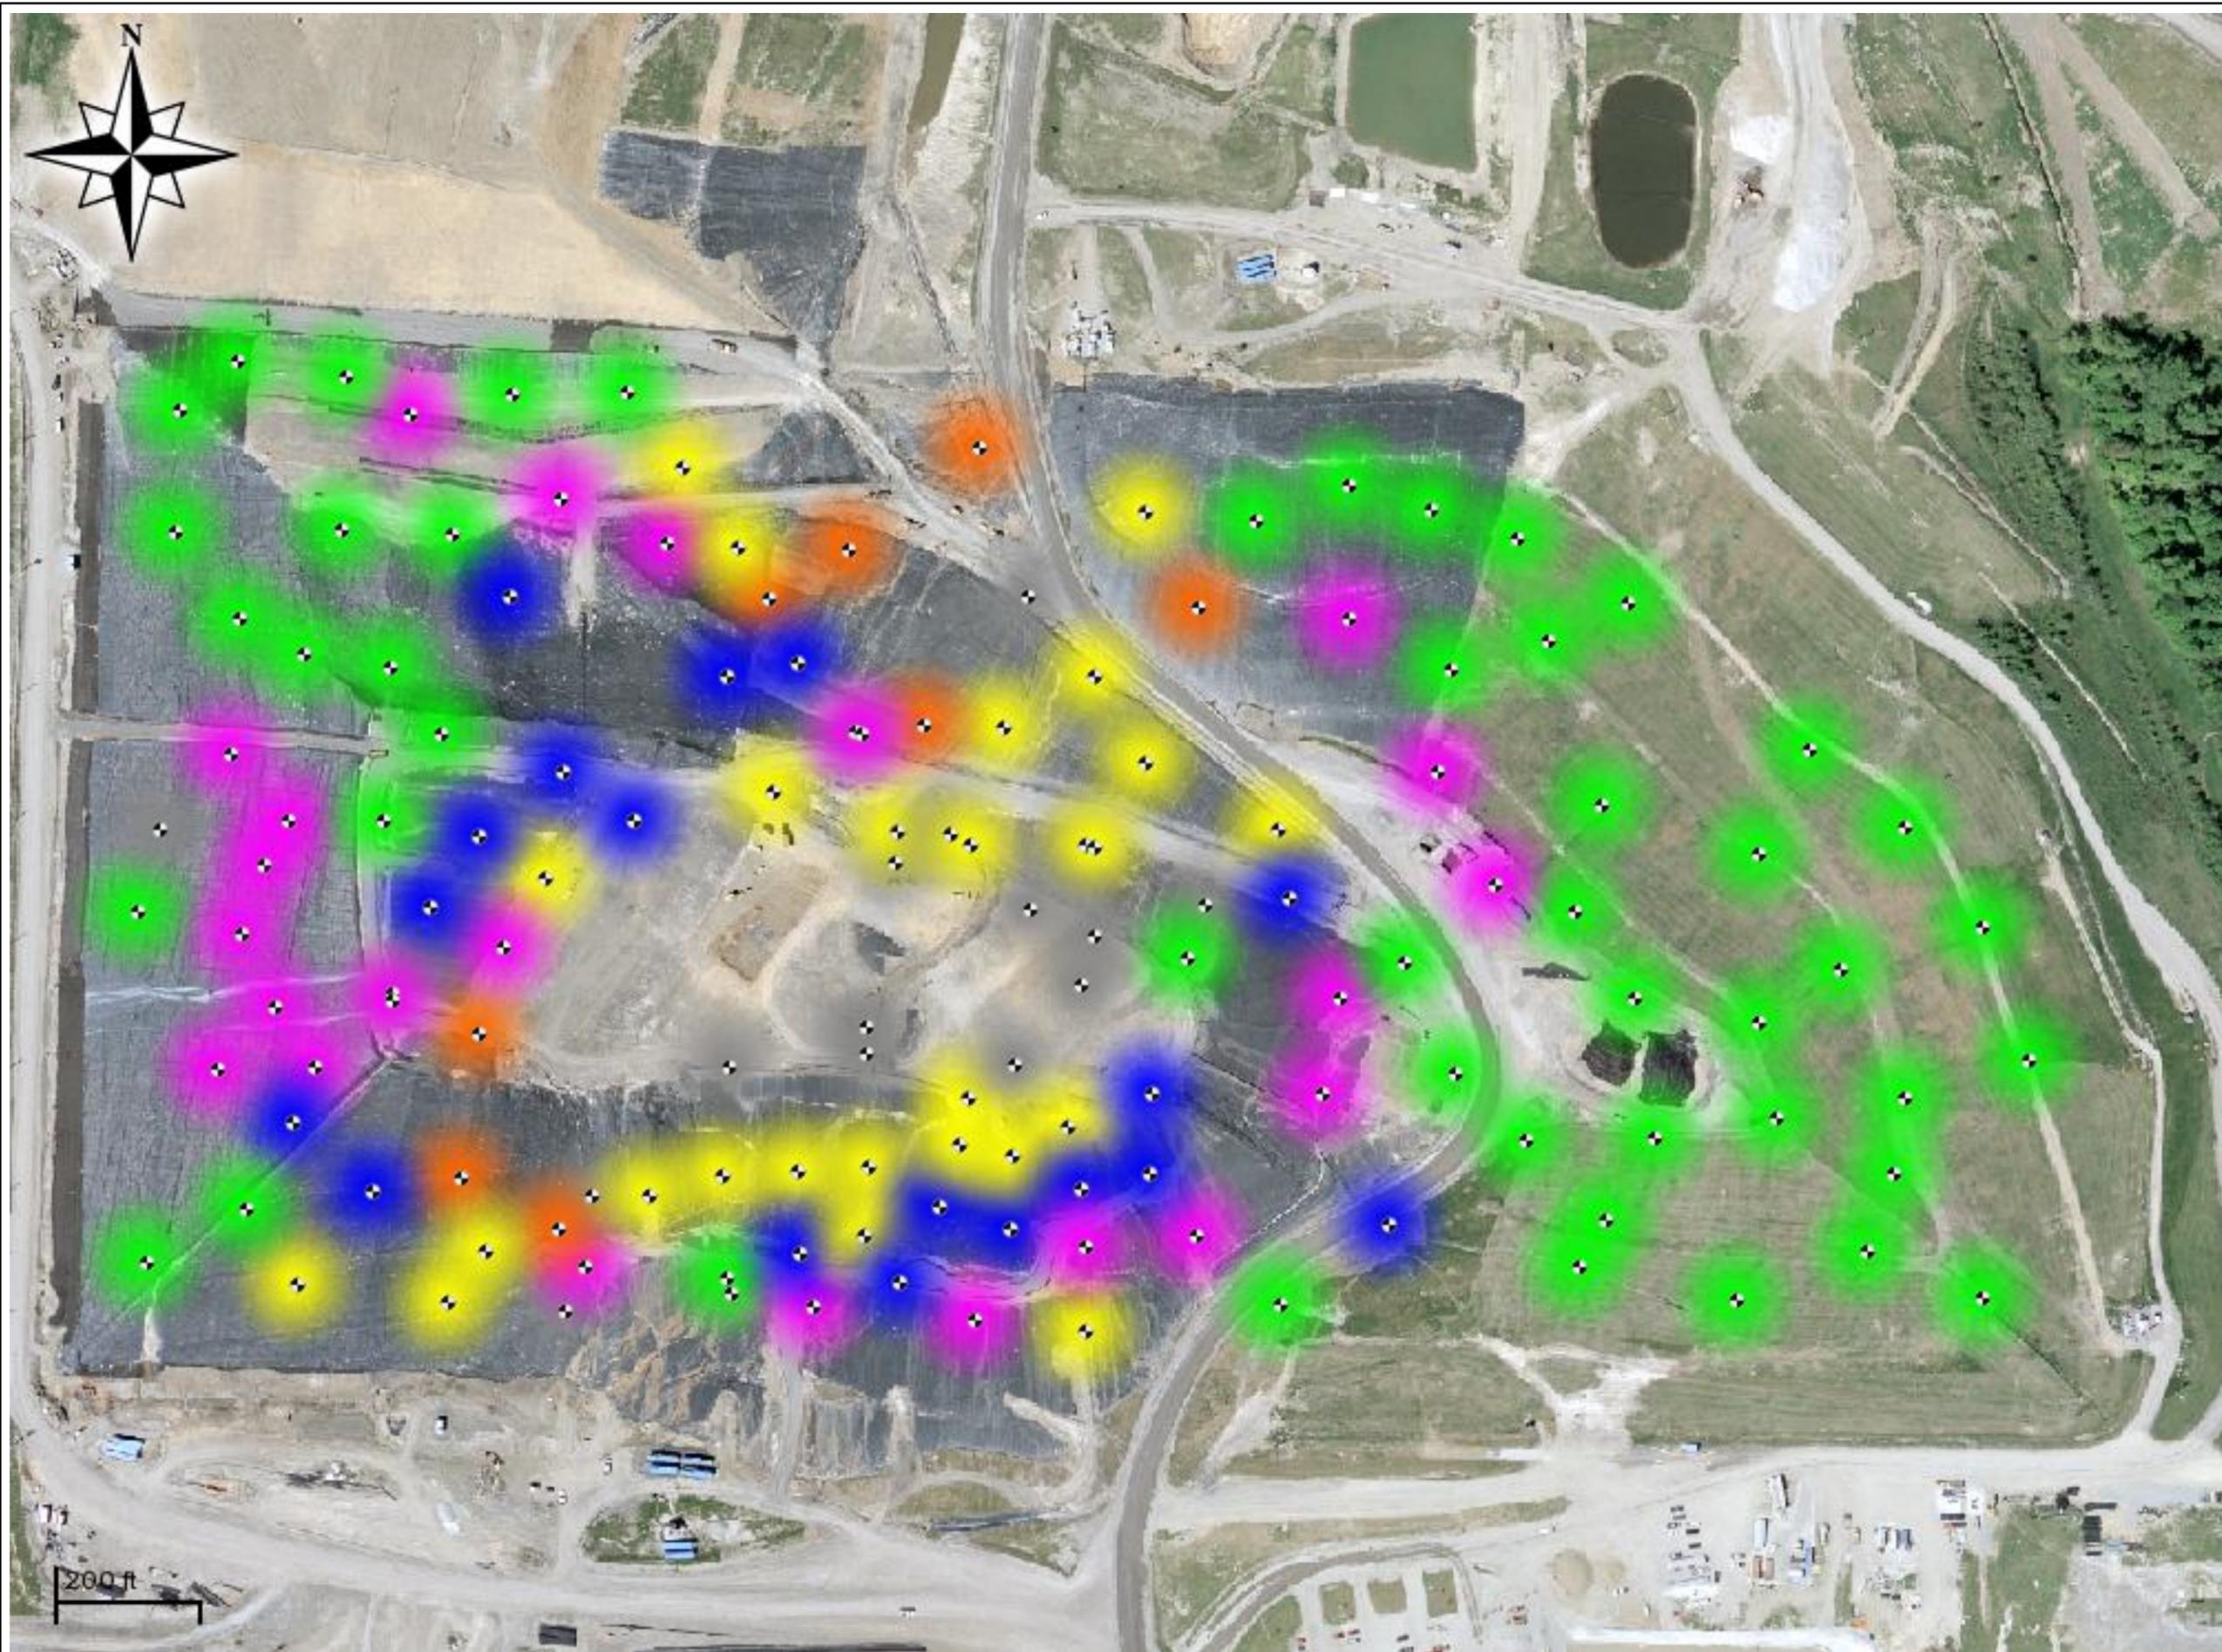
**Figure 4
Carbon Monoxide
Distribution**

A radius influence of 100 feet
is assumed at each device.

After review of the November 2009 data, it should be noted that between the October and November sampling events, the data reflects a greater than 25% increase carbon monoxide levels at both Flares 7 and 10, as well as the north header sampling branches designated as HBN01 and HBN02. There was a decrease reflected in carbon monoxide observed at the south header branch samples designated as HBS01 and HBS02. This data is presented below:

Carbon Monoxide Levels (ppm)		
Sample Location	October	November
F-10 BIN	82.5	252.8
F-7 BIN	66.5	237.1
HBN01	250.1	587.2
HBN02	61.01	247.3
HBS01	179.2	123.3
HBS02	412.3	353.7

After a review of the data and the activities conducted in October and November, Republic believes that the increase is directly related to major changes in the gas collection system that occurred between these two months. Following the October sampling event, the final tie-in of the gas system expansion was conducted. This involved the completion of the "loop" on the south side of cell 3, and the installation of a condensate removal sump in that area. This work resulted in major changes in the flow and vacuum dynamics, including reversal of flow on the eastern half of the facility, enhanced removal of liquids from the header system, and elimination of a damaged header system. Additionally, this resulted in the connection of the eastern 88 acres with western 88 acres, resulting in an increase in "88 gas" to the Flare 10 via the northeast header branch. In short, Republic believes that the increase is related to an improvement in gas collection efficiency between the two events rather than an actual increase of CO in the gas. Based upon this assessment, Republic believes that more data is needed to evaluate the relevance of this apparent increase. There have been no dramatic changes to the well field that could affect flow dynamics between the November and December events, which should result in more consistent results. Republic does not believe that additional assessment is necessary at this time.

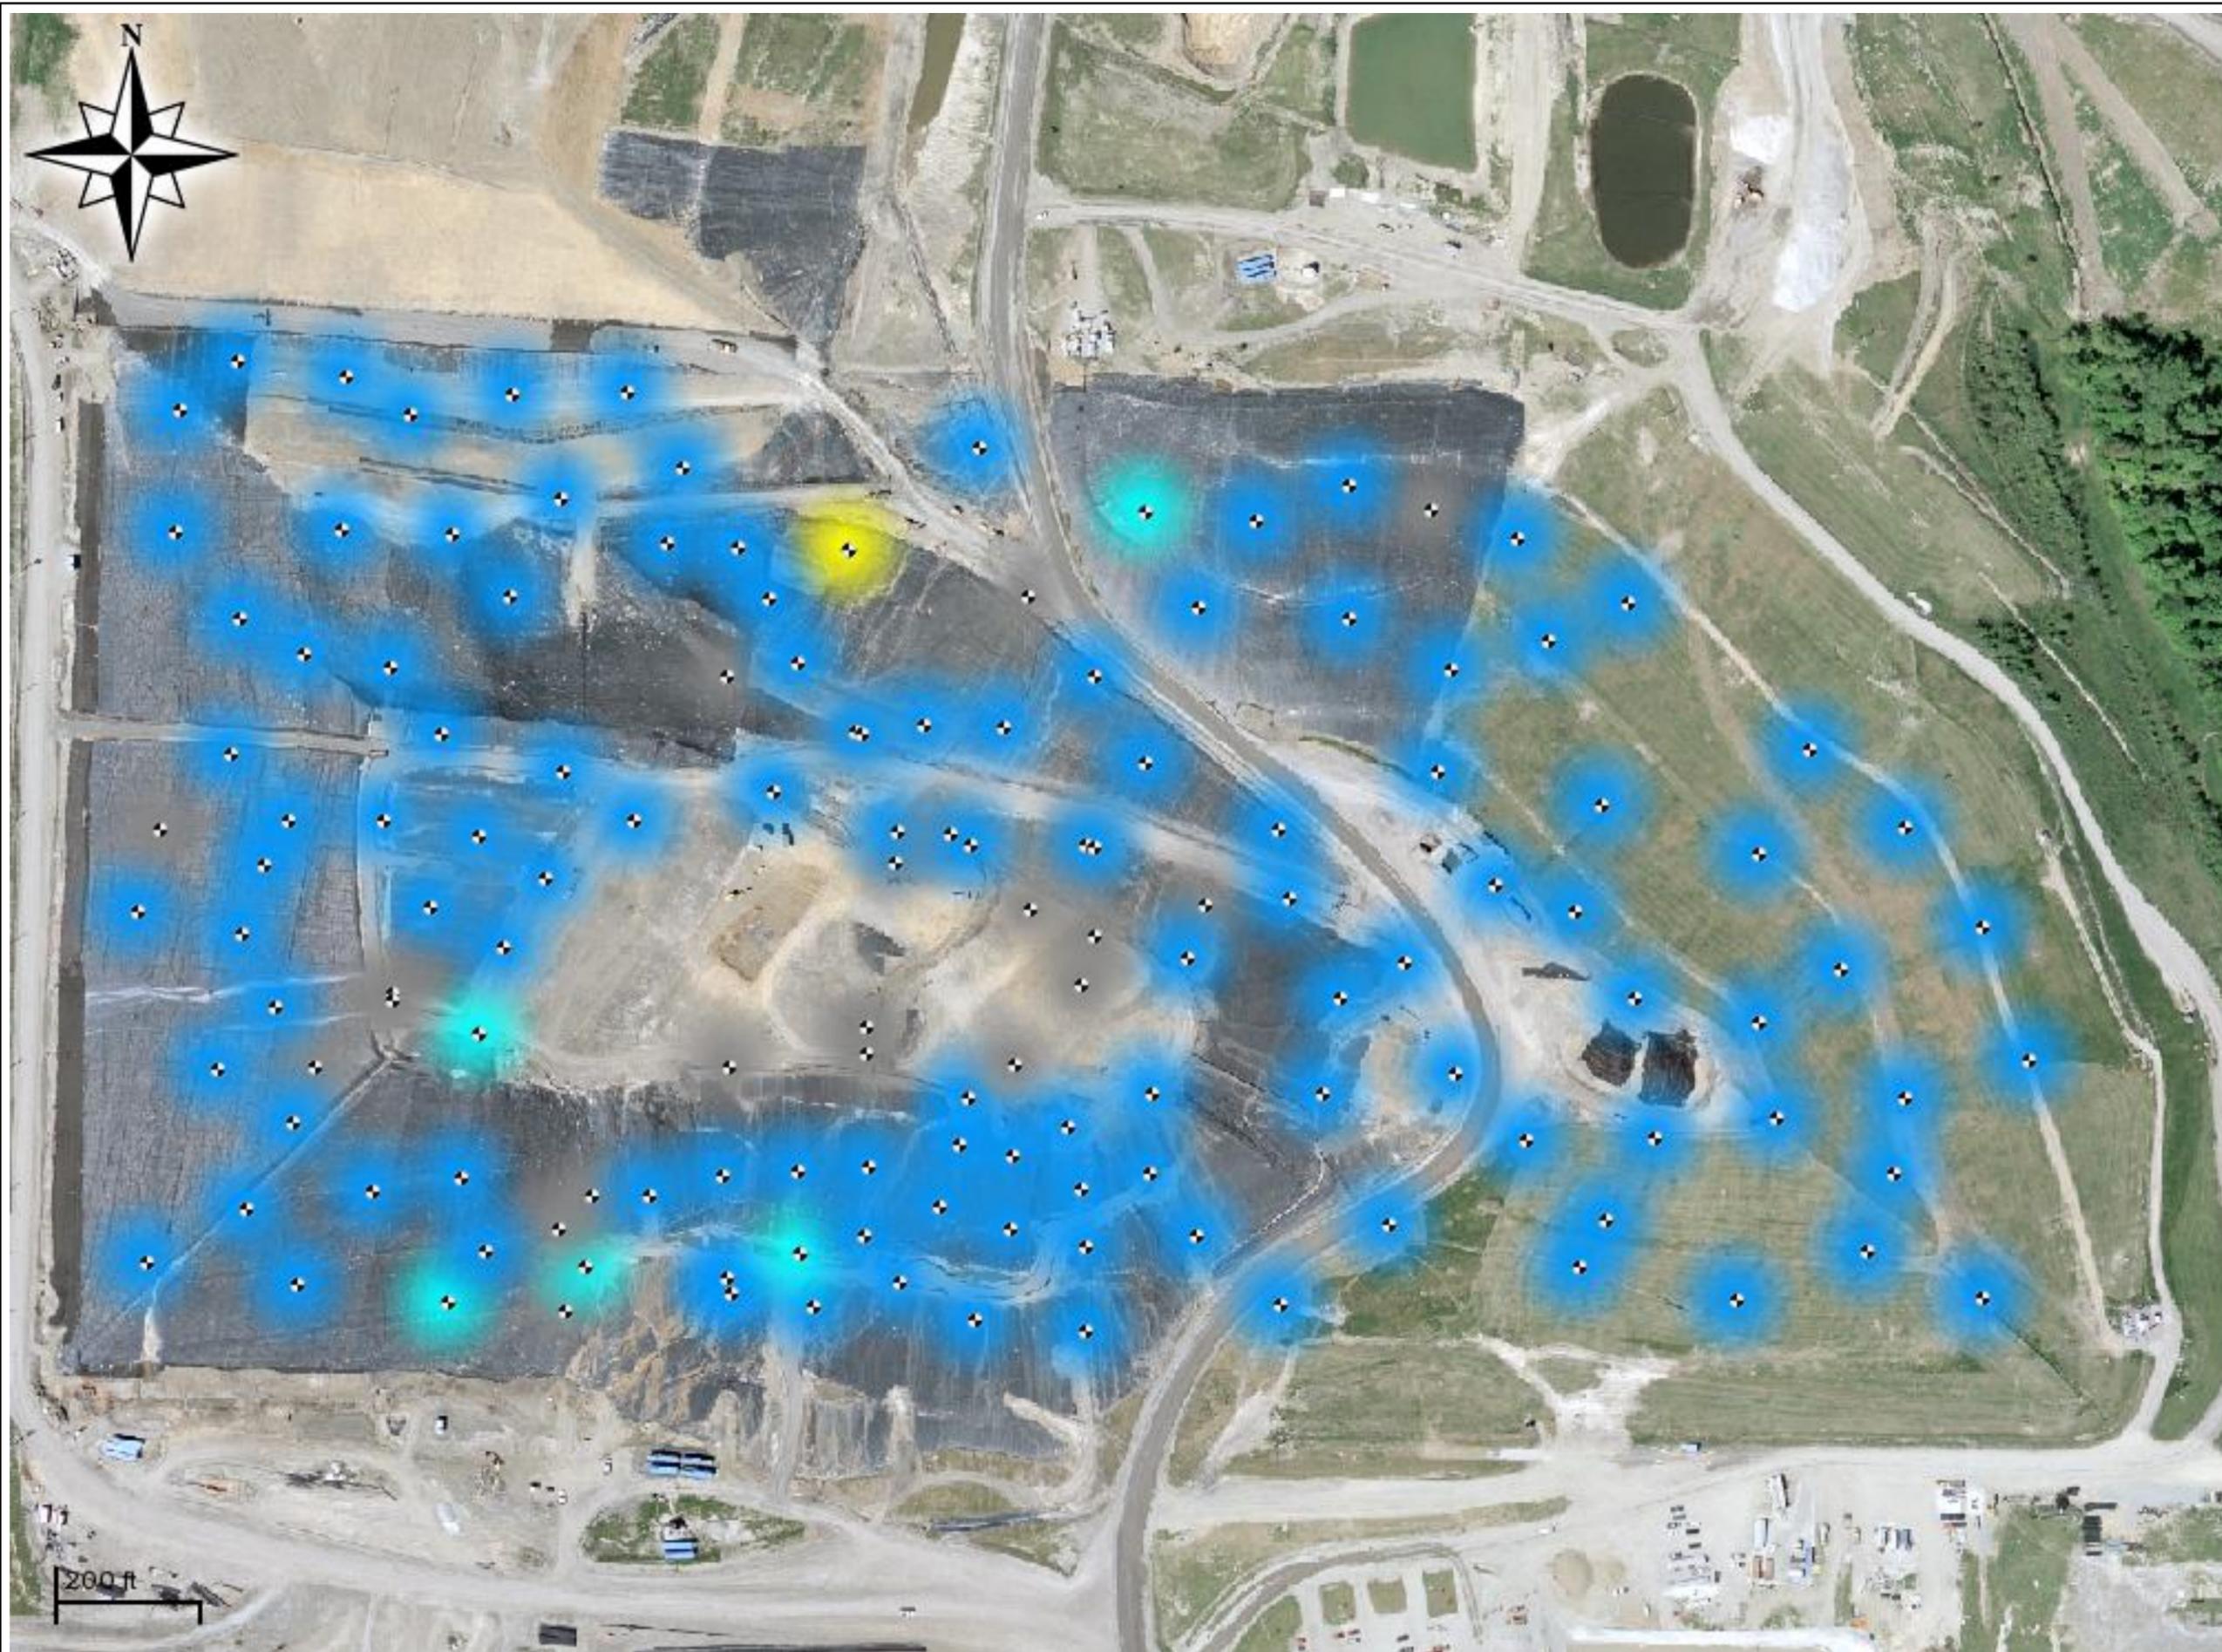
Figure 5
"Deadhead" Gas Well
Pressure Distribution
 Countywide Recycling
 and Disposal Facility
 3619 Gracemont St. S.W.
 East Sparta, Ohio

A radius influence of 100 feet
 is assumed at each device.

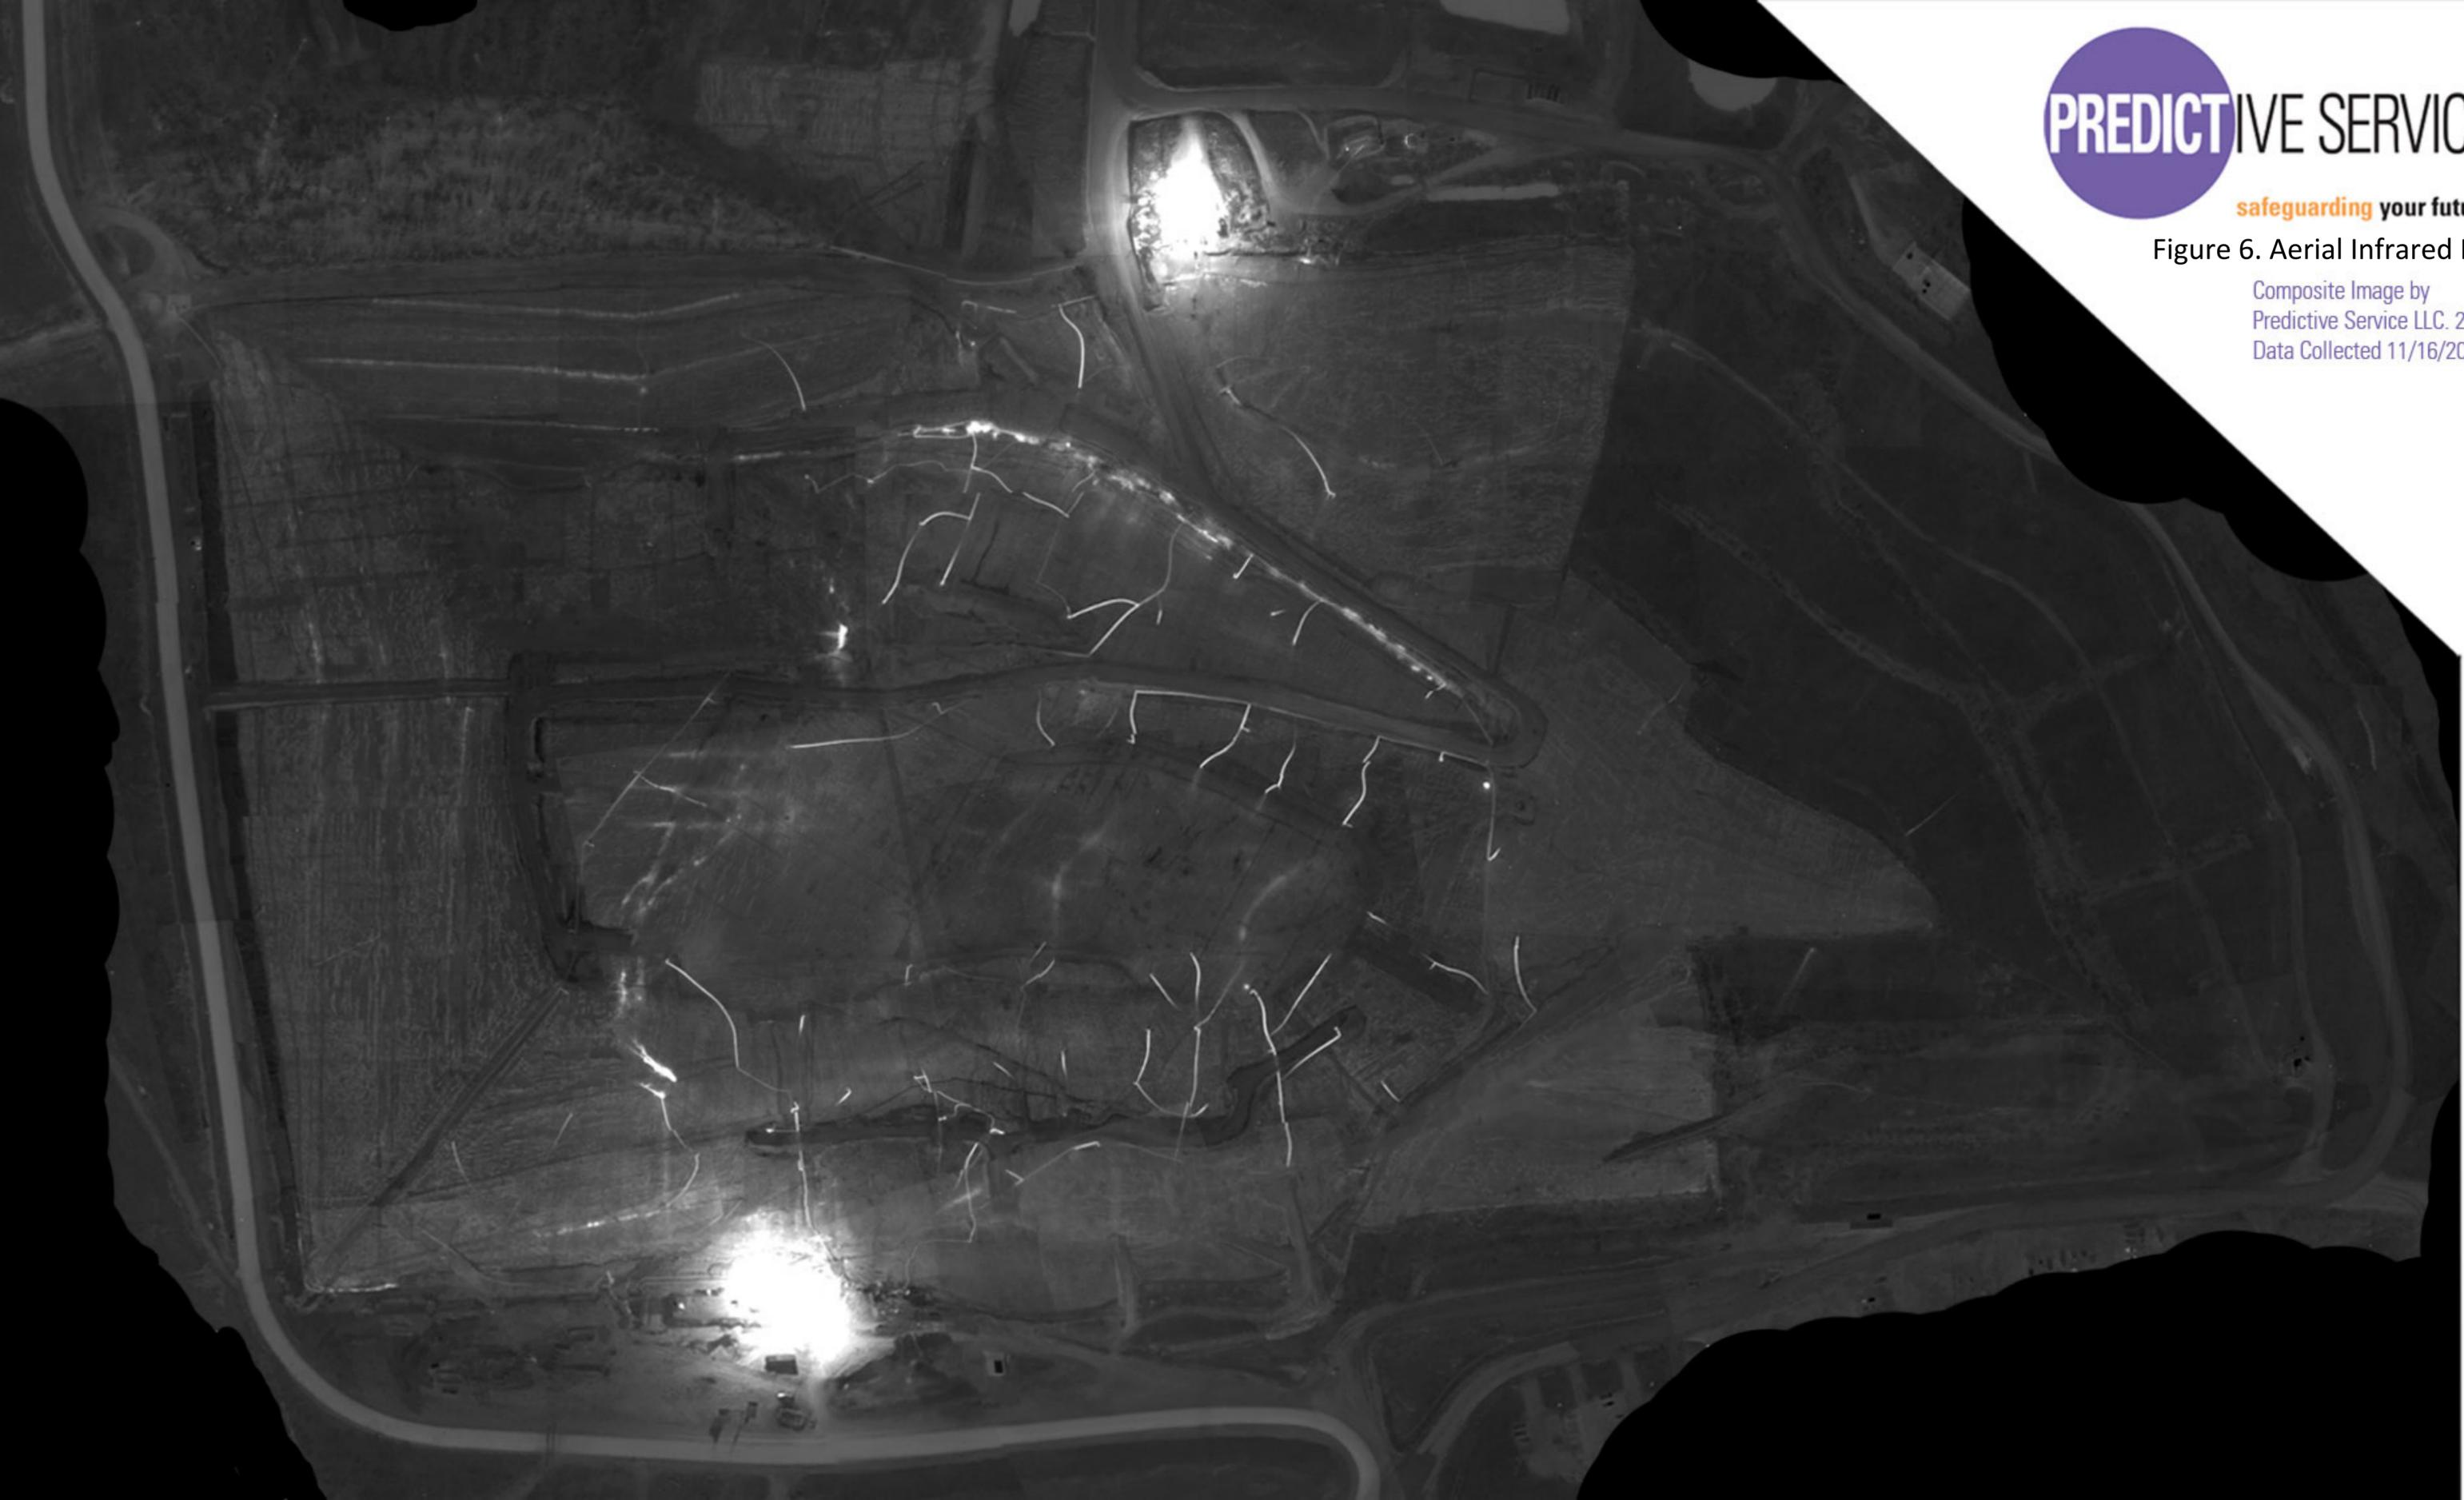
Figure 6. Aerial Infrared Photograph

Composite Image by
Predictive Service LLC. 216.378.3500
Data Collected 11/16/2009

During the November operating period, an area with elevated surface temperatures was observed during a routine temporary cap inspection. The approximate 100 square foot area was located west of RW-1 near the west end of the deep trench. Further investigation identified the area as having temperatures in excess of 150°F on the surface of the cap, and diffusion of odors through the capped surface was noted. On December 4, 2009, the area was overlain by two layers of bentomat, and then overcapped with FML. This procedure has been proven in the past to provide sufficient insulation to inhibit heat stress on the top layer of temporary cap. Following the corrective action listed above, surface temperatures were observed to be well below 150°F.
