OHIO ENVIRONMENTAL PROTECTION AGENCY
DRINKING WATER STATE REVOLVING FUND (DWSRF)
AMERICAN RECOVERY AND REINVESTMENT ACT OF 2009 (ARRA)
GREEN PROJECT INFORMATION

FFY 2009 ARRA GREEN PROJECT INFORMATION FORM

PWS Name: Cleveland PWSID: 1800311

Project Name: Baldwin Residuals & Fairmount Reservoir PPL #: 75
(as assigned by OEPA-- refer to project list on web)

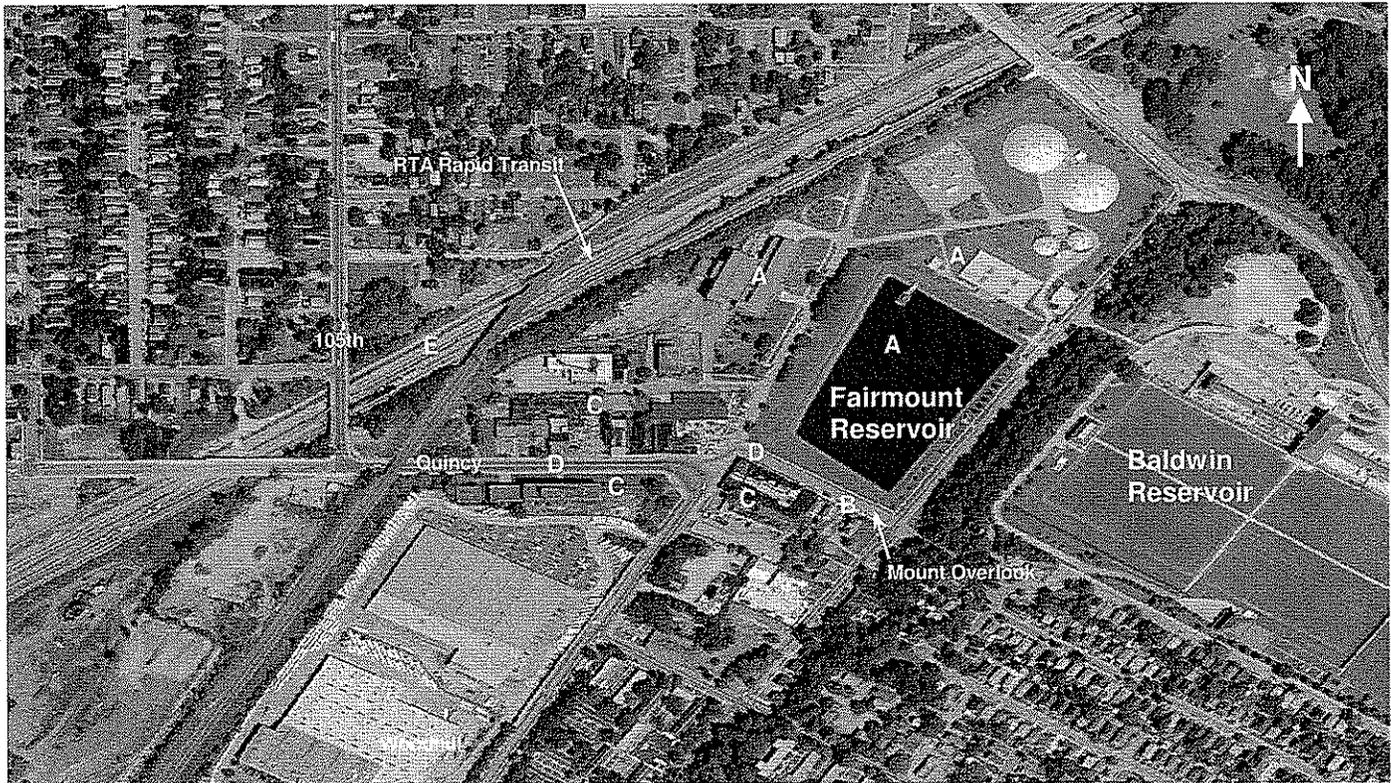
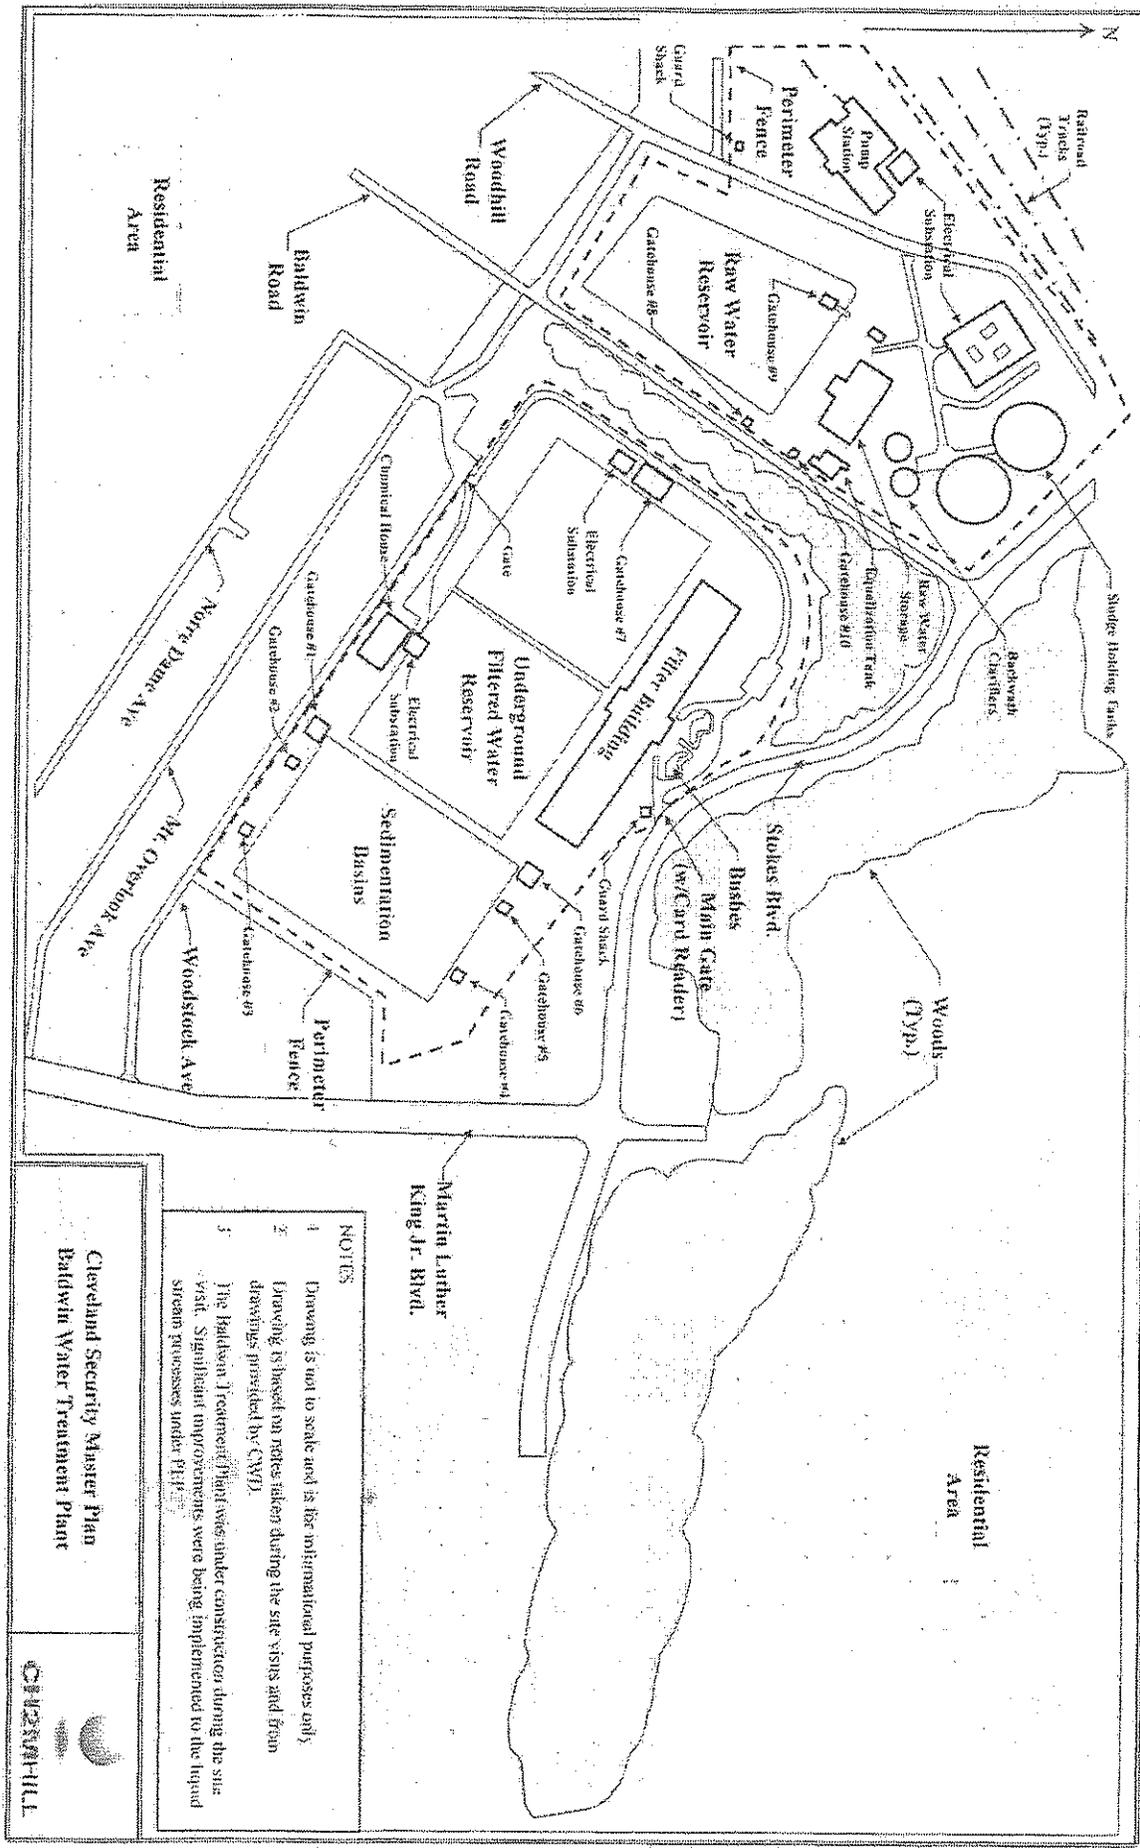
Sketch of Developments Downstream of Dam

I						III	IV	-	-				
Probable loss of human life	Loss of public water supply or wastewater treatment facility, release of health hazardous waste	Flooding of structure or high-value property	Damage to high-value or Class I, II, III dam or levee	Damage to major road (US or state route), disruption of only access to residential or critical facility area	Damage to railroad or public utility	Damage to rural building, not otherwise high-valued property, or Class IV dam or levee	Damage to local road (county and township)	Loss restricted mainly to the dam or agricultural/rural land	No hazard to structure noted	No hazard assessment; further investigation needed	Distance downstream of dam to affected structure (feet)	Vertical distance from streambed to base of affected structure (feet)	Horizontal distance from stream to affected structure (feet)
B	A												reservoir
		C											3 homes
					E	D							>10 bldgs

- NOTES**
1. Drawing is not to scale and is for informational purposes only.
 2. Drawing is based on notes taken during the site visits and from drawings provided by CWD.
 3. The Baldwin Treatment Plant is under construction during the site visit. Significant improvements were being implemented to the hybrid stream processes under P1P.

- ODNR sheet from the February 15, 2006 Inspection Report for the Fairmount Reservoir, File Number 1314-003, indicating potential downstream hazards and the sketch of Developments Downstream of Dam
- USGS Arial Survey, dated 12 Oct 2000
- Baldwin Water Treatment Plant overall site plan (indicates residential areas)
- Cleveland Water Distribution System Overview (indicates CWD Facilities)
- Fairmount Pump Station general information sheet
- Baldwin Water Treatment Plant general information sheet

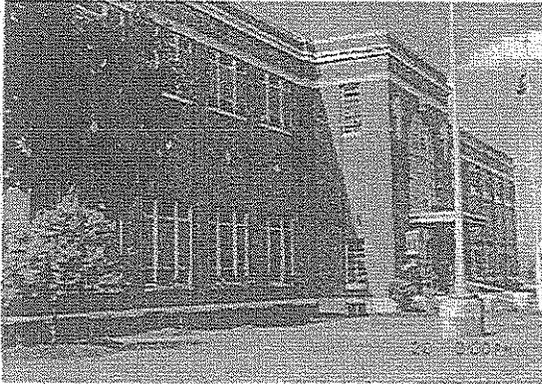
Finished water pump station for the Bakwin Water Treatment Plant to convey water to the first high and second high service areas.

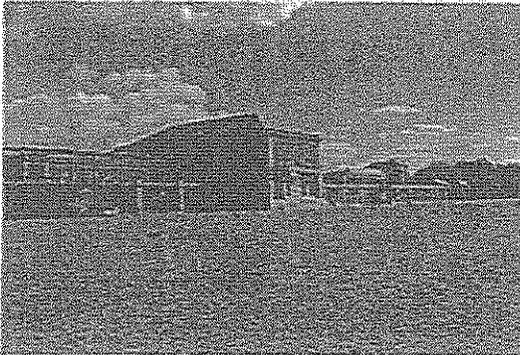
165 MGD conventional water treatment plant. Processes include rapid mixing, flocculation, sedimentation and filtration.

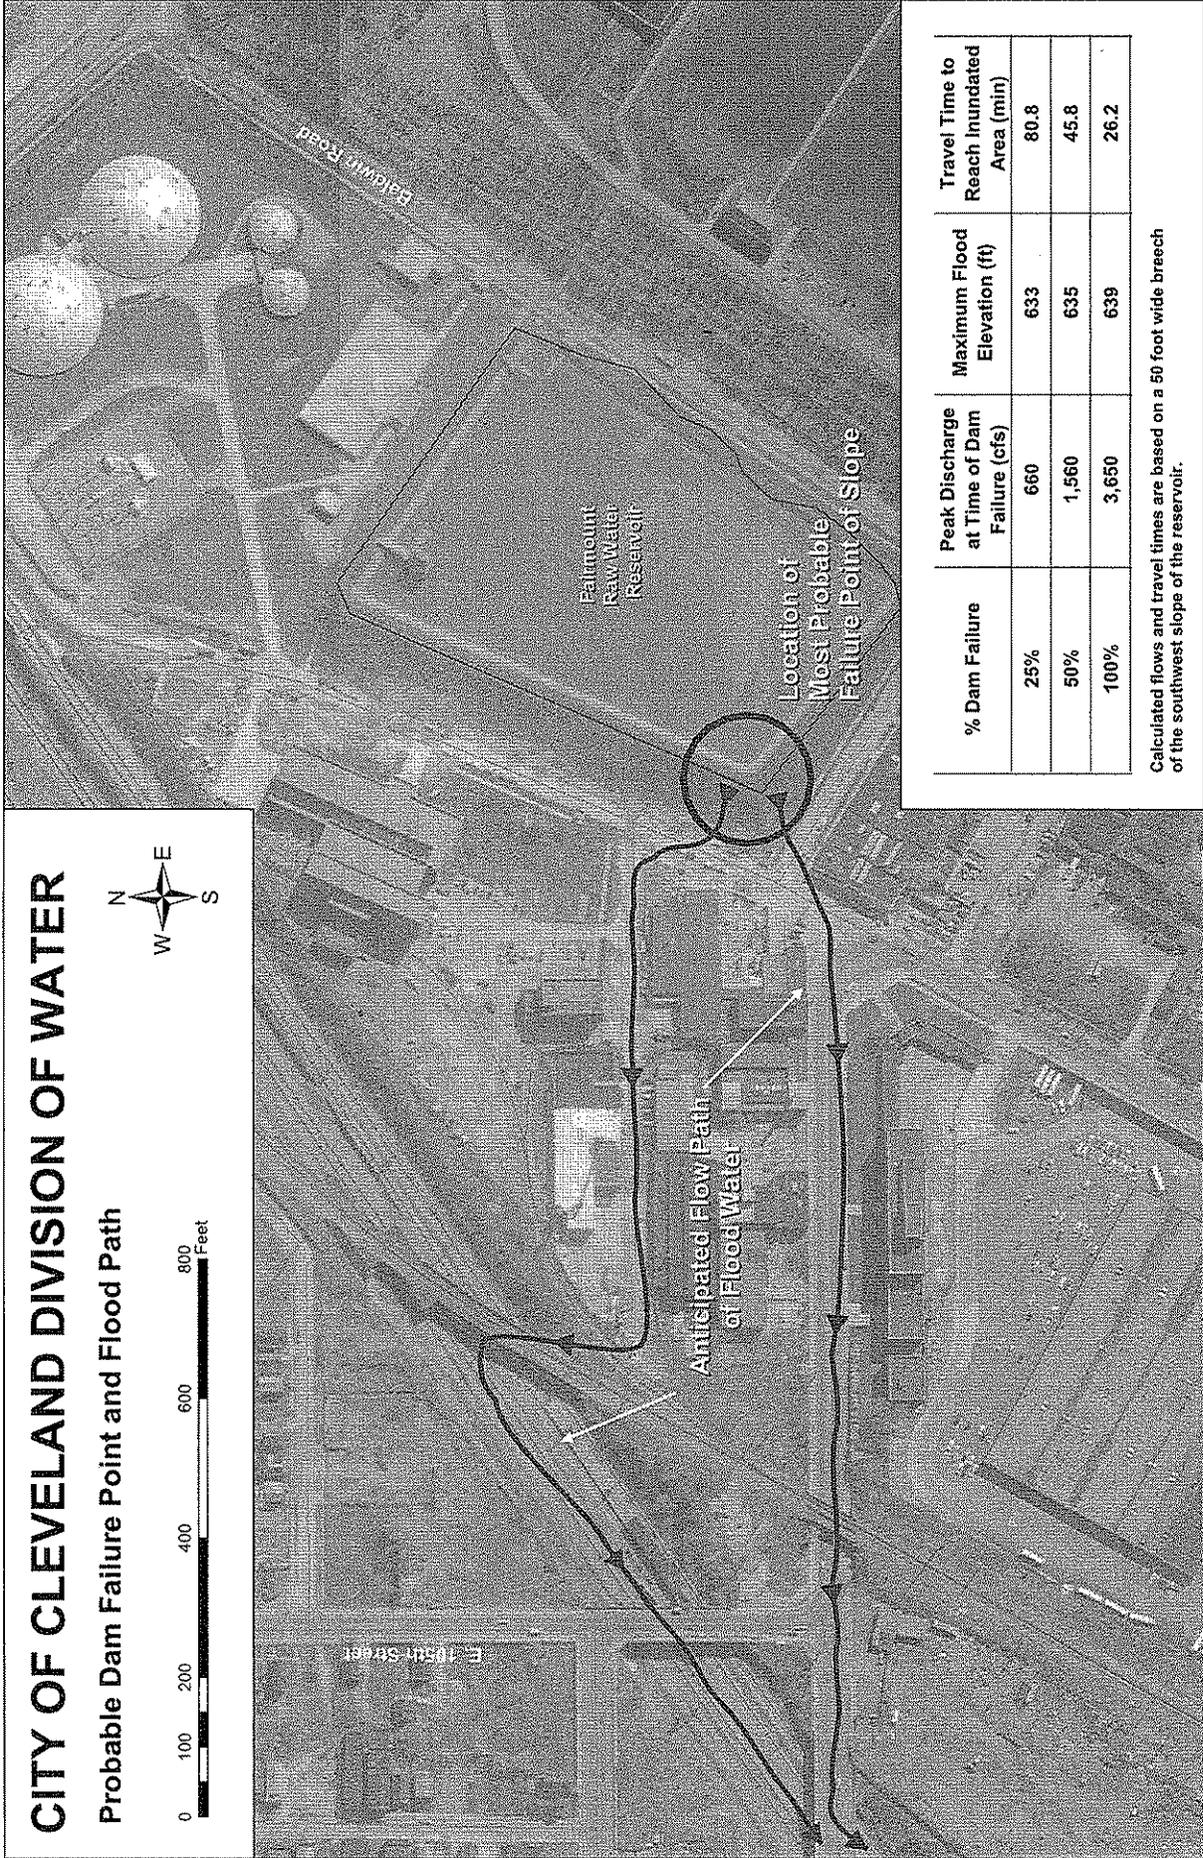
Probable Dam Failure Point and Flood Path

% Dam Failure	Peak Discharge at Time of Dam Failure (cfs)	Maximum Flood Elevation (ft)	Travel Time to Reach Inundated Area (min)
25%	660	633	80.8
50%	1,560	635	45.8
100%	3,650	639	26.2

Calculated flows and travel times are based on a 50 foot wide breach of the southwest slope of the reservoir.

Inundation maps, developed by CWD, indicate the most probable location of a dam failure as being the southwest corner of the reservoir.** As indicated in previous inspections, this is a wet area, approximately 15 feet long by 3 feet high that could cause soil saturation, slope instability and could possibly trigger a slide on the embankment, resulting in slope and/or embankment failure.

- **Probable Dam Failure Point and Flood Path**

Identifies the location of most probable failure point of the reservoir as being the southwest corner. An approximate 50 ft. breach area in the embankment was used to develop the inundation map.

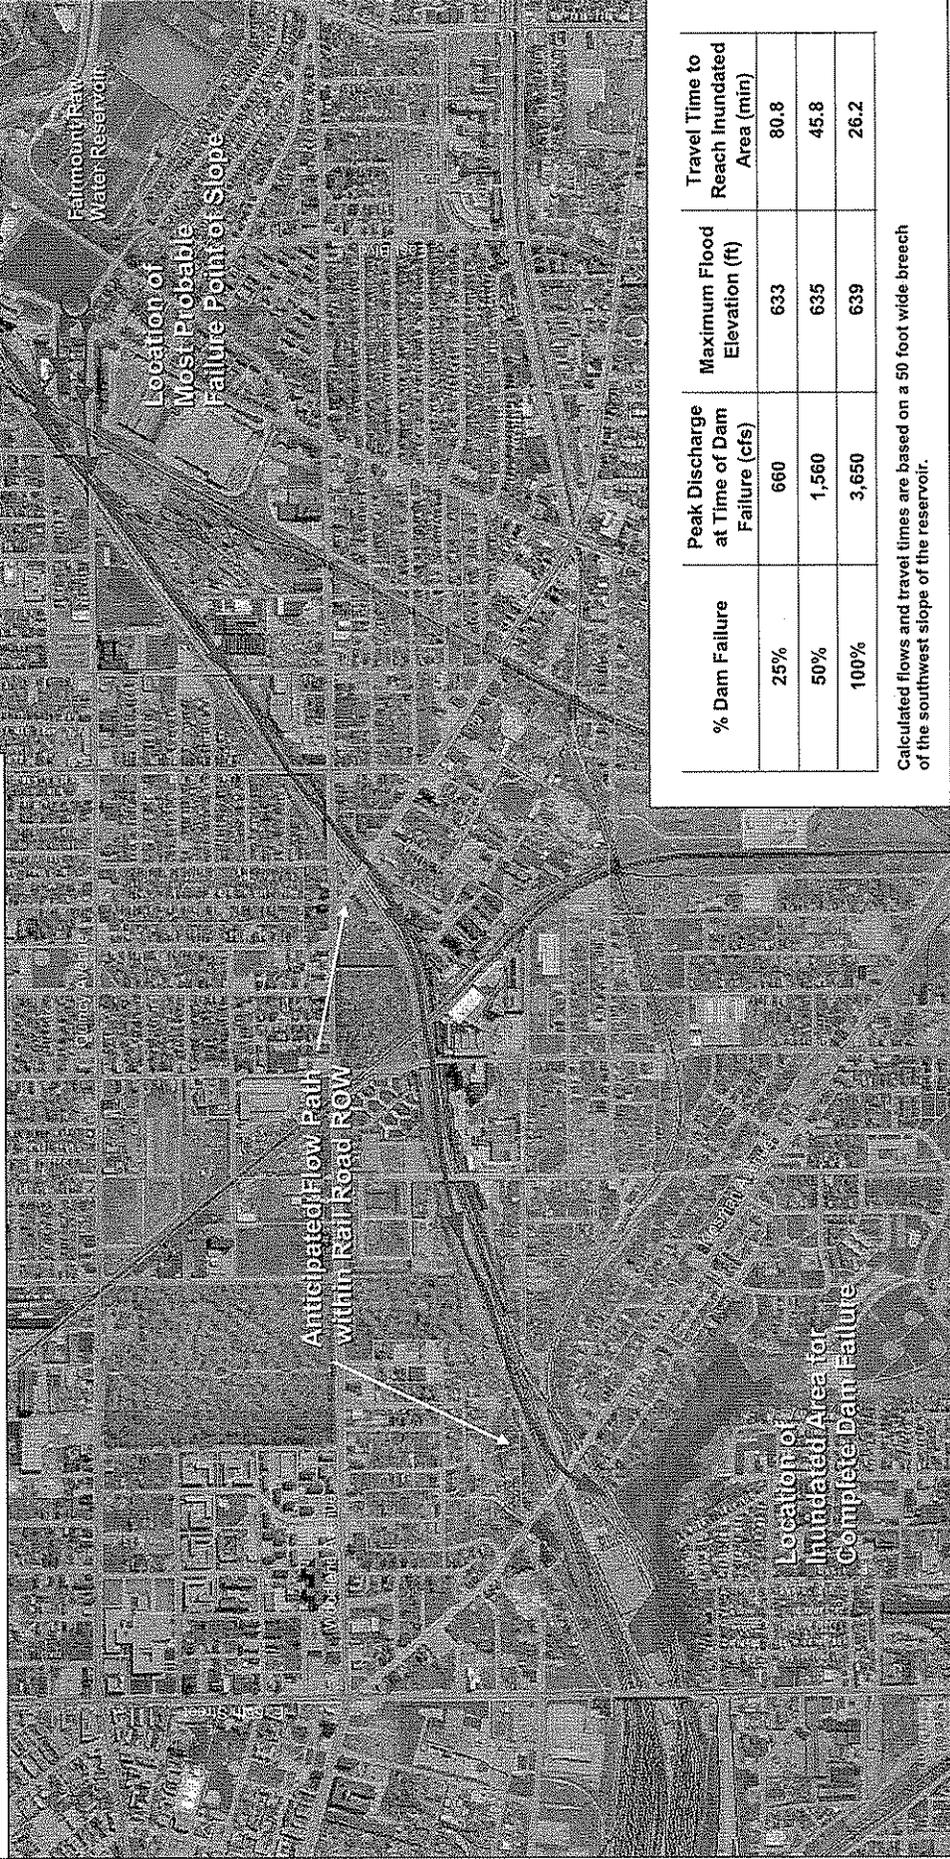
Probable Flood Path and Maximum Flood Area
with Orthographic Photography

% Dam Failure	Peak Discharge at Time of Dam Failure (cfs)	Maximum Flood Elevation (ft)	Travel Time to Reach Inundated Area (min)
25%	660	633	80.8
50%	1,560	635	45.8
100%	3,650	639	26.2

Calculated flows and travel times are based on a 50 foot wide breach of the southwest slope of the reservoir.

Indicates the anticipated flow path within the Railroad ROW. Location of inundated area for complete dam failure is approximately 1.9 miles along the RR corridor. Inundated area is the E. 55th. St. Rapid Transit Station, property owned by the City of Cleveland Rapid Transit Authority.

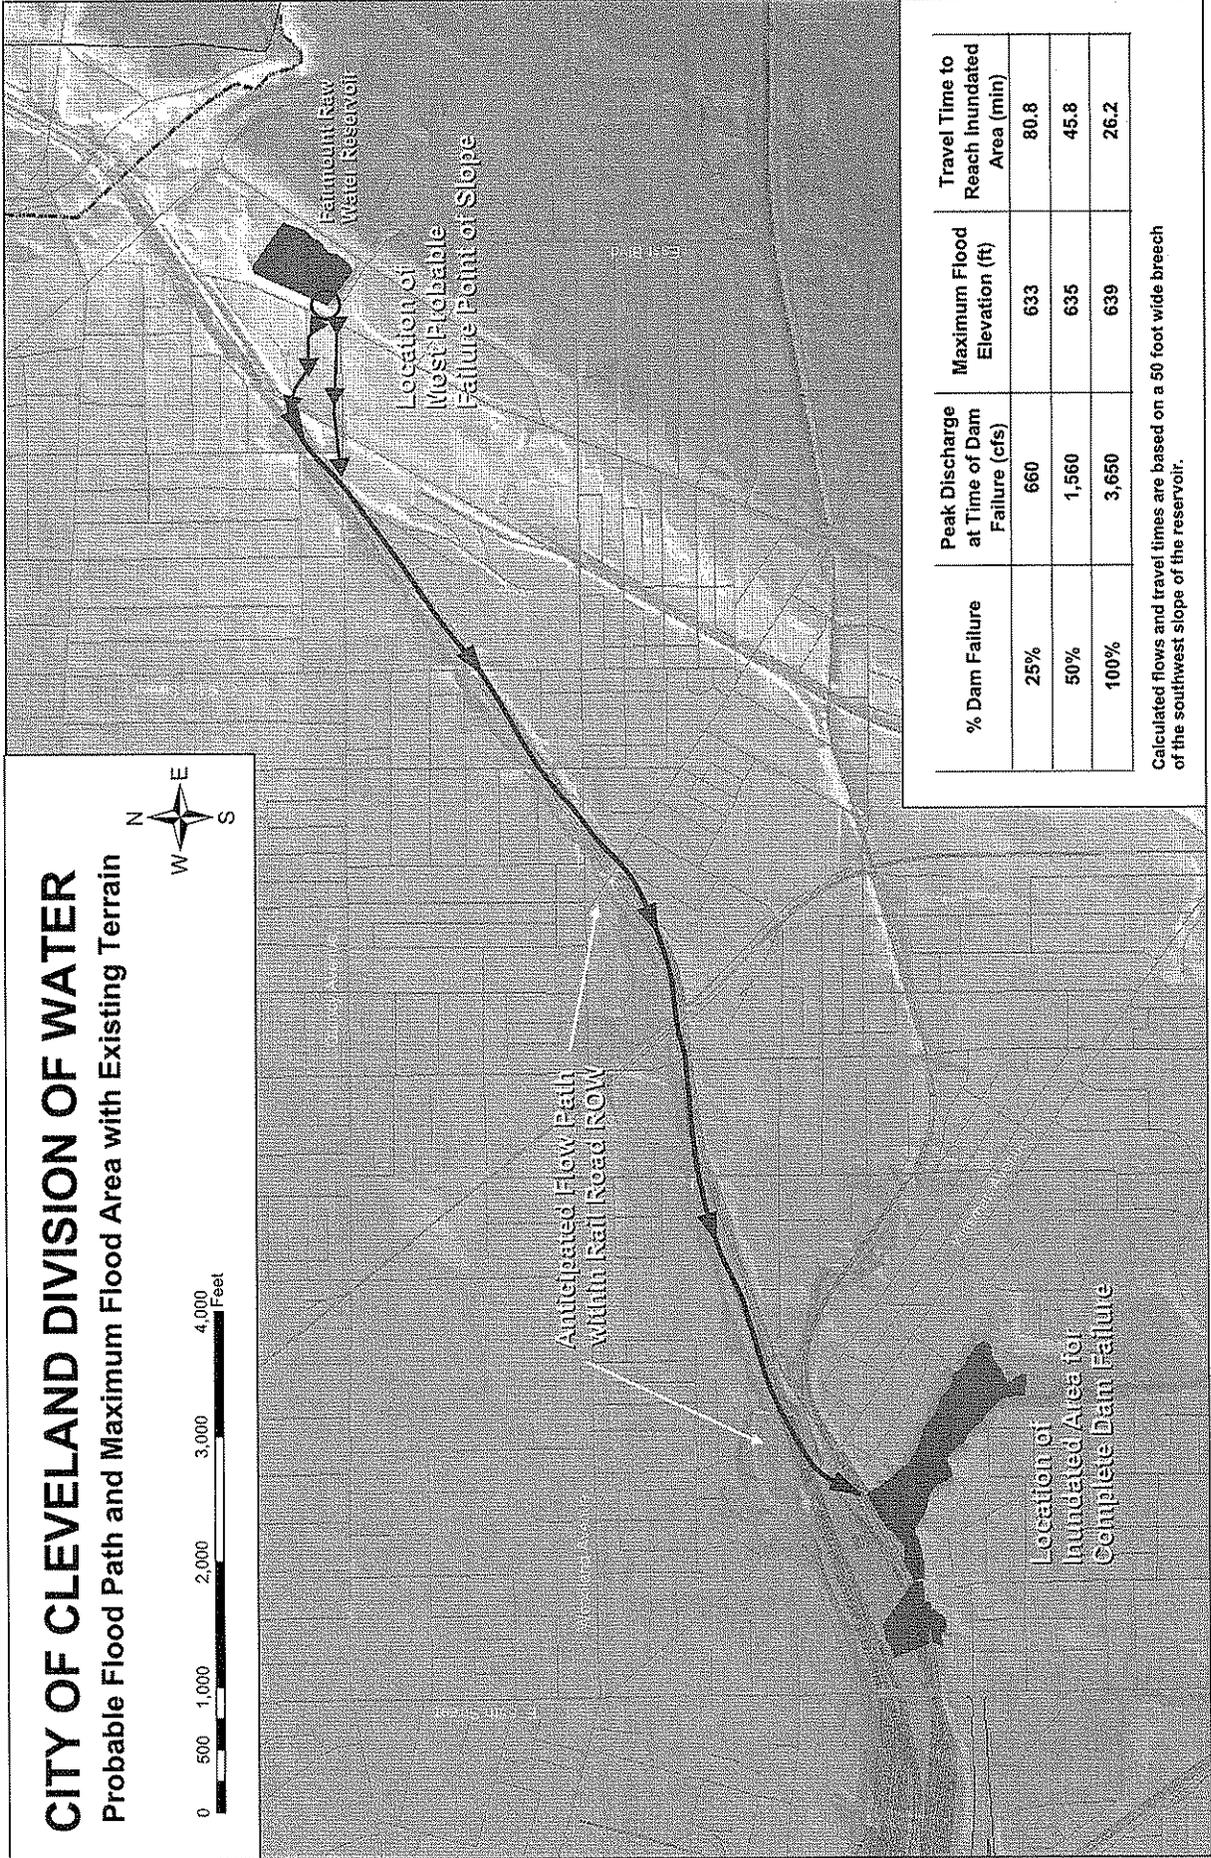
Probable Flood Path and Maximum Flood Area with Existing Terrain

% Dam Failure	Peak Discharge at Time of Dam Failure (cfs)	Maximum Flood Elevation (ft)	Travel Time to Reach Inundated Area (min)
25%	660	633	80.8
50%	1,560	635	45.8
100%	3,650	639	26.2

Calculated flows and travel times are based on a 50 foot wide breach of the southwest slope of the reservoir.

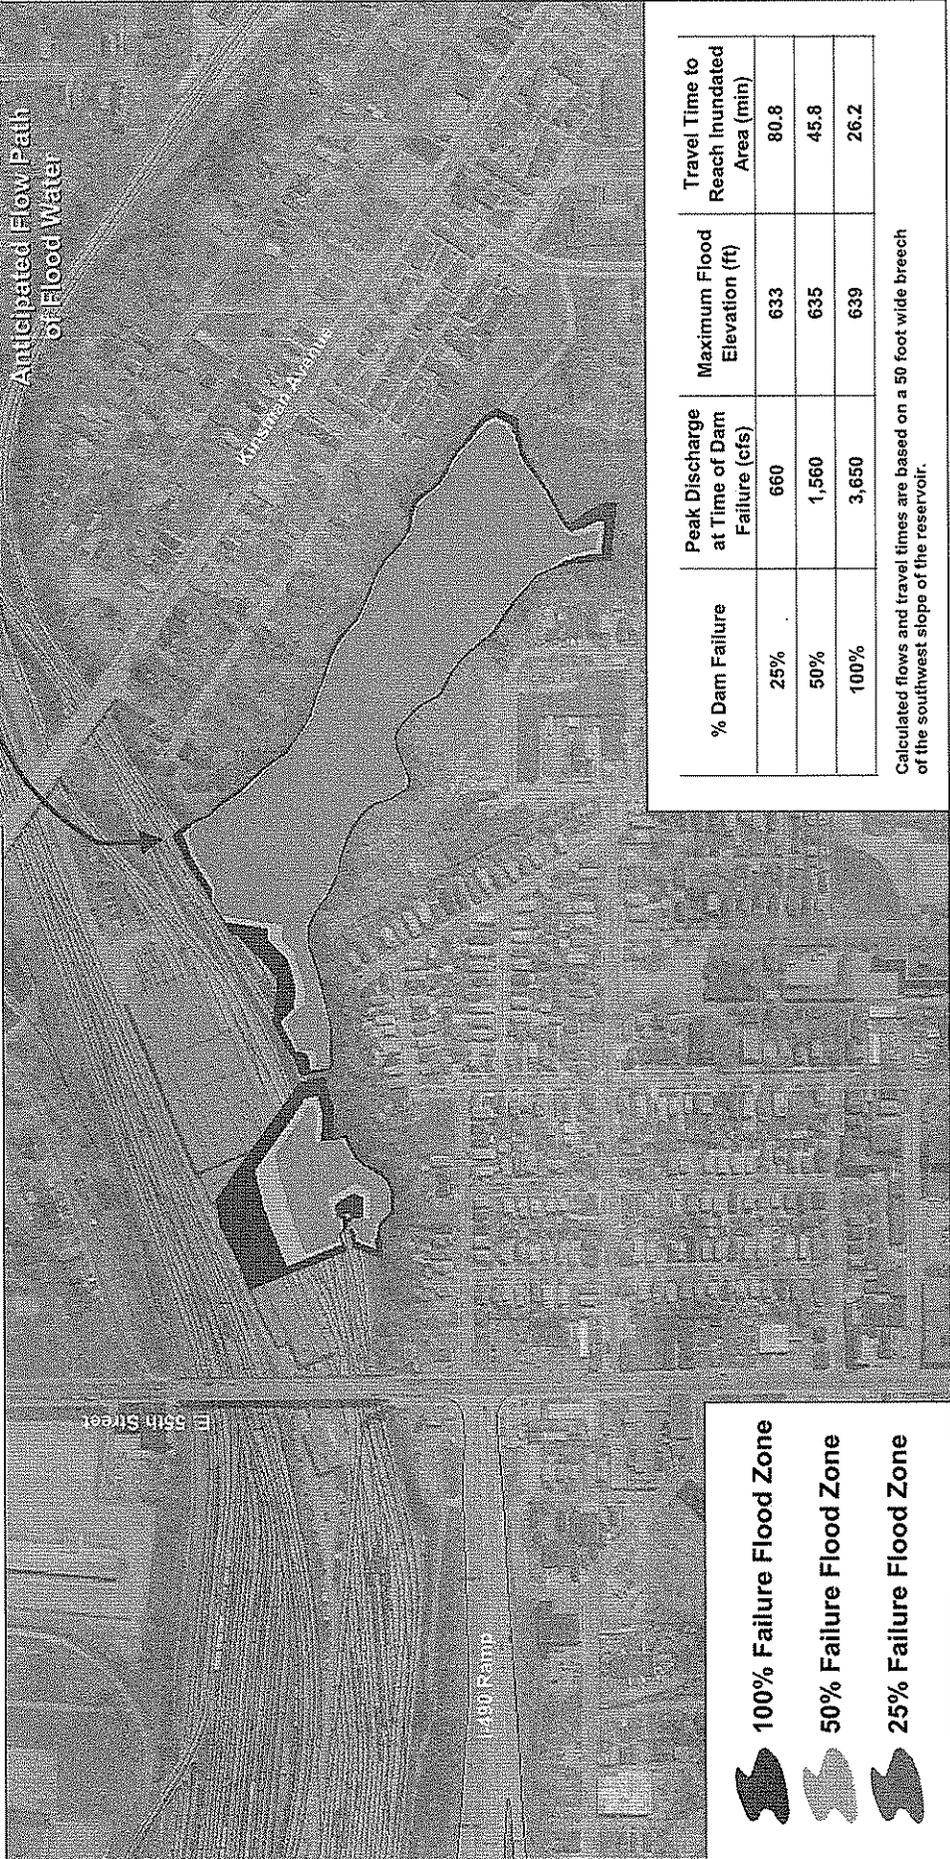
Probable Flood Zones

100% Failure Flood Zone
-

50% Failure Flood Zone
-

25% Failure Flood Zone

% Dam Failure	Peak Discharge at Time of Dam Failure (cfs)	Maximum Flood Elevation (ft)	Travel Time to Reach Inundated Area (min)
25%	660	633	80.8
50%	1,560	635	45.8
100%	3,650	639	26.2

Calculated flows and travel times are based on a 50 foot wide breach of the southwest slope of the reservoir.

This map indicates probable flood zones utilizing different colors for % of failure.

- **100% Failure Flood Zone indicated in RED**
- **50% Failure Flood Zone indicated in YELLOW**
- **25% Failure Flood Zone indicated in GREEN**

Each map includes a table evaluating the below listed items for each of the failure conditions.

- Peak Discharge at Time of Dam Failure (cfs)
- Maximum Flood Elevation (ft)
- Travel Time to Reach Inundated Area (min)

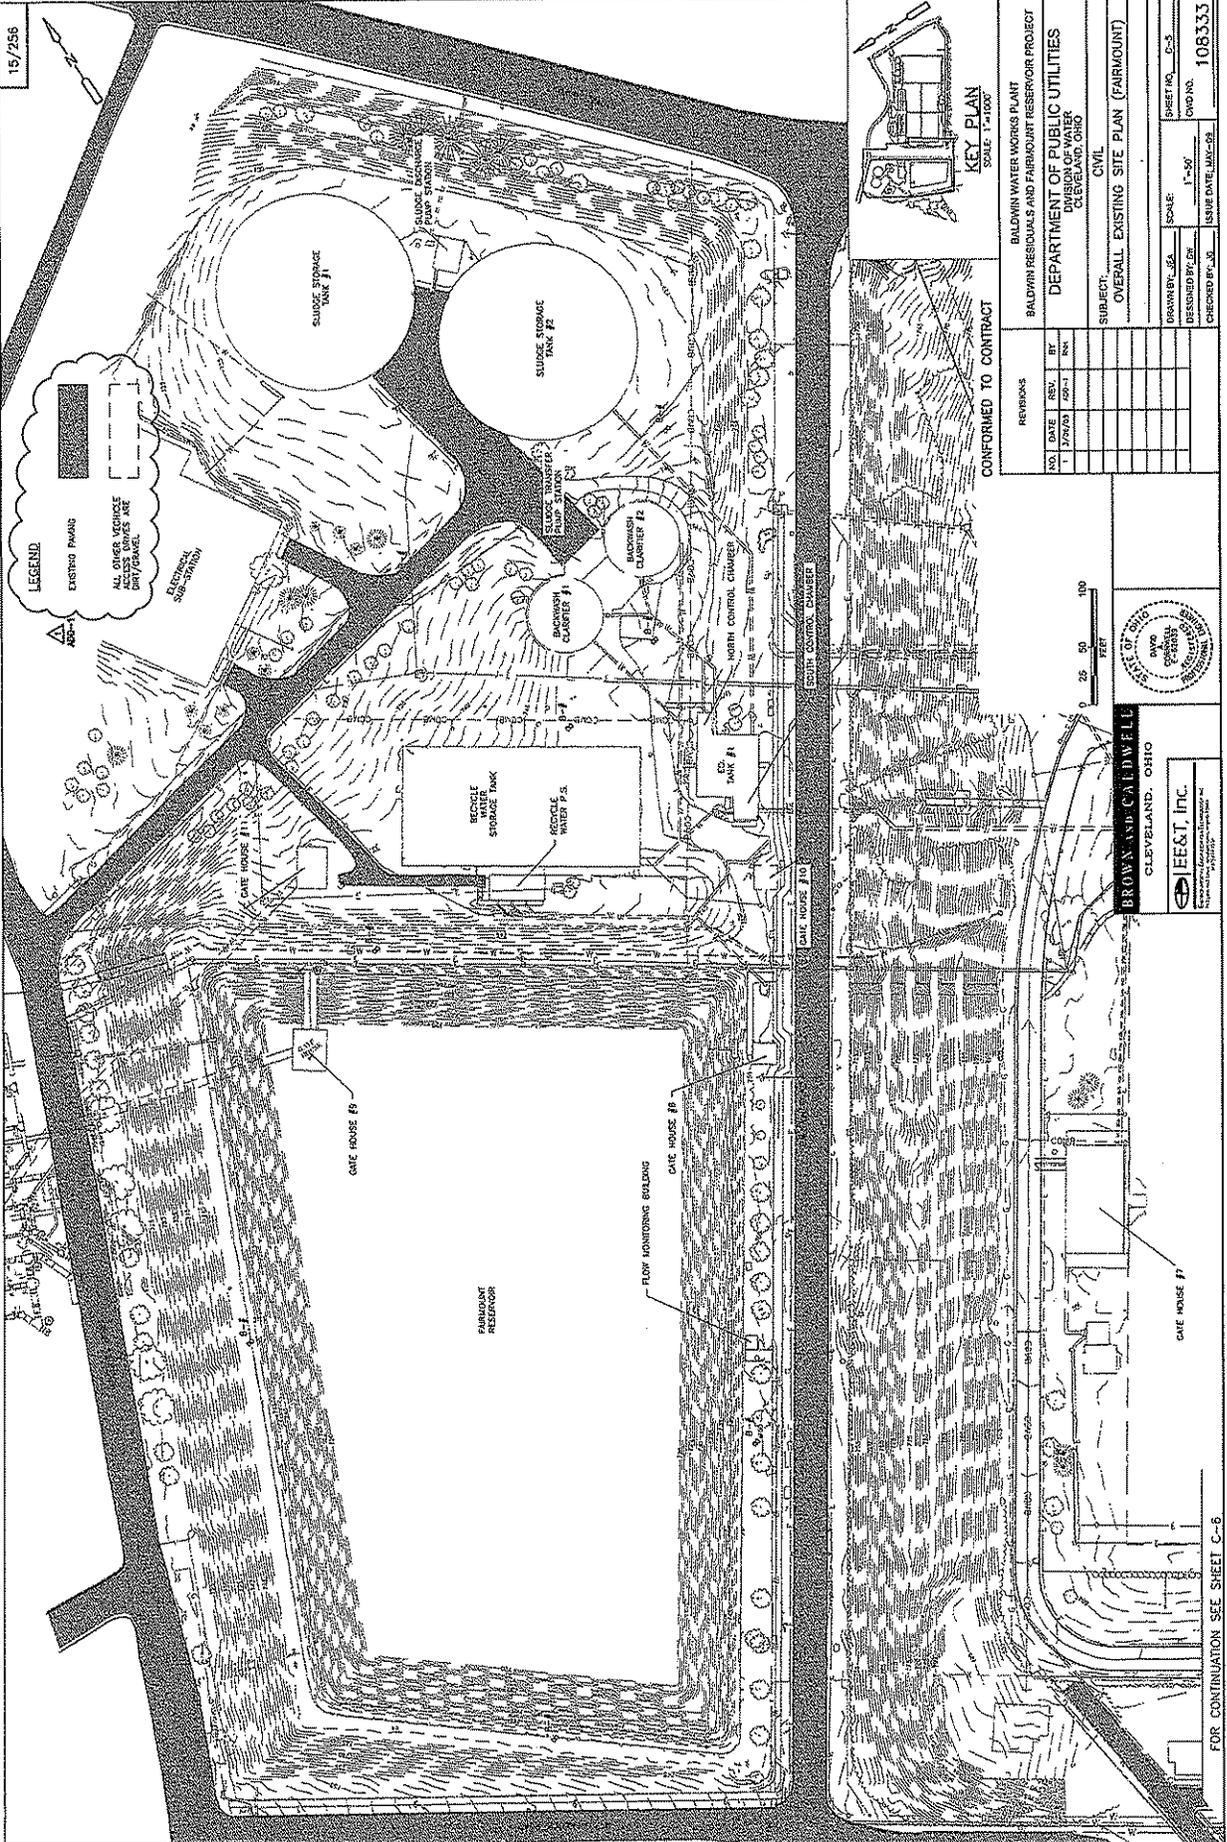
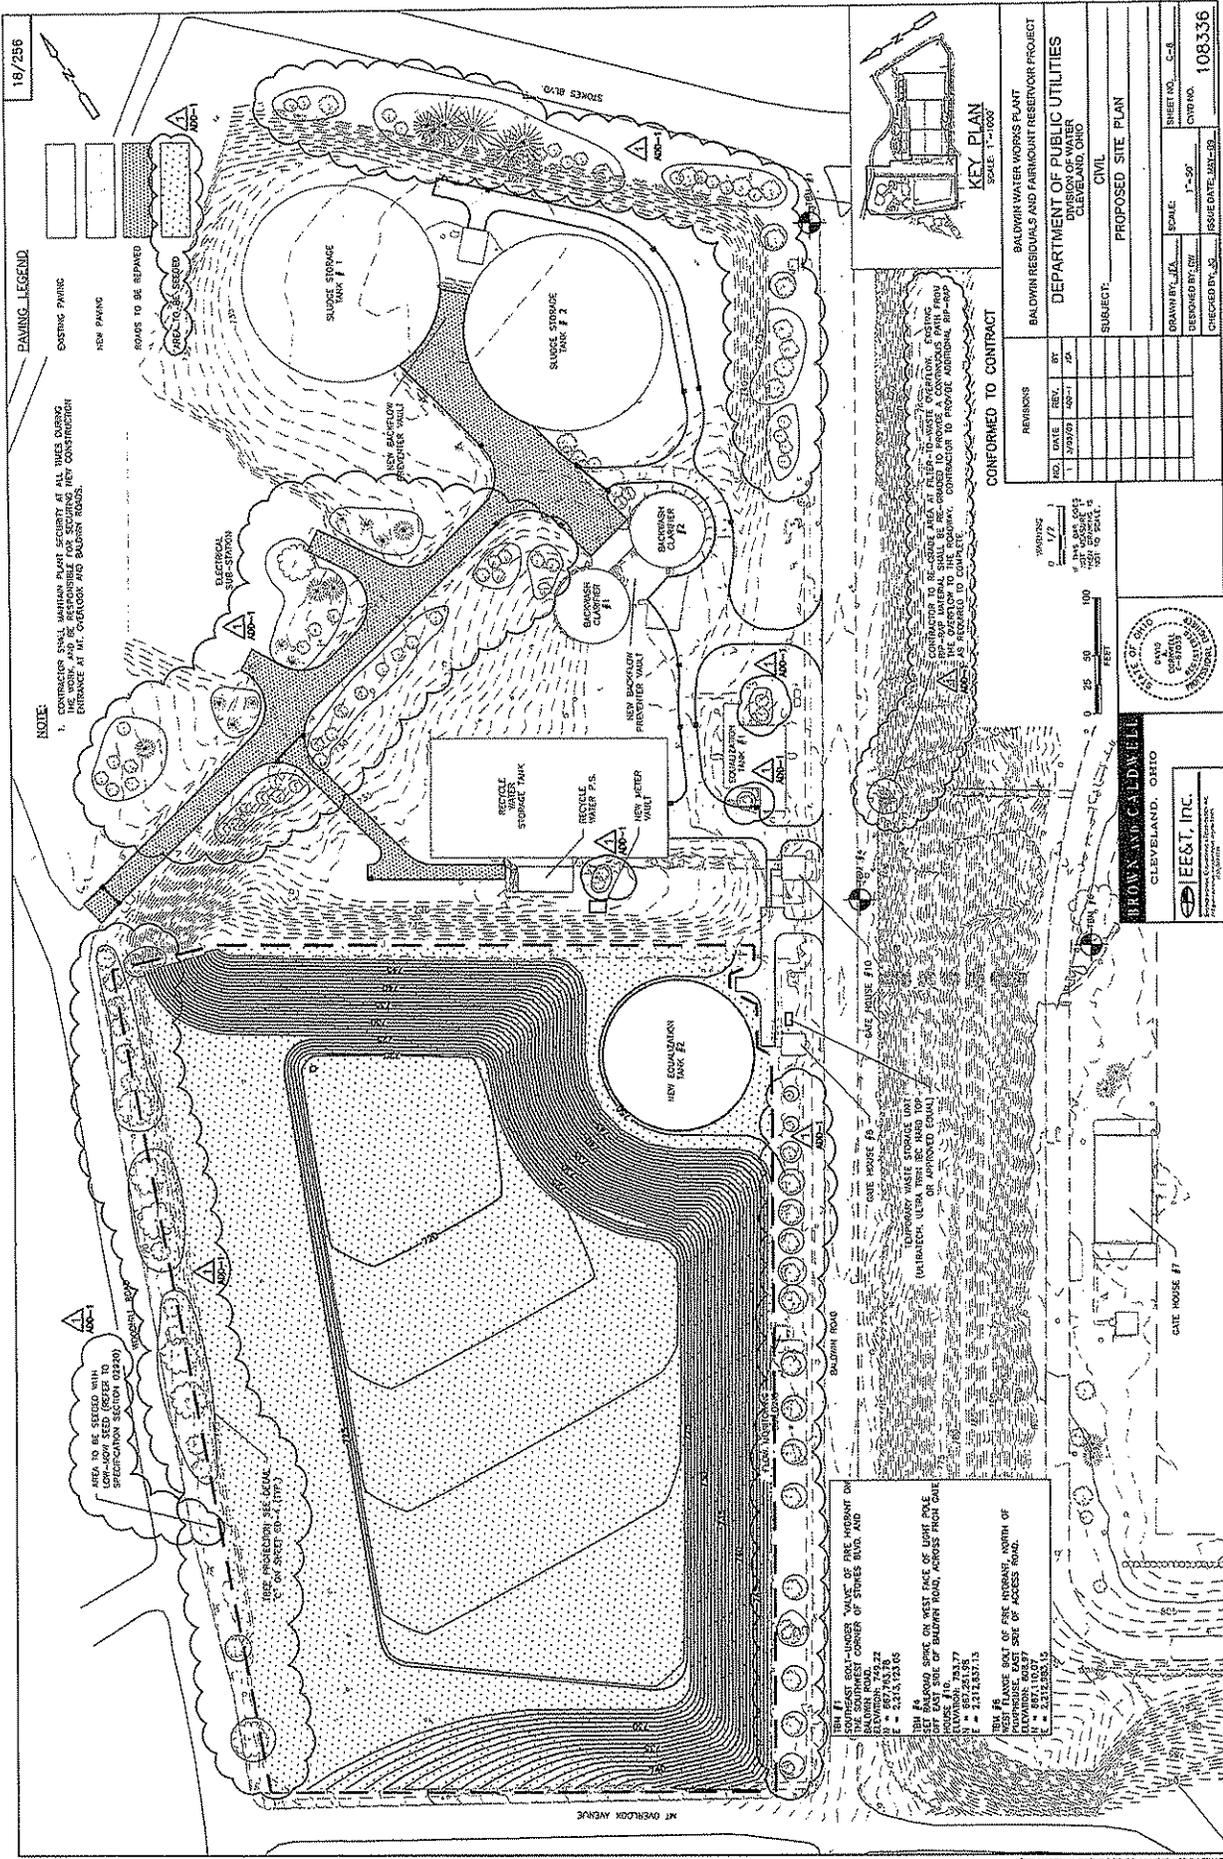
SUBJECT: CIVIL
PROPOSED SITE PLAN

DRAWN BY: JEA
SCALE: 1"=50'
CHECKED BY: JLS
ISSUE DATE: 10/20/07
SHEET NO.: C-1
CIVIL NO.: 108336
