# Ohio Section 319 Success Story

## **Project Title:** Middle Cuyahoga Watershed Restoration Project

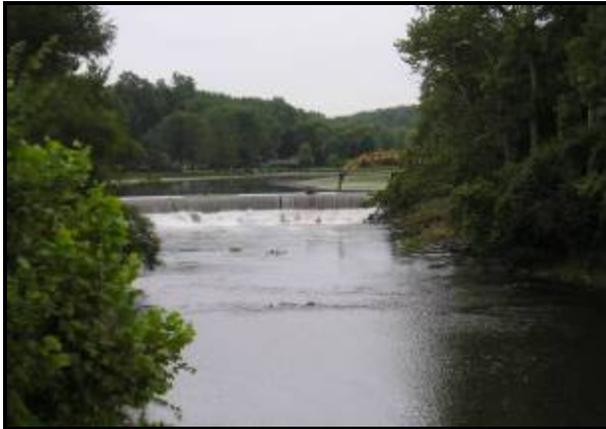
**PHOTO 1-1**

This 2005 photo shows conditions at the Munroe Falls dam PRIOR to removal. Note the large dam pool created by this dam. Low flow period caused serious dissolved oxygen shortages behind the dam extending for nearly three miles.

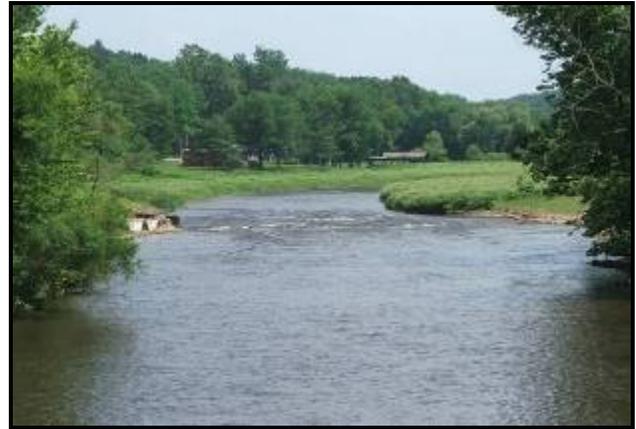
**PHOTO 1-2**

This 2006 photo shows how free-flowing conditions have been restored and exposed riverbanks exhibiting vigorous plant growth.

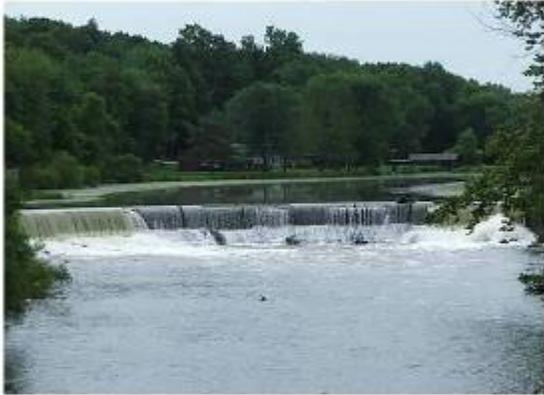
August 15, 2005

**Middle Cuyahoga River at the  
Site of the Munroe Falls Dam  
— What a difference a Year Makes!**

Daily Discharge at Portage Path streamgage:  
~190 cfs—low flow

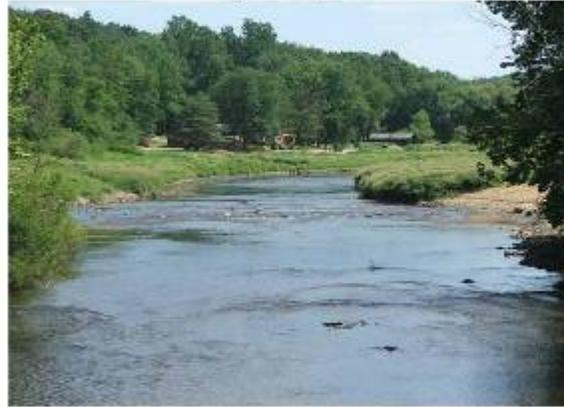
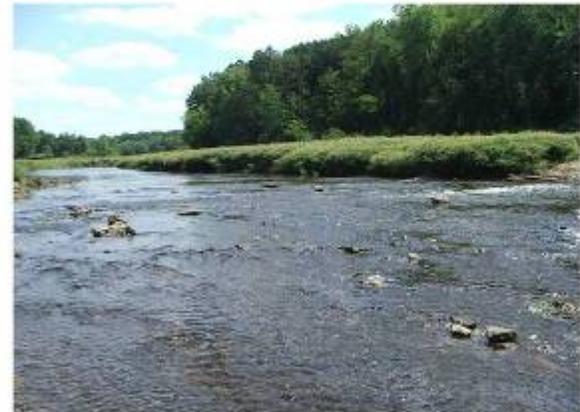
August 16, 2006

Daily Discharge at Portage Path streamgage:  
~180 cfs—low flow
